## August 4, 2026 – PCB Integration and Troubleshooting Update

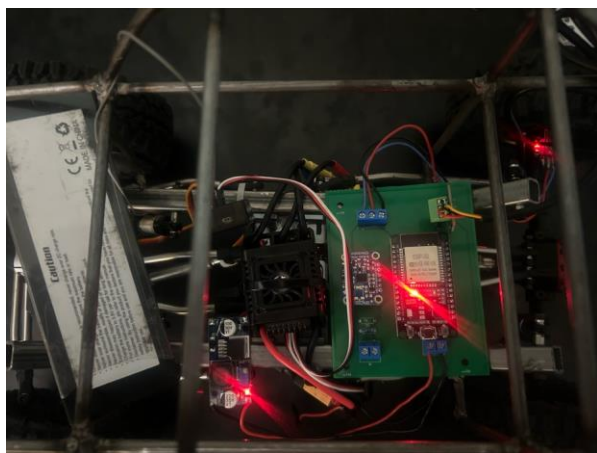
Finally, I completed an initial lifted-wheel test of the crawler. The telemetry system successfully calculated an unloaded theoretical maximum speed of **17.28 mph**. A ground-speed test is still required to determine the vehicle's actual speed under load.
