AREA A

Project 2

Area A – Project 2 focuses on the full revitalization of a residential alleyway surrounded by multi-family housing in a dense urban neighborhood. Sections 1 through 6 address different portions of the alley that have suffered from long-term neglect, graffiti, damaged fencing, and unsafe or deteriorating pavement.

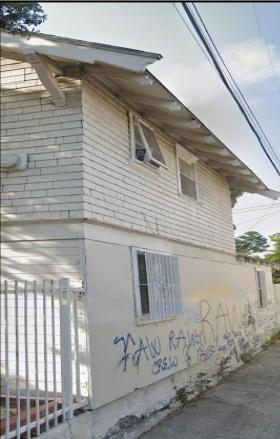
Section 2 - Wall & Pavement in Front

Wall: Clean and repaint the heavily graffitied wall with water-themed blues or neutral tones to reduce visual noise and restore a sense of care. Use exterior-grade paint with primer or optional anti-graffiti sealant for longer-lasting protection. Murals or blended colors may be applied to add personality and community identity.

Pavement: Repair uneven sidewalk cracks and surface issues with patching or re-leveling. Optional planter pots can be installed to add greenery and create a welcoming edge along the walkway. These small interventions enhance both safety and visual appeal.

This section focuses on visual transformation of the alley entrance, which serves as the first point of contact for most passersby. The bold graffiti, worn-down paint, and cracking pavement currently signal neglect. By repainting the wall and repairing the surface, this intervention signals investment in the community and encourages pride of place.

Adding murals, water-toned palettes, and sidewalk planters softens the space and reinforces a welcoming, safe, and pedestrian-friendly environment. The updates here not only improve functionality but also create a visual buffer between the public street and the inner alley, helping reframe the space as part of the community, not a forgotten edge.

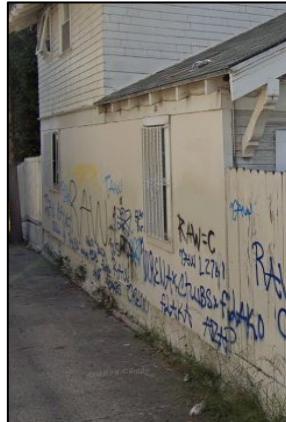
Section 3 - Paint Wall, Remove Weeds, Smooth Pavement

This section plays a key role in reactivating a neglected stretch of the alley. By repainting the wall with calming, water-themed colors and removing graffiti, the design shifts the area from one of blight to one of renewal. Overgrown weeds that previously obstructed visibility were cleared, making the space feel safer and more open.

Together, the new colors and basic pavement smoothing create a lighter, more welcoming atmosphere. This intervention helps break the pattern of abandonment and instead sets a precedent for consistent care, encouraging long-term maintenance and community pride within the alley.

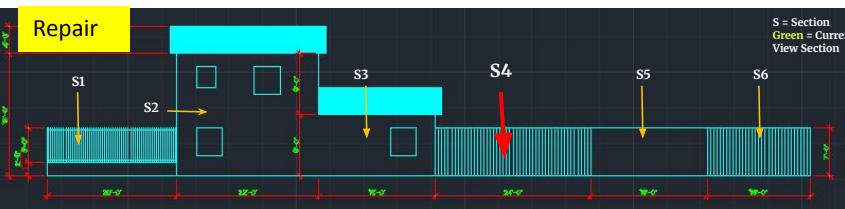
Section 4 - Warped and Tagged Wooden Fence

This section focuses on subtle but necessary restoration of a smaller alley segment that has become worn and neglected. The damaged wood fence, scattered graffiti, and uneven walking surface reflect long-term disrepair. This intervention brings the fence back to life with new wood and paint while gently refreshing the pavement.

Wall: Replace damaged wood planks and repaint with a calming, water-themed color like sky blue or seafoam. Apply primer and optional weather-resistant sealant for long-term protection. Decorative wood upgrades can be added for visual texture and cohesion with other sections.

Pavement: Focus on basic cleaning, smoothing, and weed removal. Light crack filling and surface leveling will help restore the flow of the walkway and reduce tripping hazards. This area may not require full concrete work, keeping it a light intervention.

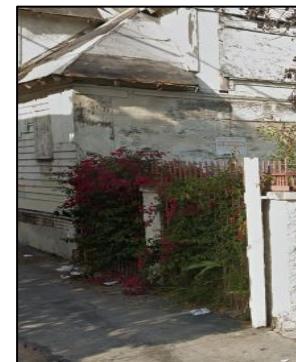
Section 1 - Overgrown Fence with Vegetation and Cracked Pavement

Wall: Section 1's wall intervention focuses on revitalizing rusted iron fencing through a multi-step process that includes vegetation removal, surface sanding, rust-resistant priming, and repainting. A protective sealant or color upgrade can be added to extend durability and offer visual cohesion with surrounding sections. These improvements restore both function and appearance, creating a clean boundary line for the space.

Pavement: Repair efforts are light but essential, covering crack patching, edge clearing, and weed removal to reduce hazards and improve walkability. An optional curb edge paint or sealant adds polish to the walkway, subtly reinforcing the path's edges and improving visibility without full concrete replacement.

As the first section in the alley, this space sets the visual and structural tone for the project. The rusty, overgrown metal fencing and surrounding debris once marked a neglected entry point. Through targeted repairs and surface detailing, this section transforms into a clear, safe, and freshly defined border.

Repainting with durable materials, paired with minor pavement upgrades and planter cleanup, reintroduces care into a corner previously overlooked. This intervention serves as the visual threshold of the larger effort, inviting the community into a newly reimagined alley space.

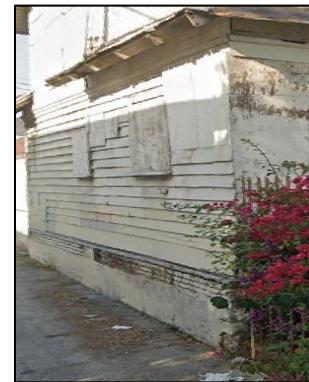
**Section 2 - Wall & Pavement Repair with Paint and Base Work**

Wall: Section 2 addresses the largest stretch of wall in the alley, where peeling paint, deep cracks, and weathered siding signaled long-term neglect. Repairs focus on prepping and repainting with durable exterior wood-safe paint, applying putty or filler for surface cracks, and optionally using a skim coat or brick filler to restore structure. Accent colors or mural details can be layered in to highlight identity and add character.

Pavement: Ground-level improvements target cracks, base unevenness, and optional curb touch-ups. Cleaning, patching, and sealant help prevent further decay while subtly enhancing the visual flow between the fence line and walking surface. Though minimal, these touches increase accessibility and continuity with nearby upgrades.

This section plays a critical role in bridging aesthetic improvements with structural restoration. The sheer length of the wall and its highly visible decay made it a priority for both safety and design consistency.

Through resurfacing, repainting, and optional decorative upgrades, Section 2 softens the visual impact of aging infrastructure and supports the transformation of the alley into a unified corridor. It turns a harsh backdrop into a clean, neutral canvas, maintaining the tone of the project while restoring stability and pride in place.

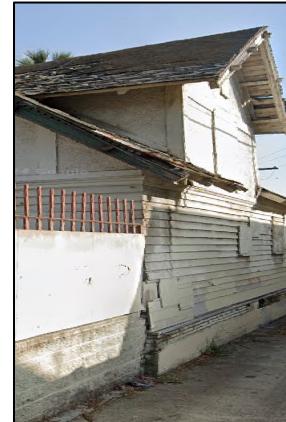
Section 3 - Wall, Pavement, and Roofline Repair

Wall: This section required extensive surface prep, including graffiti removal, patching, and siding repairs. The wall was painted using a white base coat to cover existing damage, followed by additional coats in accent or mural colors. Optional repairs included siding panel replacement and stucco or skim-coat for a smoother finish. These enhancements ensure the wall not only looks restored but is also protected against future damage.

Pavement: The pavement work included basic crack fill, light curb repainting, and surface cleaning. While not as intensive as the wall repairs, this cleanup helps maintain continuity throughout the alley. By refreshing the walking surface and ensuring debris was removed, this zone now ties in visually with surrounding improvements.

Roofline: The pavement work included basic crack fill, light curb repainting, and surface cleaning. While not as intensive as the wall repairs, this cleanup helps maintain continuity throughout the alley. By refreshing the walking surface and ensuring debris was removed, this zone now ties in visually with surrounding improvements.

Section 3 tackled one of the most visibly neglected areas of the alley, combining structural fixes with thoughtful visual restoration. The highly graffitied wall was treated as a key visual anchor, where mural accents or bold colors could reshape perception. With siding replacement, roofline touch-ups, and redefined pavement edges, this zone now feels complete. The improvements help shift this space from overlooked to maintained setting a tone of care and accountability while reestablishing it as a community-facing corridor.

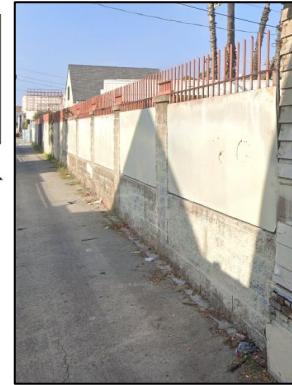
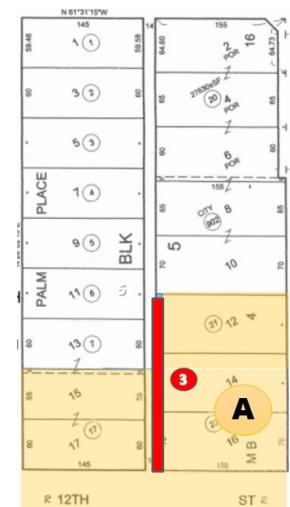
Section 4 - Repaint Masonry Wall, Seal Cracks, and Clean Up Pavement

Wall: Wall repairs in this section include sealing masonry cracks and repainting the entire surface using a neutral, masonry-safe base coat. Additional detailing, such as accent paint on metal spikes or touch-ups on panel seams, may be included for a finished look. These updates improve wall durability while reducing visual signs of aging and wear.

Pavement: Work includes crack filling, curb sealing, and the removal of vegetation encroaching onto the walking path. Optional power washing or light leveling may also be done to improve traction and safety. These repairs reduce tripping hazards and give the pathway a cleaner, smoother finish.

This section revitalizes a long stretch of wall that previously showed signs of neglect—cracking, surface warping, and uneven pavement edges. Through simple but meaningful repairs, including structural patching and repainting, the area regains a sense of care and order.

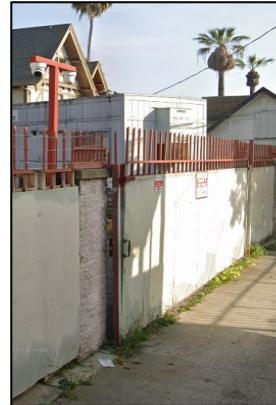
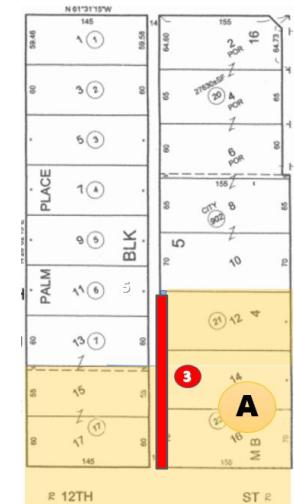
Section 5 - Gate Wall Paint, Curb Patch, and Minor Panel Repair

Wall: Refinishing includes rust removal, applying rust-inhibiting primer, and repainting the gate and fence with outdoor enamel. Optional accent or trim color may be added for aesthetic enhancement. Hardware or panel repairs may include latch replacement or plywood patching.

Pavement: Work includes patching cracks along the curb and edge of pavement. May include light sealing, curb painting, or other visual safety indicators to reinforce the transition between driving/walking paths and the fence.

This section targets a smaller but highly visible segment of the alley, a gated area near the entrance. While it may not span the full length of the block, its restoration plays a key visual and functional role in improving perception of the alley's upkeep. The gate is often the first thing seen by passersby, so refinishing rusted areas and reinforcing curb edges help communicate safety, stability, and active care.

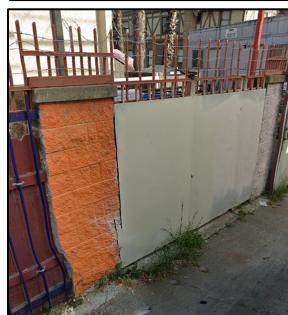
Section 6 - Gate with Rusted Frame, Painted Panel, and Overgrown Pavement

Wall: This area focuses on a small gate structure that's been affected by rust and fading paint. Repairs include applying rust-inhibiting primer, repainting with a neutral exterior-grade color, and possibly adding anti-graffiti sealant. Some wood/metal patching or joint filling may be required.

Pavement: Surrounding pavement will receive surface weed removal and minor crack filling. Optional curb paint or sealant can help clean up transitions and boost visibility near the gate.

Section 6 may be compact, but its repair is impactful due to its location and condition. Rust, overgrowth, and cracked pavement create a neglected look at the site's edge. By restoring the gate's appearance and lightly polishing the pavement zone, this section serves as a key detail in stitching together the full alley upgrade.

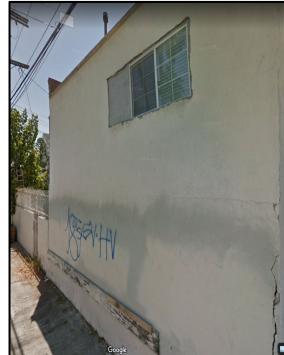
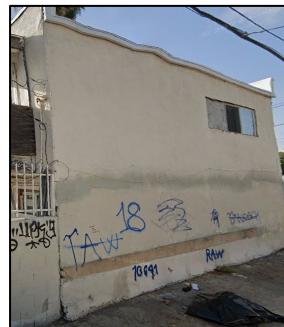
Section 1 - Wall with Graffiti, Stucco Damage, and Pavement Wear

Wall: The long wall surface is worn with visible cracks, graffiti, and faded banding. Work includes crack patching using stucco mesh and skim coat, repainting (including optional two-tone restoration), and graffiti sealant. The area is large and highly visible, requiring more coverage and prep time than other segments.

Pavement: The base pavement area needs light crack filling, weeding, and debris clearing. Minor edge sealant or touch-up painting can help define the pathway and restore a clean look around the wall.

As one of the longest and most prominent walls in the alley, this section plays a key role in defining the character of the space. The large surface area, previously marked by graffiti and decay, offers a strong visual opportunity for neighborhood renewal.

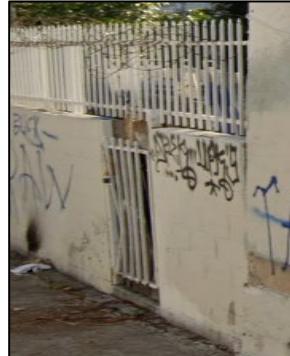
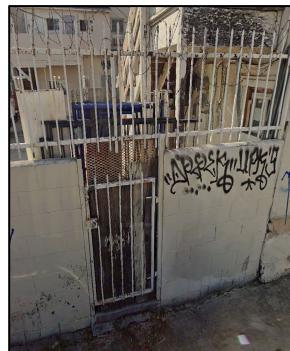
Section 2 - Metal Gate, Concrete Wall with Graffiti, Rust Damage, and Paint Wear

Wall: This section includes a gated opening with a damaged wall area showing graffiti, patch deterioration, and fading paint. Repairs include prepping the metal gate, repainting with weather-resistant coatings, and cement-based patching on the surrounding wall. Optional finishes like anti-graffiti sealant or accent colors can enhance durability and visibility.

Pavement: The area around the gate requires light crack fill and curb touch-up. Weeding and cleaning will help transition the pavement to a walkable condition. Optional sealant or paint lines can improve polish and safety perception.

As an access point into a private space or building, Section 2 contributes to the overall image of upkeep and security. Restoring the metal gate, clearing weeds, and sealing cracks help revive the entryway functionality while reinforcing the wall's structure.

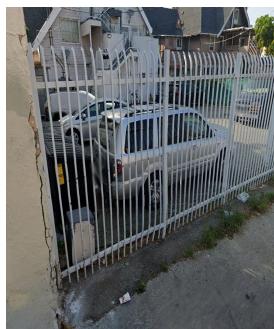
Repair: Section 1 – Metal Gate & Stucco Column with Rust and Pavement Damage

Wall: Rust removal prep and sanding of full gate, followed by a full iron repaint (2 coats, anti-rust base + finish).

Pavement: Minor crack fill, weed pulling, and edge detailing. Includes surface cleaning and power wash.

This intervention targets a narrow yet visually prominent segment of the alley, where a metal gate and stucco column had been significantly worn by rust, weather, and graffiti. As one of the first sections visible when entering the alley, its condition set a tone of deterioration for the surrounding area.

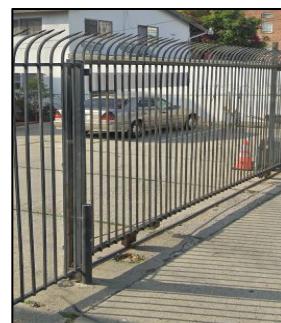
Section 2 - Sliding Iron Gate with Pavement Damage

Wall: The sliding iron gate in this section had visible wear from rust and uneven weathering, especially along its lower bars and joints. Restoration included full rust removal, primer application, and repainting with two coats of metal enamel. A clear coat was optionally considered to improve finish durability and sheen. These updates improved not only the gate's structural resilience but also its overall visual uniformity with the surrounding segments.

Pavement: Pavement repairs focused on treating visible cracks and surface imperfections. Light patching was combined with pressure washing and edge sweeping to restore a cleaner, safer walking surface. These upgrades were especially important due to the gate's function as an active sliding entrance, where a smoother ground finish enhances both accessibility and appearance.

This section serves as a transitional segment between static wall sections and an active entryway. The restored gate now appears more intentional and visually connected to the rest of the alley. Combined with subtle but effective pavement touch-ups, this portion of the alley reinforces continuity while addressing structural and cosmetic issues.

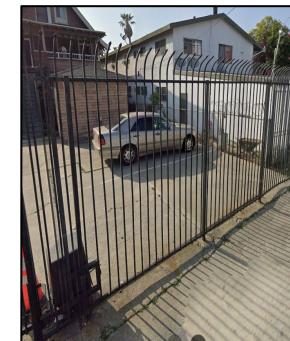
Section 3 - Curved Black Iron Fence with Concrete Base (Right of Gate)

Wall: This section features a curved black iron fence that required rust removal, full repainting, and optional clear topcoat finishing for a sleek, protective surface. Rust was sanded down and sealed with rust-resistant primer, followed by a two-coat application of black iron paint. The work was focused and efficient, aimed at refreshing the existing fence without structural replacement.

Pavement: Surface work included concrete patching along the base, addressing cracks and wear near the edge of the alley. Weeding and pressure washing were also done to restore the area's visual appeal and eliminate debris buildup. An optional sealant was considered to extend the longevity of the touch-ups and unify the finish.

Though compact, this fence segment marks the edge of the larger gate zone and helps define the alley's overall rhythm. Its updated black finish and restored base give it a clean, modern look that ties in with adjacent sections while standing out visually.

These repairs eliminate signs of rust and curb wear, creating a polished bookend to the block's gated area. The attention to sealing and edging reinforces the intent to preserve and protect, adding long-term value to the investment.

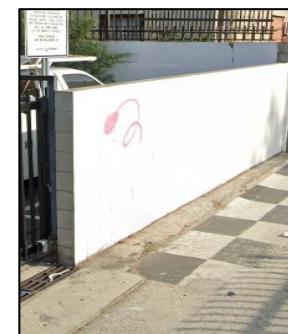
**Section 1 - White Concrete Wall with Graffiti & Surface Wear**

Wall: This section features a white concrete wall along the property line that has been affected by surface wear and visible graffiti markings. The repair plan includes a full wash and degreasing of the surface, followed by spot sanding and the application of primer. Two coats of white masonry paint are used to restore the appearance, and an optional anti-graffiti finish is added to help protect the surface from future vandalism. All materials, including trays, tools, and rollers, are factored into the estimate. The total labor time is approximately 3 hours, resulting in a clean and refreshed barrier that blends into the streetscape more cohesively.

Pavement: The adjacent pavement is a checkered concrete surface in fair condition with minor cracks and wear along the edges. The repair scope focuses on filling edge cracks and patching small problem areas. A full power sweep ensures that debris is removed before repainting the edge lines for a more defined and finished look. Labor is kept minimal at 1.5 hours, and overall costs remain low due to the limited extent of the pavement intervention.

Section 1's urban intervention focuses on enhancing both aesthetic value and functional upkeep within a high-visibility pedestrian zone. Located at the intersection of the sidewalk and property boundary, this area is frequented by residents and passersby. The presence of graffiti and surface wear previously contributed to a sense of neglect. By introducing targeted maintenance such as cleaning, repainting, and sealing, the intervention shifts the visual narrative of this segment—from one of deterioration to one of care and attention.

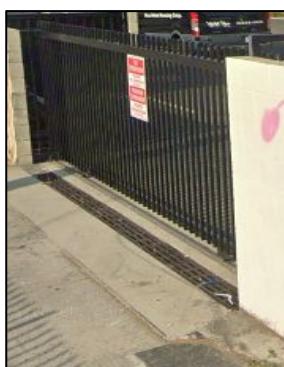
Section 2 - Black Metal Gate with Drain Cover Base

Wall: This section contains a black metal gate that shows visible signs of rust, wear, and aging. The repair plan focuses on restoring the gate's finish and structural integrity through a multi-step process. It begins with rust removal and sanding to prepare the metal surface, followed by the application of two coats of durable black paint. An optional gloss or sealant topcoat is added for long-term protection and a clean, polished look. Materials like primer, enamel, and tools are included in the estimate, with labor totaling around 5 hours. This thorough treatment not only improves the appearance of the gate but also extends its lifespan and functionality.

Pavement: Directly beneath the metal gate is a narrow strip of pavement with a built-in drain cover base. Repair efforts here focus on edge detailing and light patching around the drain area, which may include optional crack filler depending on the level of deterioration. The work ensures that water drainage remains unobstructed while improving the overall presentation of the base area. This type of targeted intervention helps prevent future pooling or damage to nearby surfaces, maintaining both aesthetics and function with only 1-1.5 hours of labor.

Section 2 addresses the transition between private access and public sidewalk space, where a black metal gate marks the boundary between community and residential activity. The gate, once rusted and tagged, serves not only as a barrier but as a visual focal point for anyone passing by. Its restoration demonstrates an investment in both upkeep and visual order. A fresh coat of paint and optional glossy sealant signal a shift from neglect to intentional care, reinforcing safety and pride in place.

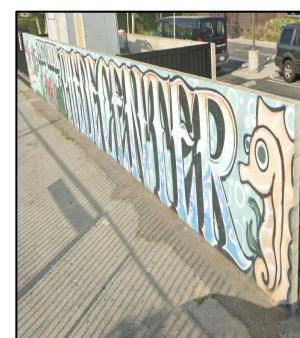
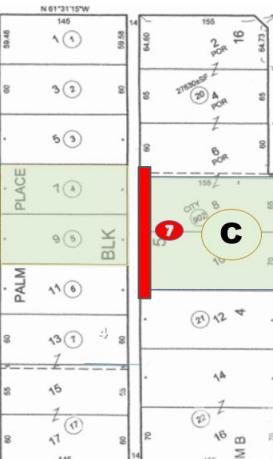
Section 3 - Concrete Wall with Painted Mural

Wall: This section features a concrete wall covered in a vibrant hand-painted mural. The mural has been exposed to the elements and shows signs of wear, tagging, and surface buildup. Restoration begins with graffiti removal and a general wall wash to clean and prep the surface. To protect the mural's integrity, a UV-protective clear coat is applied, shielding it from sun fading and weathering. If needed, touch-ups using acrylic paint are performed to revive faded or damaged parts of the mural. Labor spans about 4 hours, and materials include sealant, paint, and standard tools to ensure a lasting finish.

Pavement: The pavement along this section is in relatively stable condition but requires detail cleaning. Minor crack cleaning and an edge sweep are performed to eliminate debris and prep the surface for potential line repainting or curb rescaling. This quick pavement update adds to the mural's visual impact by sharpening the edges and reinforcing the site's clean, cared-for appearance.

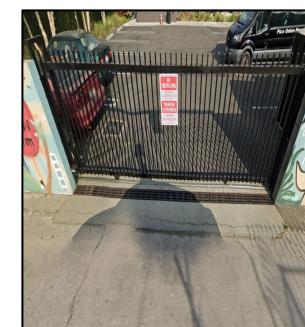
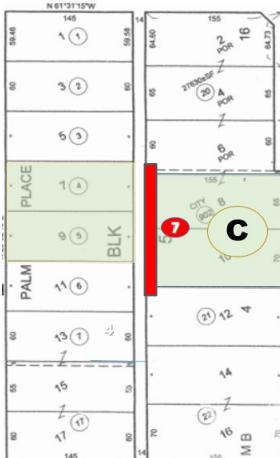
Section 4 - Black Iron Gate Between Painted Walls

Wall: This section centers around a black iron gate placed between two previously painted walls. The gate shows visible rust, dullness, and surface wear. Repairs begin with rust removal and full surface prep, followed by two coats of black rust-resistant paint. For added durability and visual appeal, an optional gloss or shine topcoat may be applied. All necessary tools, skim coat, and materials are included in the estimate, with labor totaling around 4 hours. These efforts help restore the gate's appearance while protecting it from further corrosion and environmental damage.

Pavement: The ground beneath and around the gate consists of a concrete surface with visible buildup and minor wear near the drainage area. Work in this section involves light edge patching, spot concrete cleaning, and optional sealing for added protection. Grate cleaning and possible weed removal are also included to ensure proper drainage. The pavement improvements are minor but necessary for preventing further surface degradation and enhancing the presentation of the entry point.

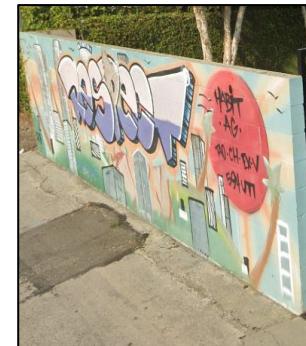
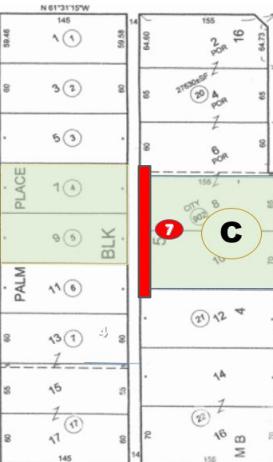
Repair: Section 5 — Area C: Concrete Wall with "Respect" Mural

Wall: This section features a concrete wall adorned with the "Respect" mural, which is currently faded, tagged, and partially damaged. The restoration effort begins with light touch-ups or full repainting depending on the condition of the artwork. A UV-protective sealant or anti-graffiti coating is optionally added to protect the mural from future damage and environmental wear. All necessary materials—paint, brushes, trays, and protective gear—are included, with about 3–4.5 hours of labor. The goal is to revive the mural while keeping its original message and artistic value intact.

Pavement: The pavement at the base of the mural wall shows spalling and cracking, especially along the mural's lower edge. Work in this section focuses on patching surface cracks and prepping the base with a full sweep and cleaning. Although minor, this pavement repair plays a key role in the mural's presentation and longevity by preventing water intrusion and wear from foot traffic. Only 1–1.5 hours of labor are needed, making it a cost-effective but meaningful improvement.

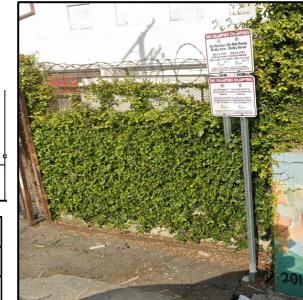
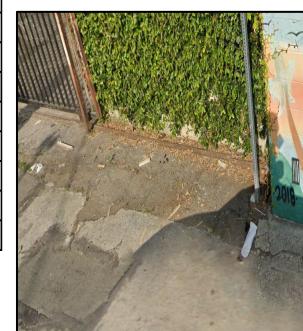
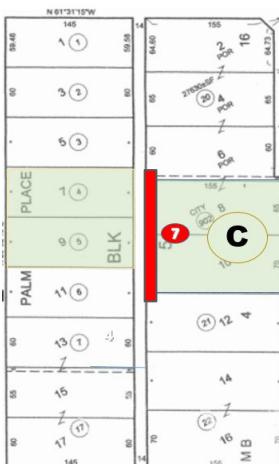
**Section 6 - Hedge Fence with Signpost**

Wall: This section features a tall hedge acting as a green fence alongside a public signpost. The hedge is currently overgrown, uneven, and visually unkempt. The repair scope includes overgrowth trimming using shears or a hedge trimmer, followed by edge cleanup and optional curb detailing for a more refined look. Materials like trimmer rentals, bags, and cleanup tools are included, with 1.5–2 hours of labor dedicated to restoring order and shaping the hedge cleanly along the walkway.

Pavement: The surrounding pavement is scattered with litter, debris, and organic waste. The repair plan focuses on trash pickup, ground debris removal, and sidewalk sweeping to create a more walkable and inviting space. The signpost, which anchors part of the site, is also wiped down to improve visibility and appearance. Labor is minimal but impactful, helping restore visual clarity around the base of the hedge and adjacent signage.

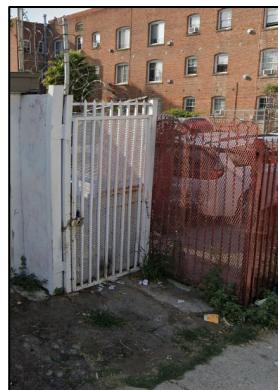
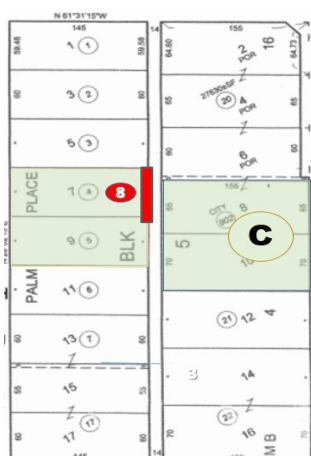
C**Area C****Project 8****Repair: Section 1 – White Iron Gate Near Sidewalk****Repair**

Wall: This section includes a weathered white iron gate that shows visible rust and peeling paint. Restoration efforts begin with full rust removal and surface sanding, followed by the application of two coats of white rust-resistant paint. An optional anti-graffiti or weatherproof sealant may also be applied for extra durability. Materials include brushes, primer, enamel, and other prep tools. The work helps restore the gate's appearance and reinforces its structure for long-term protection.

Pavement: The pavement surrounding the gate is impacted by debris, overgrown weeds, and general surface wear. This area receives targeted sidewalk cleaning, trash removal, and optional patching at the base of the gate. The goal is to restore visibility and access while improving safety and appearance. Though light in scope, the cleaning helps define the space around the gate and creates a cleaner entry point for pedestrians.

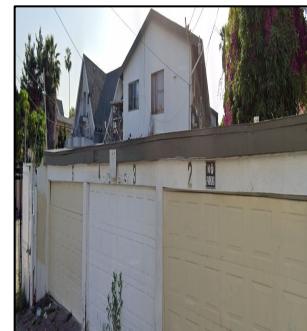
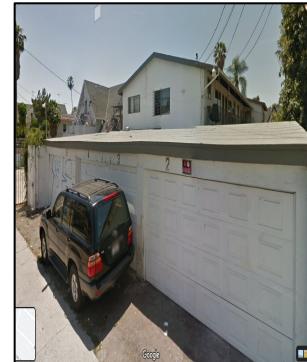
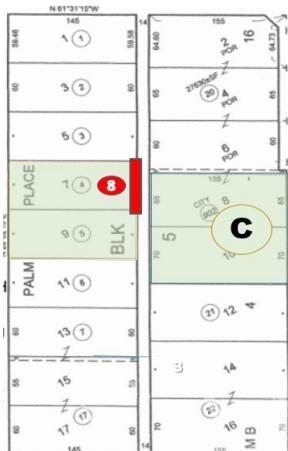
Section 2 - Garage Roof of Units #2–#5

Roof: This section addresses the deteriorating garage roof of units #2 through #5, which shows visible signs of moss growth, staining, and surface wear. The repair process includes full surface scraping and moss removal, followed by two coats of roof sealant or coating. Optional upgrades include a base primer for added adhesion and a UV-protective waterproofing topcoat for long-term durability. Tools such as squeegees and sealant kits are included in the materials. The labor effort, estimated at 3.5 to 4.5 hours, ensures a thorough application and proper drying time between coats, restoring the roof's function and appearance.

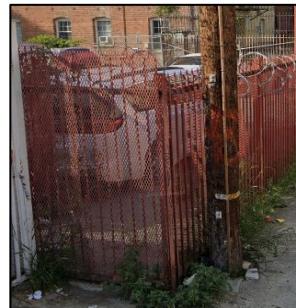
D**Area D // Project 9****Repair: Section 1: Red Fence/Gate**

Wall (Gate): This section includes a long red metal fence with multiple gates and segments showing heavy rust, paint erosion, and potential structural wear. The repair plan starts with rust removal using wire brushes and rust remover supplies, followed by the application of rust primer and a fresh coat of red exterior paint. Steel bar replacement is included for damaged sections, and barbed wire may be replaced if needed. Welding materials and mesh patches are used to repair broken or bent segments. Labor totals about 6 to 8 hours, depending on the level of rust and welding required. The result is a reinforced, cleaner, and more secure perimeter fence.

Pavement: The pavement near the base of the fence shows minor cracking and surface unevenness. Repairs include crack patching, leveling, and removal of debris along the fence line. Though limited in scope, this helps stabilize the ground around the fence and improves both appearance and safety.

This urban intervention targets a highly visible and heavily used boundary fence that separates public space from residential property. Over time, rust, peeling paint, broken bars, and old barbed wire have contributed to an overall sense of decay. By fully prepping, repainting, and repairing this red fence, the intervention transforms it from a symbol of neglect into one of maintenance and care.

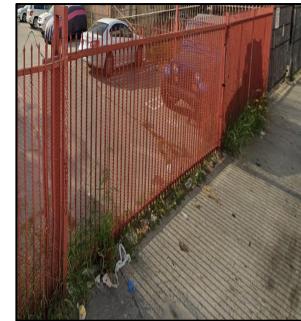
D
Area D
Project 9
Repair: Section 2 - Red Gate w/ Hinge Door
S5
(Door and fence)

Wall (Gate): This section features the large front red gate with a hinge door, which has visible rust, paint wear, and structural alignment issues. Restoration begins with rust removal and sanding, followed by the application of primer and exterior paint. Steel rod replacement is included for damaged bars, along with targeted hinge repairs to restore smooth function and alignment. Welding and sealing work ensure the gate is stable and secure. These updates not only improve the gate's durability but also enhance its overall appearance and ease of use.

Pavement: The ground at the base of the gate is uneven and cluttered with debris and overgrown weeds. Pavement work includes leveling the entry area and cleaning to ensure safe and stable access through the gate. These improvements also help prevent future wear and water pooling, reinforcing the overall quality of the entry point.

This intervention addresses one of the most visible and frequently used access points along the property's front boundary. The gate's rust, loose hinges, and uneven base not only created a safety issue but also projected an image of neglect. Through repainting, hinge repair, welding, and pavement leveling, the project transforms the entry into a well-maintained and secure space.

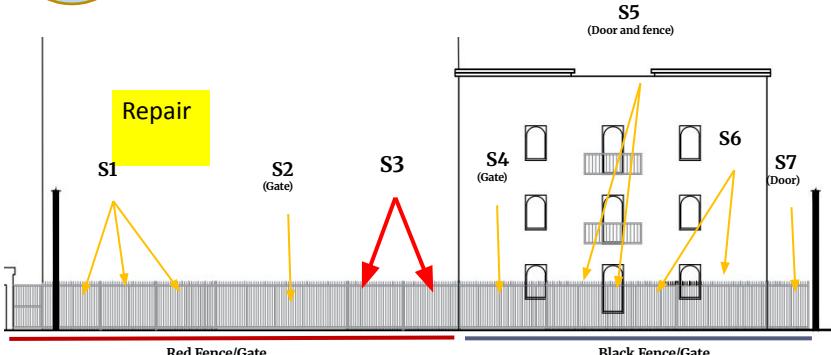
D**Area D - Project 9****Repair: Section 3 - Red Fence w/ Minor Repair and Cleanup**

Wall: This section includes the red fence panels along the property's edge that show moderate wear, including faded paint, minor rust, and slightly misaligned rods. The repair plan focuses on light sanding, rust cleaning, minor rod realignment, and small weld touch-ups. One gallon of red exterior paint is used for basic coverage and touch-up. These repairs are minimal but necessary to maintain the integrity and appearance of the fence, keeping it functional and consistent with other restored sections.

Pavement: The pavement at the base of the fence is cluttered with weeds and debris. Light cleanup and scraping are performed to remove buildup and ensure the area looks maintained and safe. Though small in scope, this work helps preserve the foundation around the fence and makes the sidewalk space more accessible.

This section focuses on light restoration for fence panels that are less damaged but still show signs of neglect. Through small-scale repainting, minor repairs, and cleanup, the intervention maintains consistency with the rest of the red fence line. Even minimal attention to these areas helps prevent further deterioration and supports the larger effort to create a cohesive and cared-for public boundary.

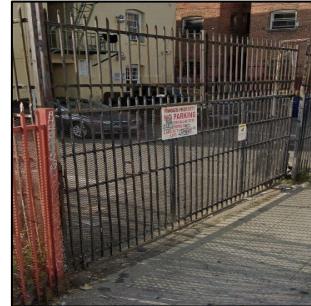
D**Area D - Project 9****Repair: Section 4: Black Gate w/ Light Repairs**

Wall (Gate): This section features a large black gate that requires only light repairs. Work includes rust removal, minor weld touch-ups, and application of anti-rust paint for maintenance and preservation. The gate's hinges are checked, tightened, or replaced as needed to ensure proper function. Optional sign replacement is included to restore clarity and visibility. While the damage is minimal, these touch-ups help maintain durability and ensure the gate remains secure and functional.

Pavement: Pavement repair is limited to basic cleanup around the gate's base, including trash removal and light sweeping. This helps clear access for foot traffic and enhances the appearance of the entryway. Though the scope is small, it supports the goal of making the area look maintained and cared for.

This urban intervention focuses on preventative maintenance for a frequently used entry gate. While the gate was not severely damaged, it showed early signs of wear and neglect, especially with surface rust and minor debris at its base. By addressing these issues early with small repairs, cleaning, and optional sign replacement, the project helps prevent future deterioration and keeps the gate in reliable condition.

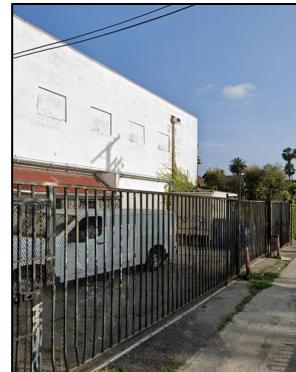
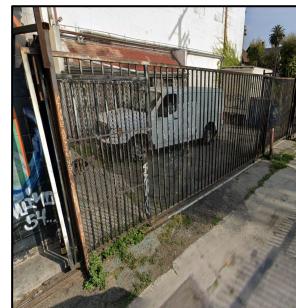
Area D
Project 10
Repair: Section 3 - Fence w/ Track & Rod Repair

Wall (Gate): This section includes a large black rolling gate that has extensive wear, including rust, bent rods, and a damaged track system. Repairs begin with full rust removal, priming, and repainting using rust-proof black paint. Six to eight rods are repaired or replaced, and the gate's rolling track is stabilized with roller or rail adjustments. Additional welding is completed to reinforce hinges and structural points. These comprehensive repairs improve both the functionality and appearance of the gate, ensuring smooth operation and long-term durability.

Pavement: The pavement below and around the rolling gate is cluttered with debris and overgrown weeds, particularly in the track groove. Cleanup includes trash removal, rail scraping, and general ground clearing to support proper gate function. This work helps reduce hazards, prevent gate obstruction, and improve the overall look of the access area.

This intervention focuses on restoring a key vehicle access point that had become worn and partially inoperable due to damage in the rolling track and rod structure. Through repainting, bar repair, welding, and track stabilization, the gate is returned to full function. Ground cleanup adds to the effectiveness by removing blockages and clearing space for safe gate movement.

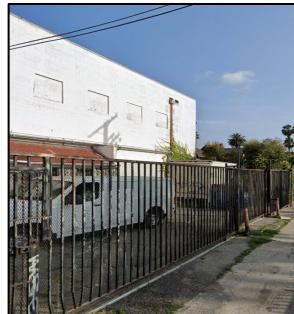
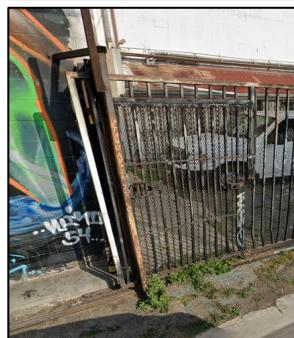
**Section 4 - Gate w/ Latch & Paint Touch-Up**

Wall (Gate): This section includes a small black walk-through gate that shows rust, minor hinge wear, and latch misalignment. Repairs begin with light rust removal and repainting using black rust-resistant spray paint. Bar straightening and hinge reinforcement are performed to ensure the door opens and closes smoothly. A small latch fix or weld patch is also completed. These minor repairs help restore both the function and appearance of the gate.

Pavement: The pavement around the gate is cluttered with weeds and grime. Cleanup includes basic sweeping, weed removal, and light scraping to clear the area and create a cleaner, safer path at the entry point.

This intervention addresses a small walk-through gate that, despite its size, plays a key role in everyday access and safety along the alleyway. Over time, this gate had developed minor rust, a misaligned latch, and visible grime at its base. These issues, while small, made the gate less reliable and contributed to an overall sense of neglect.

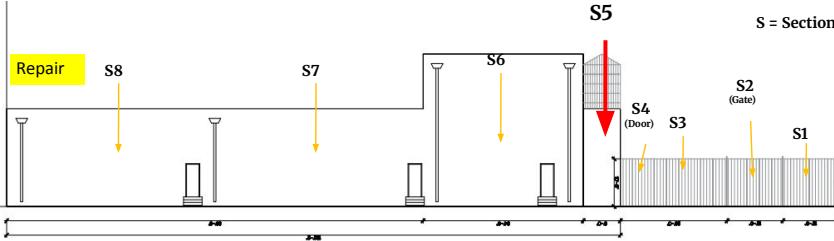
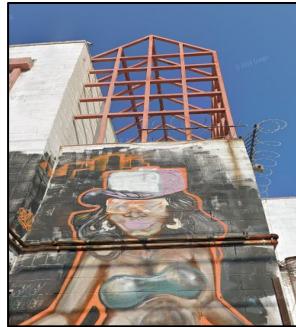
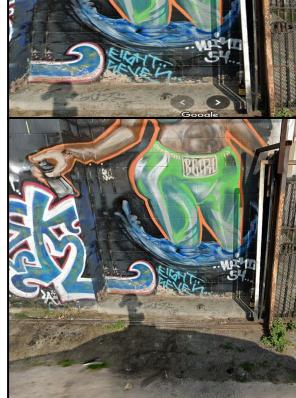
D**Area D****Project 10****Repair: Section 5 - Mural Wall w/ Red Frame**

Wall: This section features a concrete wall with a large painted mural and a red metal frame above. Repairs include patching cracks, repainting the red frame with rust-proof paint, and lightly retouching the mural edges if needed. The wall surface is prepped using rust brushes and primer, and an optional anti-graffiti sealant may be applied for long-term protection. These improvements preserve the mural, protect structural surfaces, and maintain the vibrant look of this highly visible wall.

Pavement: The pavement at the base of the wall shows grime buildup and light damage. Repairs focus on scraping, sweeping, and filling minor cracks or surface issues. This work helps stabilize the area and enhances the overall appearance of the mural's foundation.

This intervention focuses on preserving a public-facing mural and restoring the supporting wall and red frame structure. Over time, the area had developed visible wear, including cracks, faded paint, and grime along the base. The mural itself holds cultural and visual value, so care was taken to retain its original character while addressing damage and surface decay.

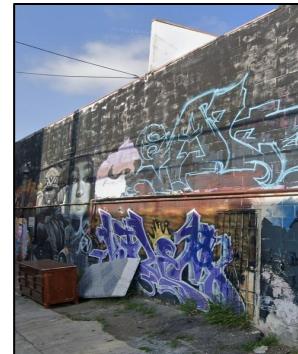
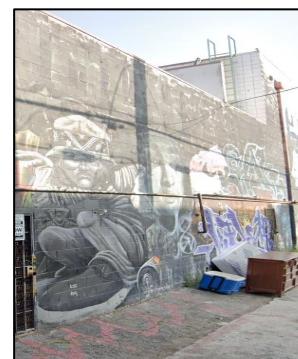
D**Area D****Project 10****Repair: Section 7 – Mural Wall with Graffiti Removal**

Wall: This section features a concrete wall covered in graffiti and surface stains, located behind an informal furniture storage area. Repairs begin with graffiti removal, surface sanding, and prep work. The wall is painted with masonry or rust-resistant paint, and an anti-graffiti topcoat may be applied for extra protection. Primer is used if needed, and all materials, including paint and tools, are selected to ensure durability and weather resistance. These efforts help restore a clean and uniform appearance to a wall that was heavily vandalized.

Pavement: The pavement at the base of the wall is dirty, with graffiti and grime concentrated near the stored furniture. Work includes full prep, surface sanding, and a fresh coat of pavement paint. An optional protective sealant may also be applied to help resist future staining or damage. These repairs clean up the alleyway and make the area more visually organized and functional.

This intervention focuses on reclaiming a neglected wall and pavement area that had become cluttered, tagged, and generally overlooked. The presence of dumped furniture and heavy graffiti made this section feel abandoned and unsafe. By removing graffiti, repainting the wall and pavement, and applying protective coatings, the space is visibly transformed.
