**RECORDS**  
OF  
**STEAM BOILER  
EXPLOSIONS,**

BY  
**EDWARD BINDON  
MARTEN,**

MEM. INST. OF MECHANICAL ENGINEERS; ASSOCIATE OF  
INSTITUTION OF CIVIL ENGINEERS, AND CHIEF ENGINEER TO THE  
MIDLAND STEAM BOILER INSPECTION AND ASSURANCE CO.

1872.

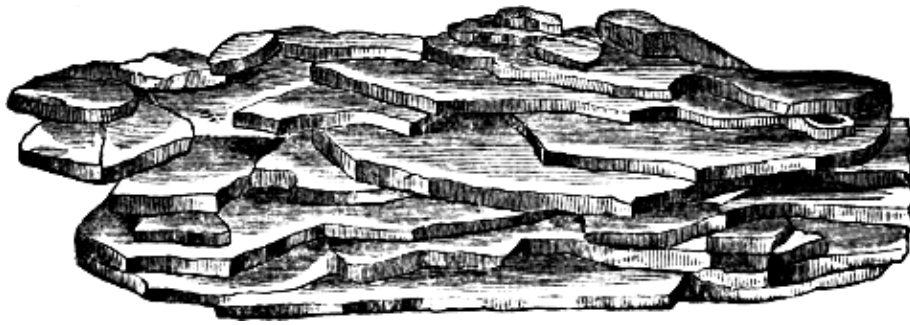
*Fig. 73.*

Many explosions of boilers have been caused by accumulation of scurf. The mischief is not so much from scurf being gradually deposited all over the interior of the boiler to a dangerous thickness as from the chips off the sides falling in heaps on the bottom. The plate beneath this accumulation becomes overheated, because not in contact with the water, and softens and sinks down into a "pocket," which if unnoticed will soon burn quite through. If the scurf that has caused the mischief is thick and hard enough to resist the pressure for a little time, the hole enlarges, until the scurf suddenly gives way and allows the contents to issue so violently as to disturb the boiler, or at least to blow the fire out of the grate. Such was an explosion at Bilston in 1863, where a large plain cylindrical boiler, 9 ft. diameter, was heated by three large fires placed side by side along the bottom; and a large "pocket" burst out over the third grate, and scalded the attendant to death. A similar pocket in a boiler, 4ft. 6 ins. diameter, which exploded at Dudley in 1864, after having been at work six weeks without cleaning, is shown in the transverse section, [Fig. 72](#). In this case the scurf had filled up the circle of the boiler to a depth of 3 inches at the bottom, as shown in the drawing, and was of a very hard description; and the boiler plate was bent out in a gradual curve, and thinned to about  $\frac{1}{16}$  inch, the original thickness being  $\frac{1}{2}$  inch.

The whole bottom of a boiler is sometimes injured, and the plates buckled and the seams sprung, from the accumulation of mud. One case may be mentioned where the water was very full of mud, and the boilers were worked day and night during the week but stopped for several hours on Sunday, during which time the deposit of mud was so thick that it did not get thoroughly disengaged again from the bottom when the boiler was set to work, but hardened into a mass. Although many of these pockets and injuries to the plates may occur without serious damage, they sometimes cause that first rent which destroys the equilibrium of the structure and leads to explosion. Some of the specimens of scurf exhibited to the Meeting show that their thickness is made up of small chips, carelessly left after cleaning or fallen from the sides of the boiler, as seen in [Fig. 73](#), or from cotton waste or other matter left in the boiler and forming a nucleus for the scurf to accumulate upon. Other specimens show that foreign matter must have been put into the boiler to stop leaking.

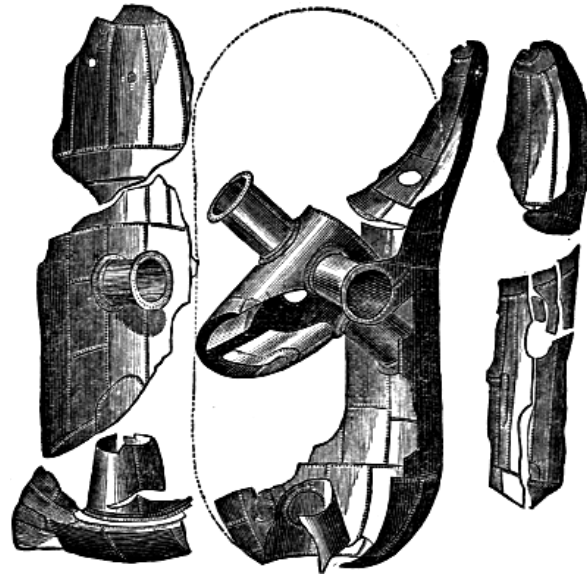
Those shown in [Fig. 21](#) and [Fig. 22](#), [No. 23, 1870](#), and [No. 53, 1869](#), were from the collapse of the central tubes, which were weakened by external and internal corrosion respectively. In [Fig. 24](#), [No. 35, 1868](#), the shell was in bad order from over work and receiving too much heat from four large furnaces, one of these especially causing a constant mass of flame to impinge upon a single plate, which resulted in a seam rip.

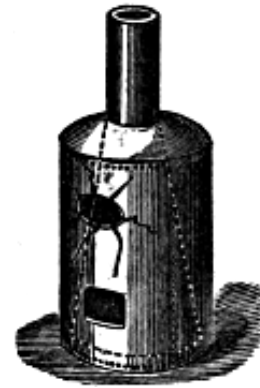
Fig. 25.

The outer shell of the boiler was rent into many pieces, leaving the central conical fireplace intact. The nature of the rents showed that the plate round the manhole, which was unstrengthened by a ring, had first given way, and all the other fractures had led away from that point. This is confirmed by the fact, that the manlid was thrown a good distance, with force enough to make its way through the timber walls of a cabin. The front plate divided into many pieces, and scattered right and left, while the back plate was thrown through a cabin in the opposite direction to the manhole.

The central flue showed a slight indication of overheating, but the construction was such that the upper portion passed through the steam space, and was always exposed to the action of the fire, without the protection of the contact of water. The manhole without a ring on its edge to strengthen the plate, and held in by two clamps, which caused additional strain when carelessly screwed up, was by far the weakest place. The engine was standing after a short time of working, and as the safety valve was very defective, and could be screwed down until tight, against almost any pressure, it is most probable that the pressure mounted much higher than usual, when the weakest part gave way, and led to the sudden tearing up and scattering of the whole fabric.

Faulty construction of both boiler and fittings, rendered it unable to bear that accumulated pressure, which the safety valve ought to have made impossible.

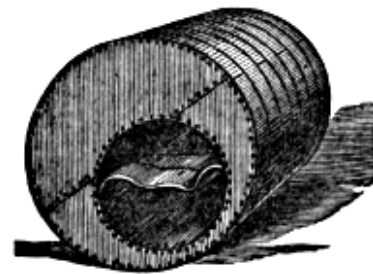
*FRONT VIEW Fig. 29.*

The tube collapsed from end to end, from over-pressure, as the man in charge had fastened 3 bricks to the lever of the safety valve causing 27 lbs. extra pressure, under the impression that he could thus accumulate a quantity of steam during the night, to be available on commencing work on the morrow.

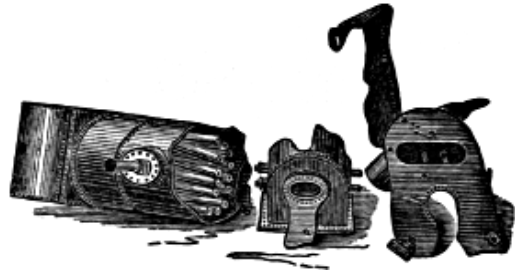
*Fig. 6.*

Agricultural, 45 lbs. pressure. Fire-box blew off, and the outer shell separated from it. The cause of explosion was over-pressure from the safety valve being screwed down.

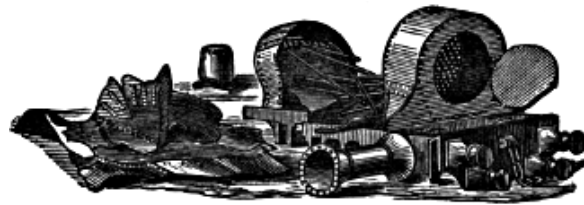
*Fig. 12.*

Locomotive, 130 lbs. pressure. Barrel blown away and broken to pieces, leaving fire and smoke boxes. The cause of explosion was supposed to be the strain on the boiler caused by its being made a stay to the frame without allowance for expansion, and thereby weakening a horizontal seam.

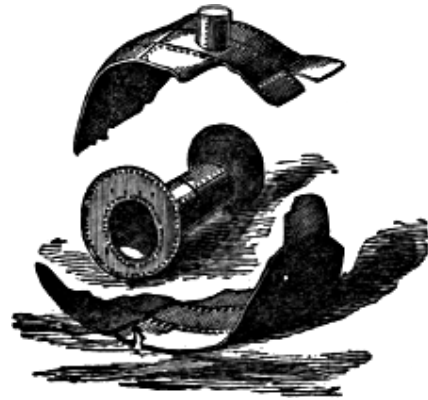
*Fig. 20.*

One tube Cornish, 11ft. long, 4ft. diameter, plates  $\frac{3}{8}$  inch, tube 2ft.  $1\frac{1}{2}$ in. diameter, pressure 50 lbs. Gave way underneath. Top thrown upwards. Front part and tube thrown to the front. The cause of the explosion was extensive corrosion at the bottom where it touched the walls.

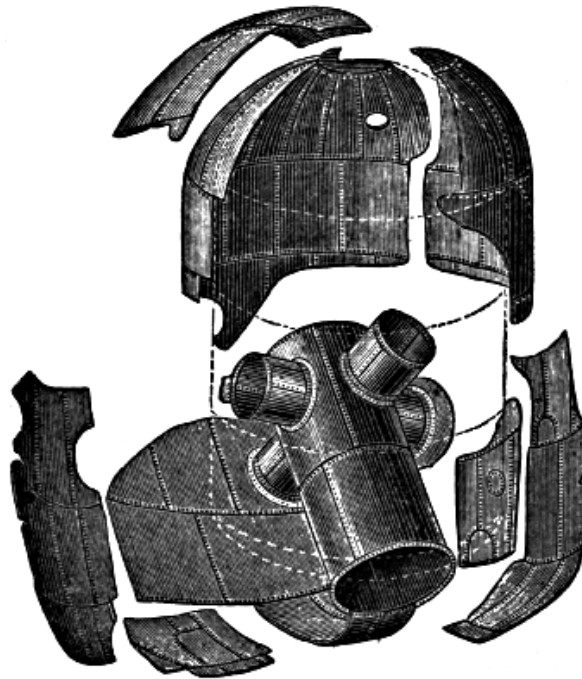
*Fig. 19.*

One of four. Four Furnace Upright, 22ft. high, 10ft. 6in. diameter, 7/16 inch plates, 40 lbs. pressure. The boiler was rent into nine pieces, one of which was not found. The dotted line in sketch shows the outline of the boiler before explosion, and the fragments are arranged as nearly as possible in their original position. The first rent was at a seam-rip opposite the largest furnace, from whence the rupture

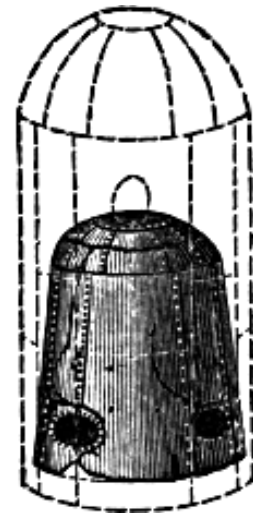
*Fig. 24.*

Marine Upright, 13ft. 3in. high, 6ft. 6in. diameter,  $\frac{1}{2}$  inch plates. Internal fire-box 8ft. 6in. high, 6ft. diameter at bottom, 5ft. 3in. diameter at the top,  $\frac{3}{8}$  inch plates, 50 lbs. pressure. In the sketch the shell is shown in dotted lines to allow the internal fire-box to be seen. The boiler was rent into many pieces, many of which were lost in a river, so that a satisfactory conclusion as to the cause of the explosion was impossible. The boiler was not very firmly stayed, and it is supposed that it was weakened by corrosion round the fire doors.

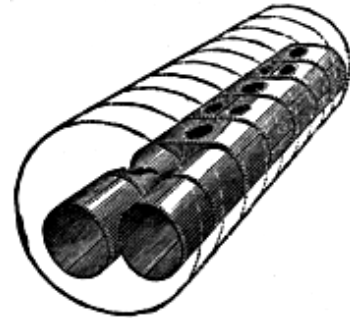
*Fig. 12.*

Double Furnace, internally fired, 28ft. long, 7ft. diameter,  $\frac{7}{16}$  inch plates, 55 lbs. pressure. Furnace tubes 7ft. long, 3ft. diameter,  $\frac{3}{8}$  inch plates. The crown of the left hand furnace collapsed and the right hand furnace was slightly altered in shape, as if from overheating by shortness of

water, although the true cause was supposed to be the thickening of the water by use of anti-incrustation composition, preventing proper contact of the water with the plates.

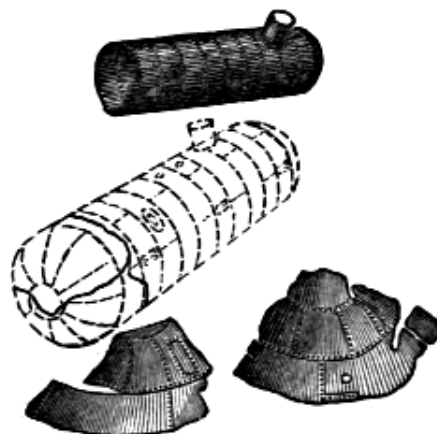
*Fig. 22.*

One of two. Plain Cylinder, 32ft. long, 5ft. diameter, 3/8 inch plates, 40 lbs. pressure. It gave way where deeply corroded on the inside.

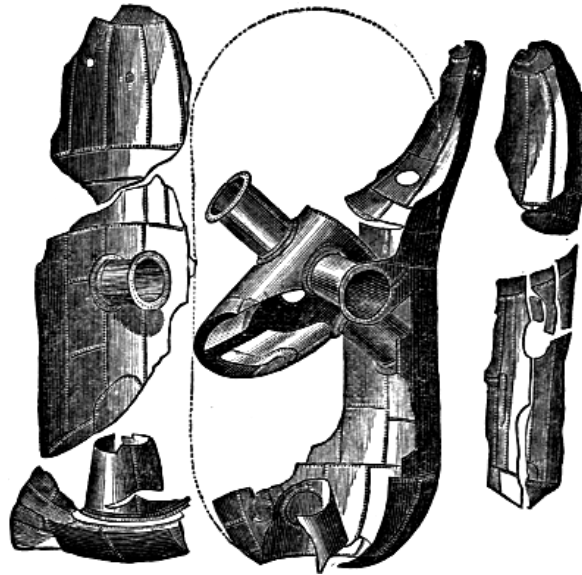
*Fig. 42*

The central tube collapsed, and the bottom part was blown out, and allowed the contents of the boiler to issue from the bottom into the culvert leading to the stack, and into the necks of the furnaces from which it was heated. The reaction sent the boiler up to a great height, and it divided into eleven fragments, which were very widely scattered. Comparatively little damage was done to the furnaces and premises, only the brickwork surrounding the boiler being thrown down.

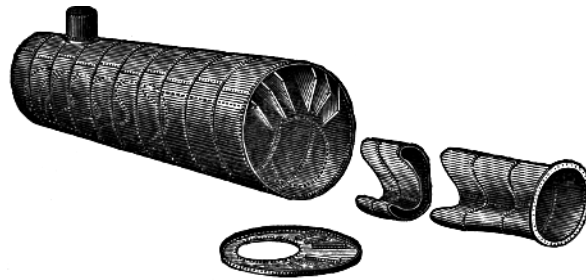
*Fig. 1.*

One of five. Cornish, 13 years old, 30ft. long, 6ft. 6in. diameter. Tube 3ft. 3in. diameter,  $\frac{3}{8}$  inch plates, 30 lbs. pressure. Tube collapsed sideways from weakness, and the front part and the front plate were blown out, carrying the attendants into a deep and swollen river which ran close in front of boilers.

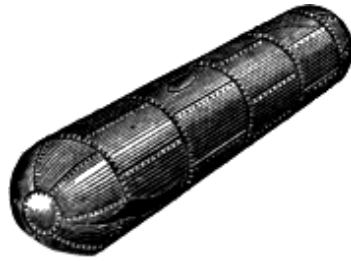
*Fig. 43.*

Plain Cylinder, 22ft. long, 4ft. diameter,  $\frac{7}{16}$  inch plates, 25 lbs. pressure. The water was allowed to get so low that the sides were softened by overheating, and rent open. The boiler was not moved and only a few bricks were disturbed.

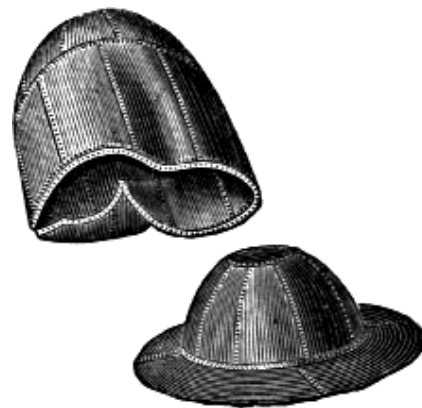
*Fig. 47.*

One of two. Balloon, used for evaporating only, nearly new, 9ft. high, and 9ft. diameter,  $\frac{1}{2}$  inch plates, not usually worked at any pressure. The top was thrown 60 yards away, and the bottom left on furnace. The boiler was temporarily exposed to pressure which it was too weak a shape to bear.

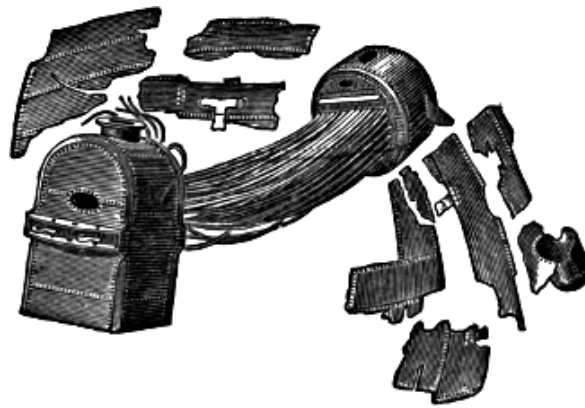
*Fig. 56.*

No.67. Northallerton. ([Fig. 56.](#)) December 29th.

Locomotive, 20 years old, 12ft. 9in. long, with plates arranged lengthways, 3ft. 8in. diameter,  $\frac{3}{8}$  inch plates, 80 lbs. pressure. The barrel appears to have given way on the under side near fire box, and opened out and rent into fragments. As the pieces containing the probable first rent were missing, nothing positive could be ascertained. It may have contributed to the rupture that the engine drew from the fire box instead of from the frame.

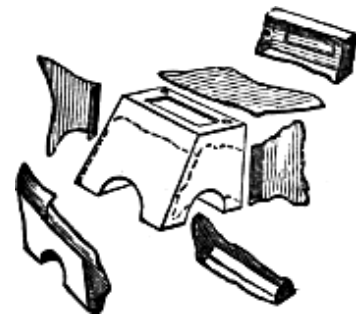
*Fig. 1.*

Domestic. Cast-iron, 1ft. 4in. wide, 1ft. high, and 11in. deep. The circulating pipes being frozen the pressure accumulated, and rent the boiler into pieces, doing great damage.

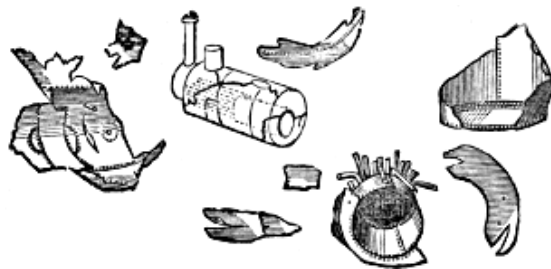
*Fig. 23.*

No.38. Shields. ([Fig. 23.](#))

Multitubular, 10 years old, 7ft. long, 3ft. 6in. diameter, 5/16 inch plates, 50 lbs. pressure, but valve loaded to 80 lbs. Rupture commenced at the unguarded manhole, and the shell was rent into several pieces which were much scattered. The safety valve was defective, and the boiler had been much weakened by many patches, and was in poor condition and unable to bear the pressure at which it was worked at the time of explosion.
