# Acid Rain and Our Nation's Capital

*A Guide to Effects on Buildings and Monuments*

U.S. Department of the Interior/U.S. Geological Survey

*by Elaine McGee*

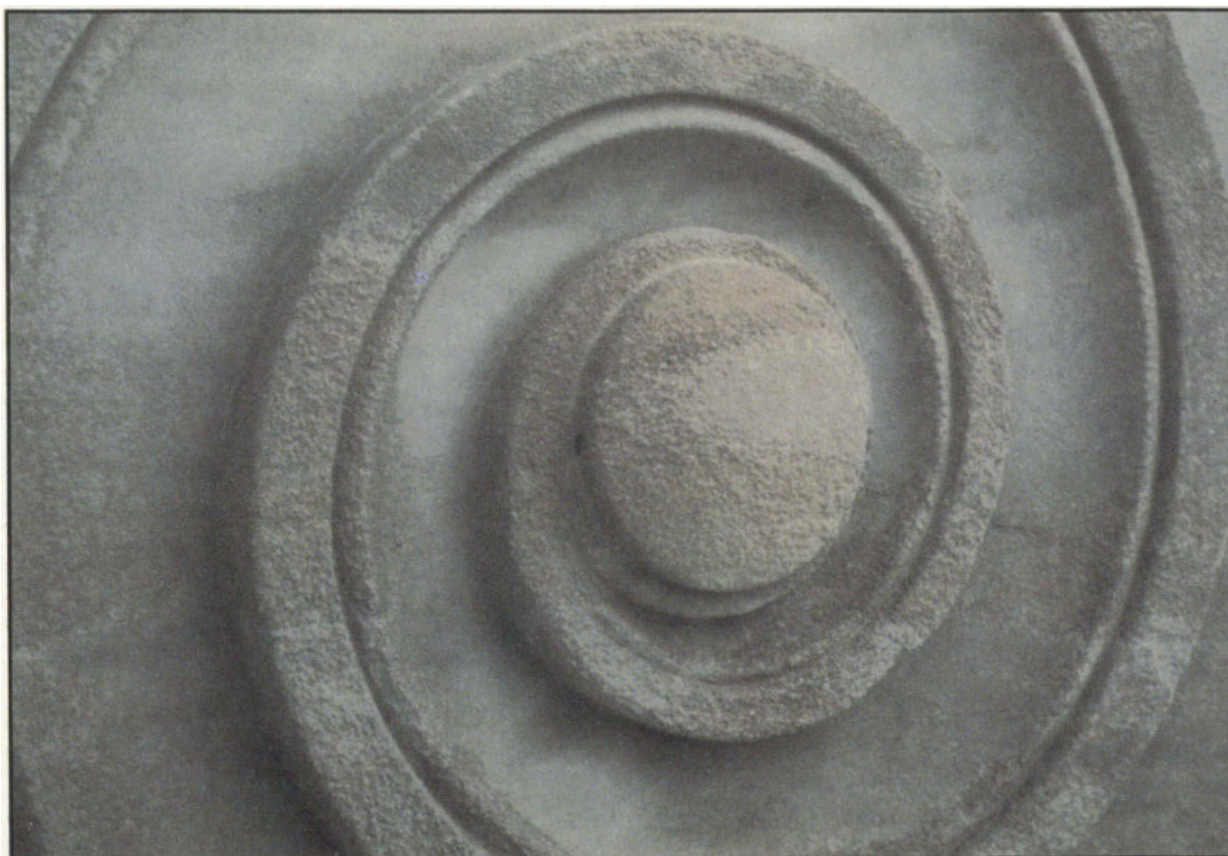
Marble surfaces exposed to rain develop a rough “sugary” texture because the calcite grains are loosened as the edges dissolve in the rain water. Column capital volute, Jefferson Memorial, Washington, D.C.

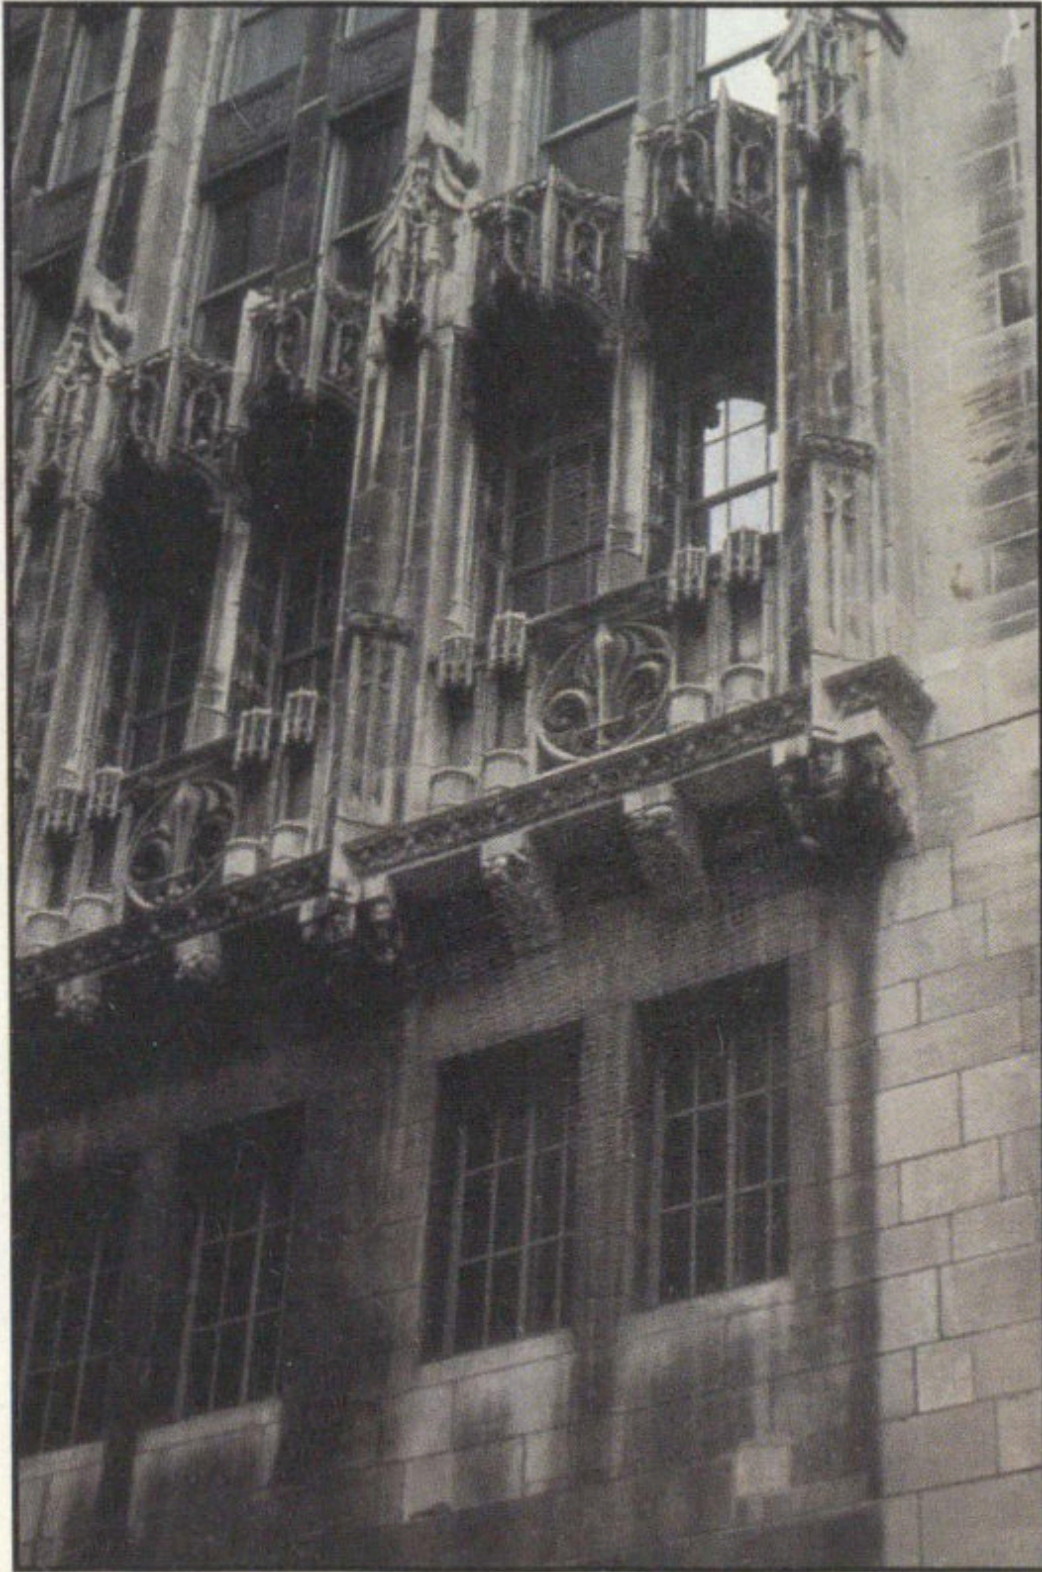
**Blackened crusts on sheltered portions of the limestone Chicago Tribune Building, Chicago, Illinois.**

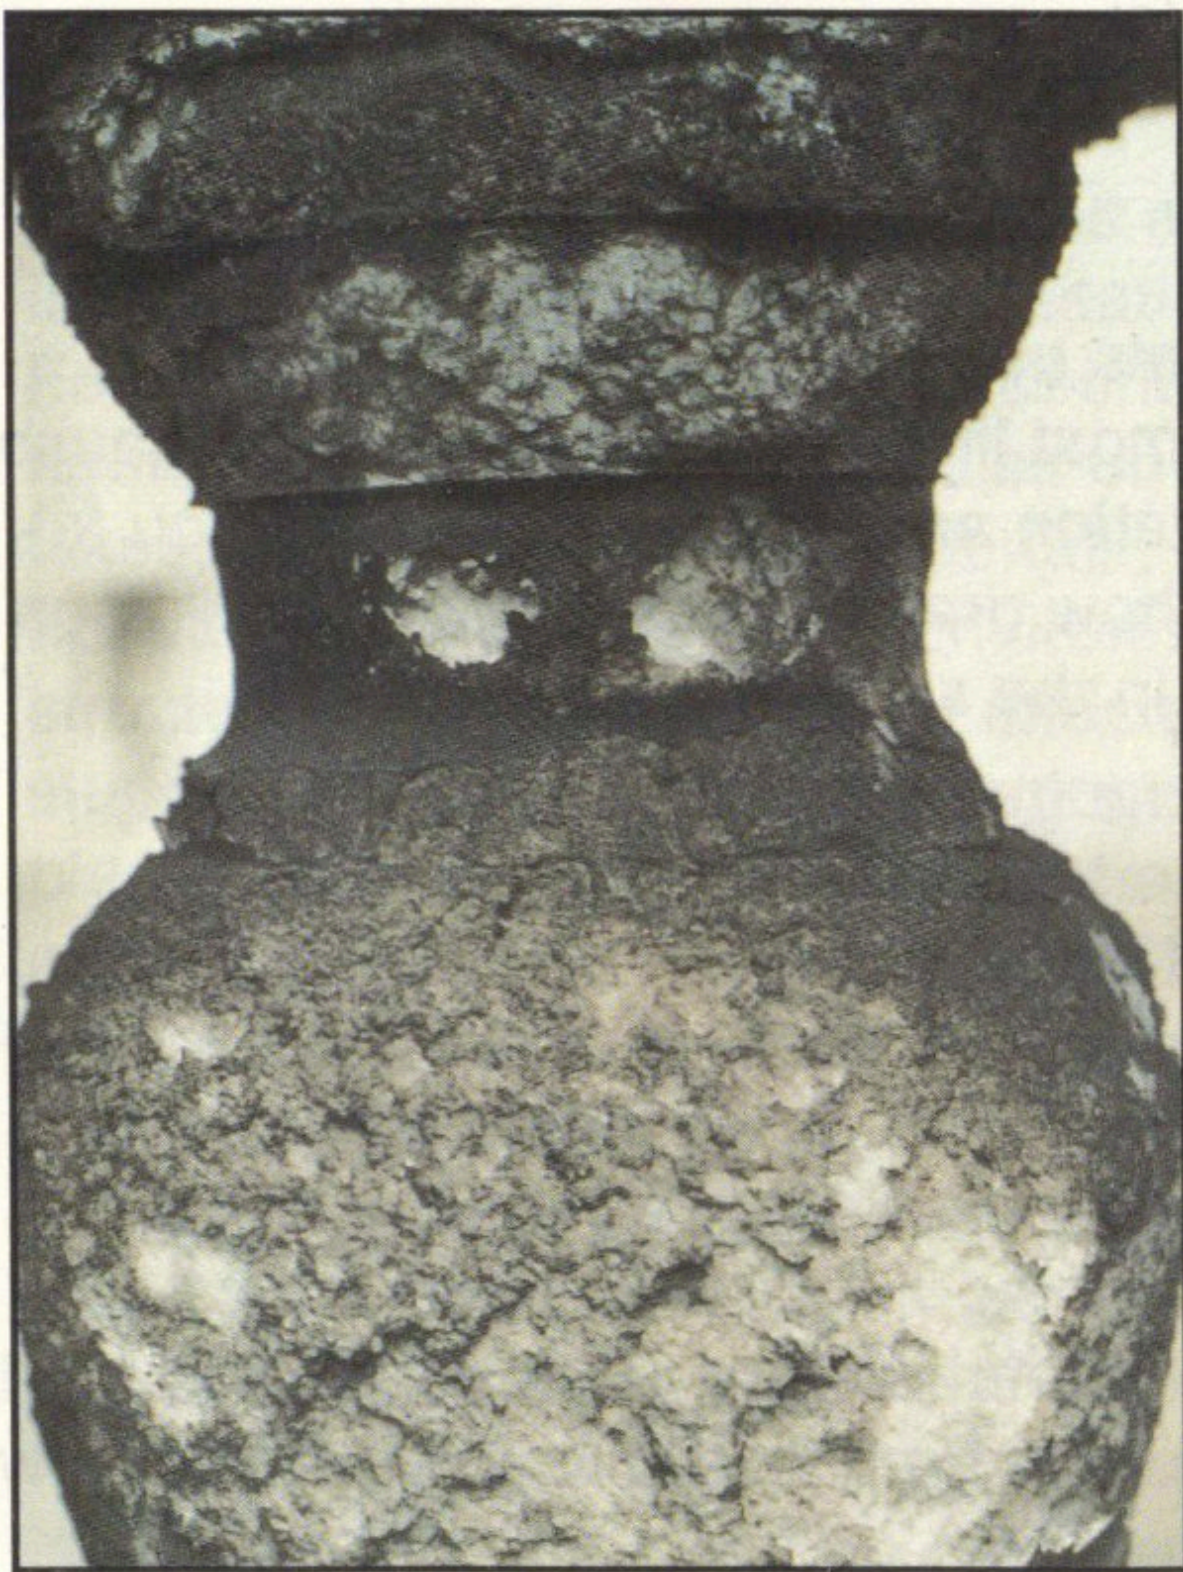
Formed as a result of air pollution, gypsum alteration crusts have blackened, blistered, and spalled from a marble baluster at the Organization of American States building, Washington, D.C.

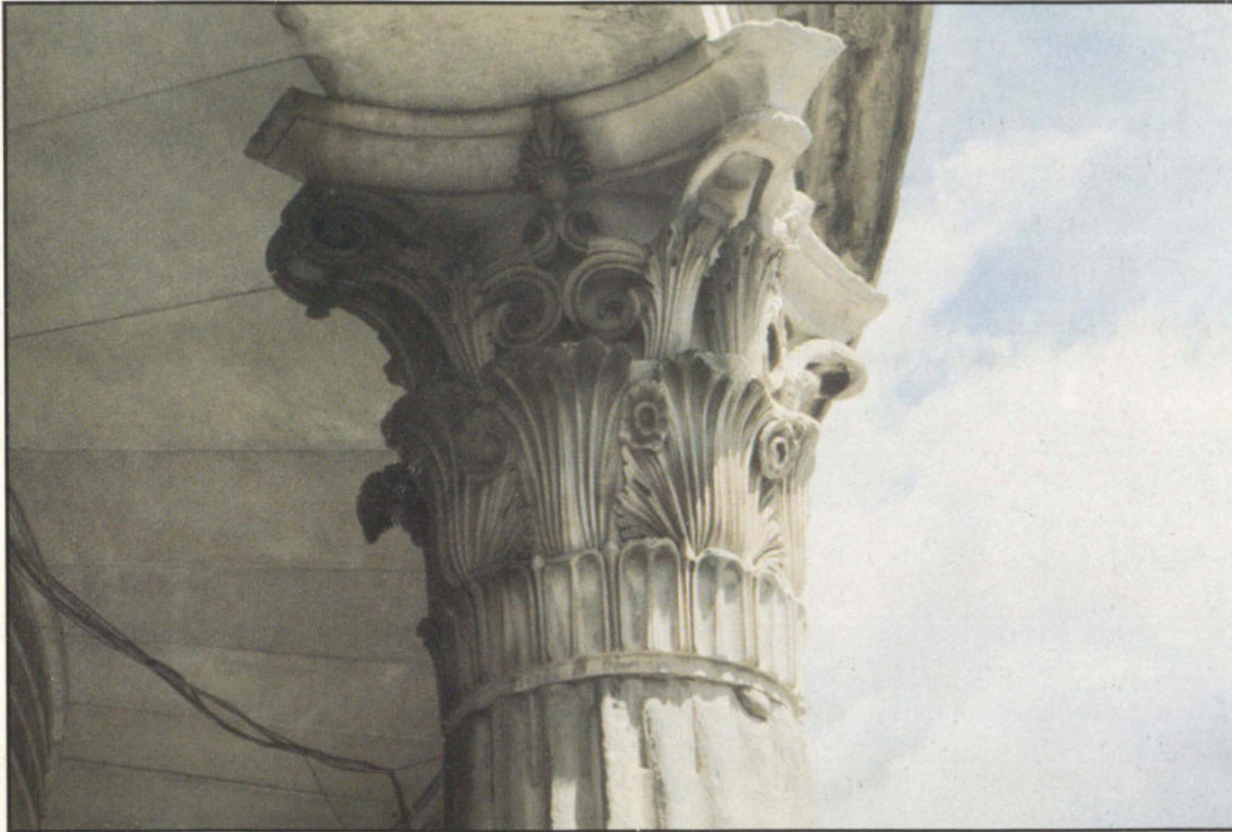
**A marble column at the Merchants' Exchange in Philadelphia shows loss of material where the stone is exposed to rain and blackening of the stone surface where the stone is sheltered from rain.**

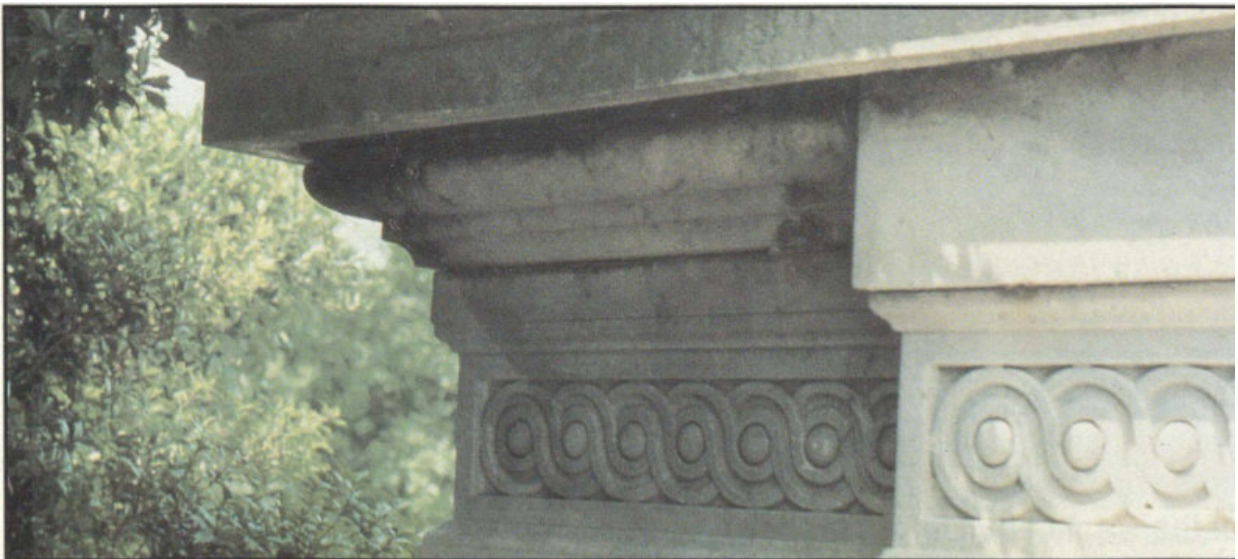
Beginning at the southeast corner of the building, by using binoculars we can see some areas of blackened alteration in the Corinthian column capitals. A more accessible example is found under the overhang of the large square ends of the marble balustrade at the southeast corner of the building. 13 The black crust is made of gypsum plus dirt that accumulates in sheltered areas. No black crust is present along the cracks between the stones; rain water probably flows in these areas, dissolving the gypsum and preventing accumulation of a crust. Not all black areas on this baluster are gypsum; in some places near the bushes, you can see greenish-black moss growing on the stone. The top surfaces of the marble balustrade are coarse and rough, because of dissolution between grains, compared to areas that are protected from running or washing water where the black alteration crust forms.

**Blackened alteration has accumulated under the overhanging edge of this marble balustrade corner. Southeast corner, U.S. Capitol Building.**

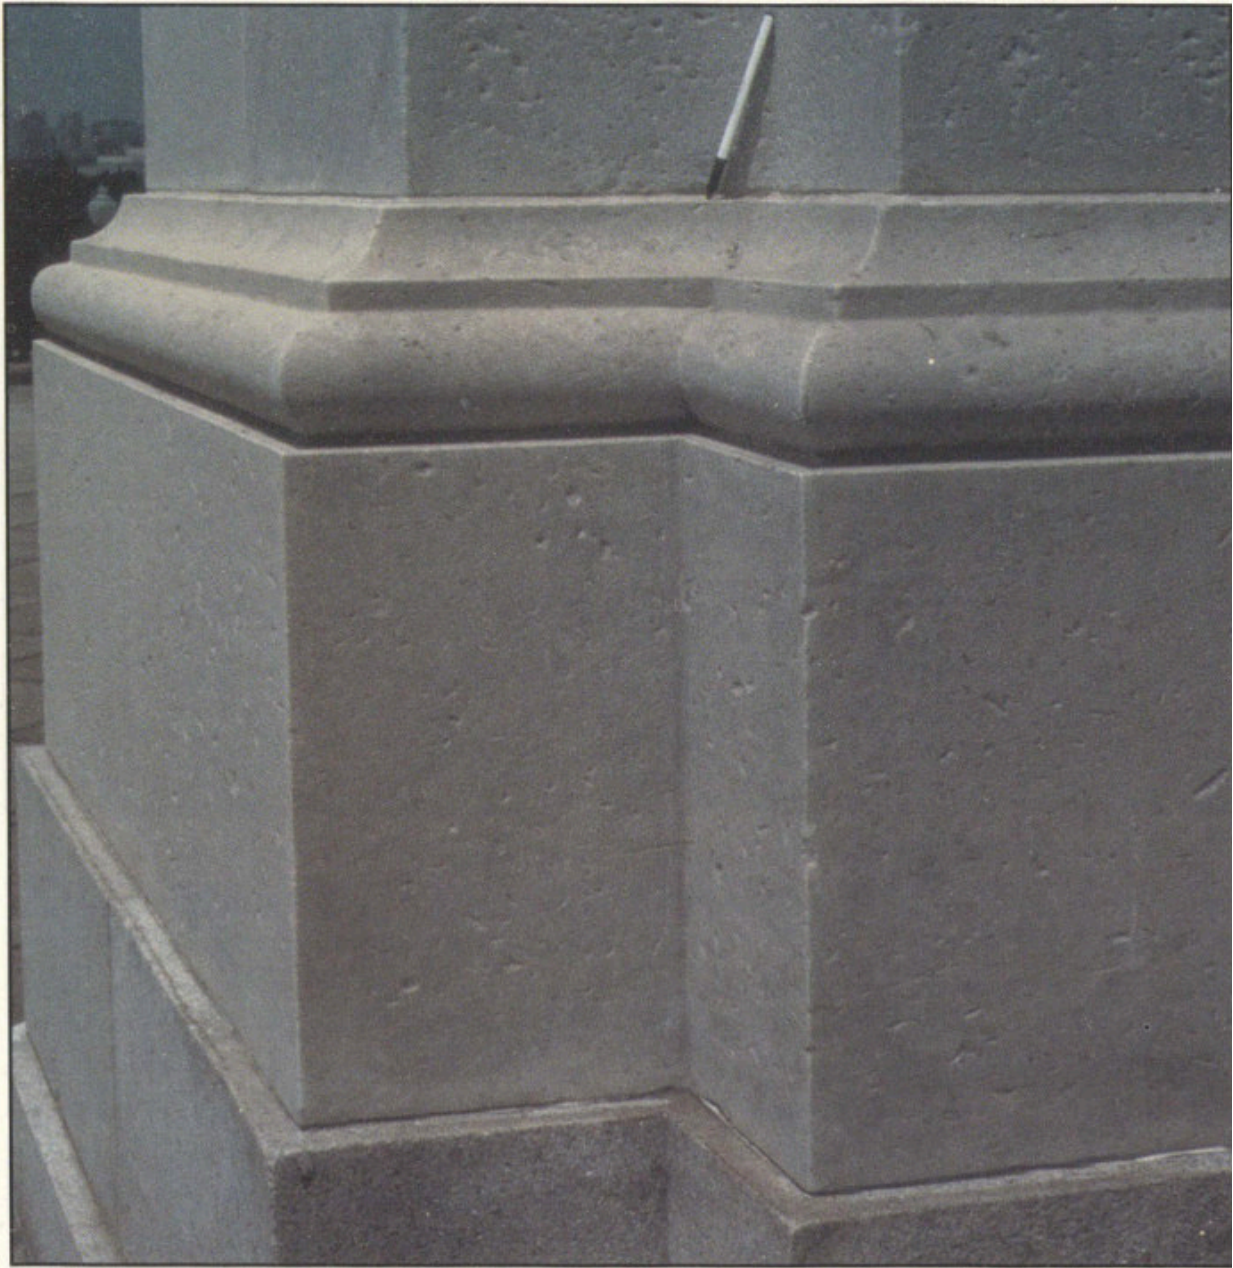
**Pock marks in marble columns, south side of U.S. Capitol building. Silicate mineral inclusions in the marble loosen and fall out when the calcite around them is dissolved by acid rain.**

Another dissolution feature of marble is the pock-mark effect on the square bases of the building columns. Silicate mineral inclusions in the marble were loosened by the dissolution of the surrounding calcite, causing the inclusions to fall out of the stone. A particularly good example of this is found on the

fourth column west from the southeast corner of the Capitol building. The pock-mark dissolution is also found at several other places on the building.

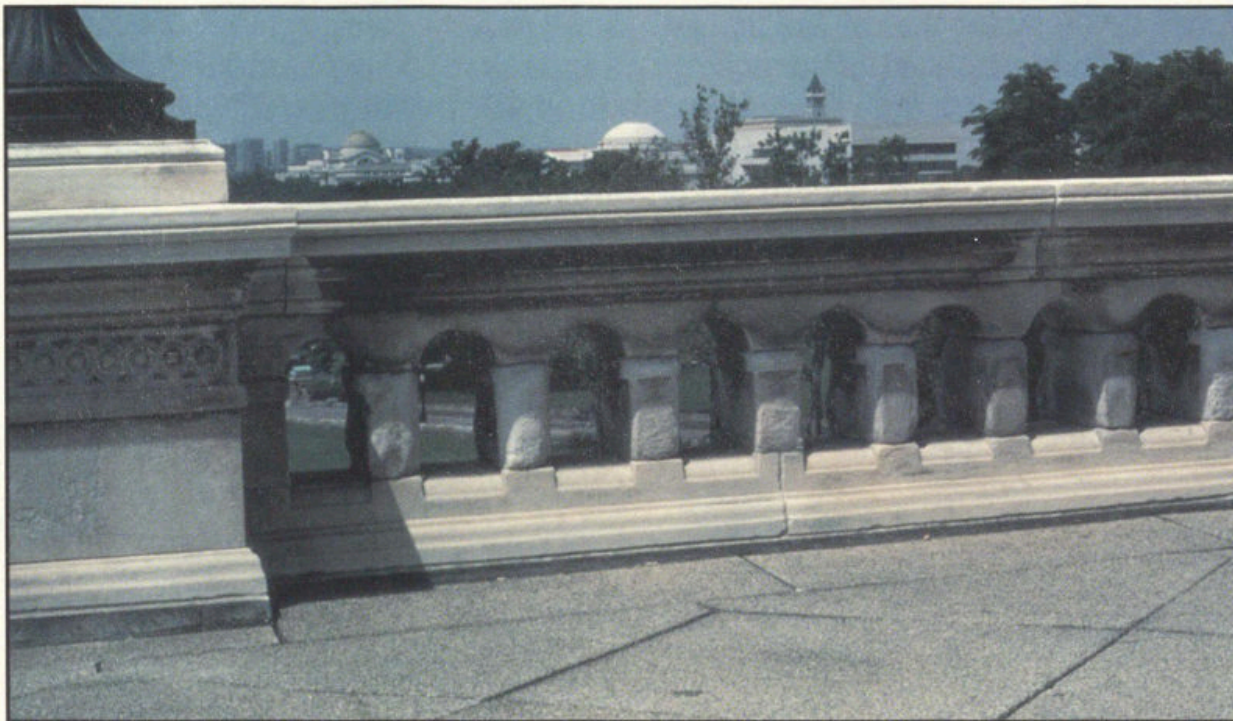
**The marble balustrade on the west side of the Capitol building shows both dissolution and alteration.**

We will follow the marble balustrade around the building, noting differences in deterioration. Some parts of the balustrade have obviously been replaced, thus enabling us to observe various stages in the stone deterioration. The edges of the balusters are sharp when new and become rounded as they age. Blackened alteration crusts have accumulated on the sheltered sides of the balusters and under the overhanging top of the balustrade. In some spots under the rail the blackened crust has spalled off, exposing fresh surfaces and more vulnerable stone. Some carvings on the balustrade corners are worn, whereas others have blackened alteration; this difference in weathering may be due to local effects of wind and rain. Along the steps leading to the terrace on the west side of the Capitol, gypsum has accumulated on large areas of the wall. Gypsum can accumulate on any surface that is not washed by water. 16

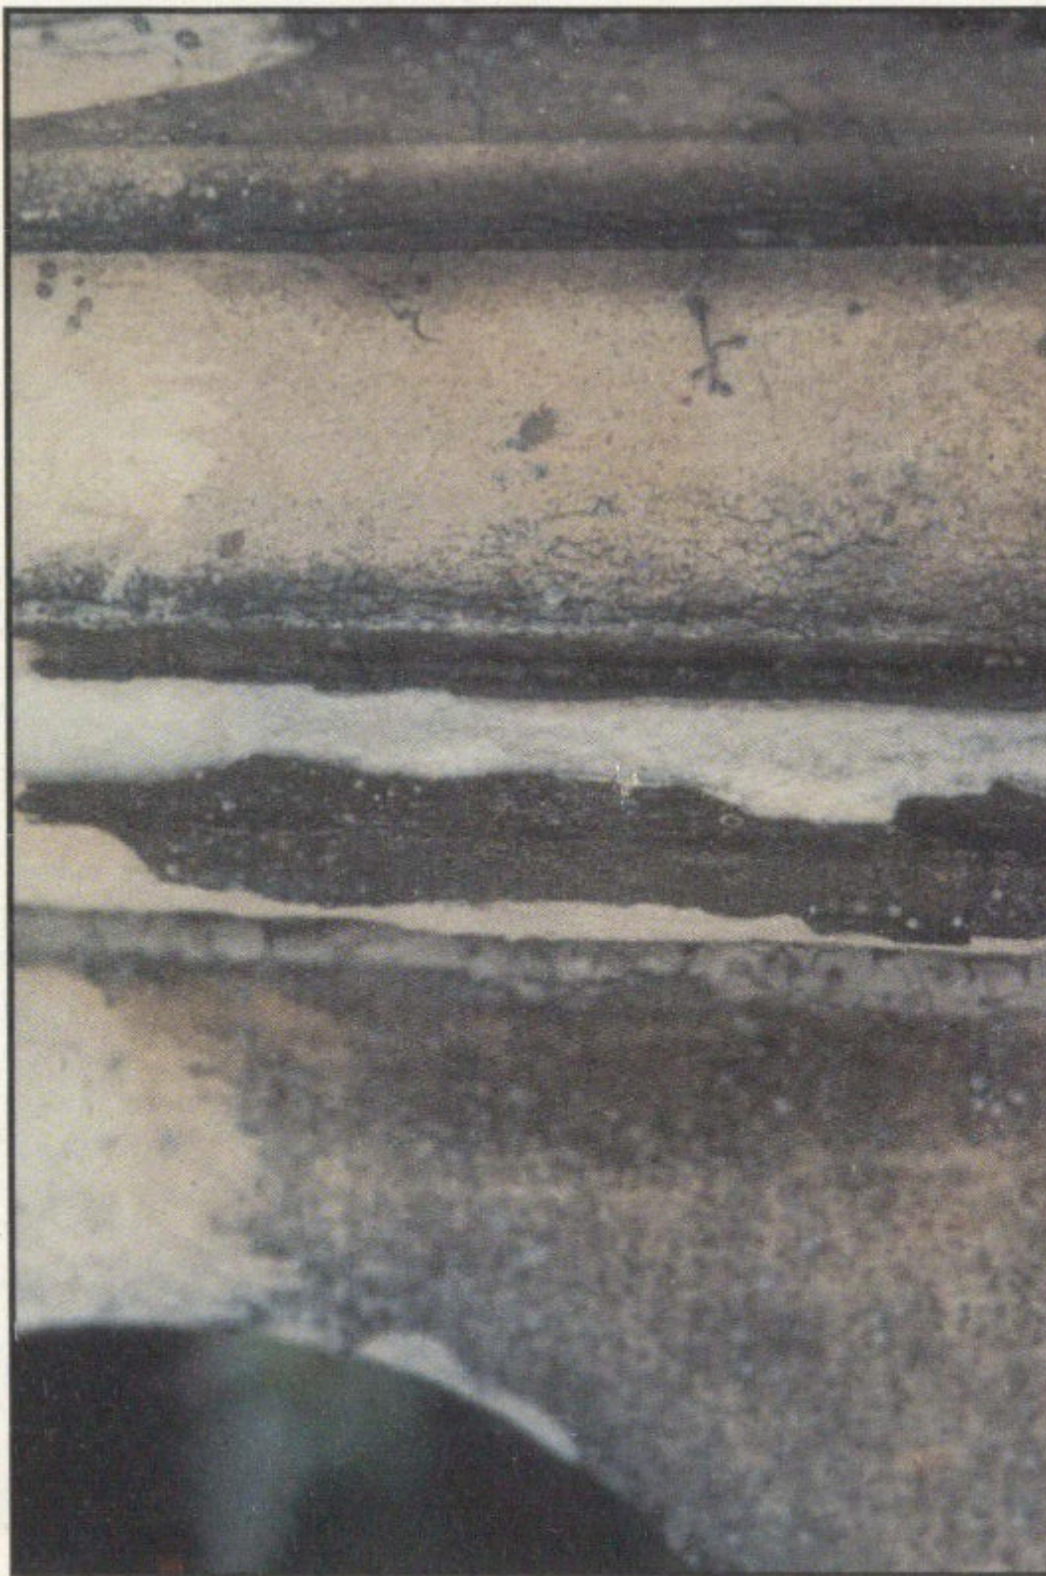
**Black alteration crusts under the west balustrade of the Capitol have begun to spall (peel) off, revealing crumbling white marble underneath.**

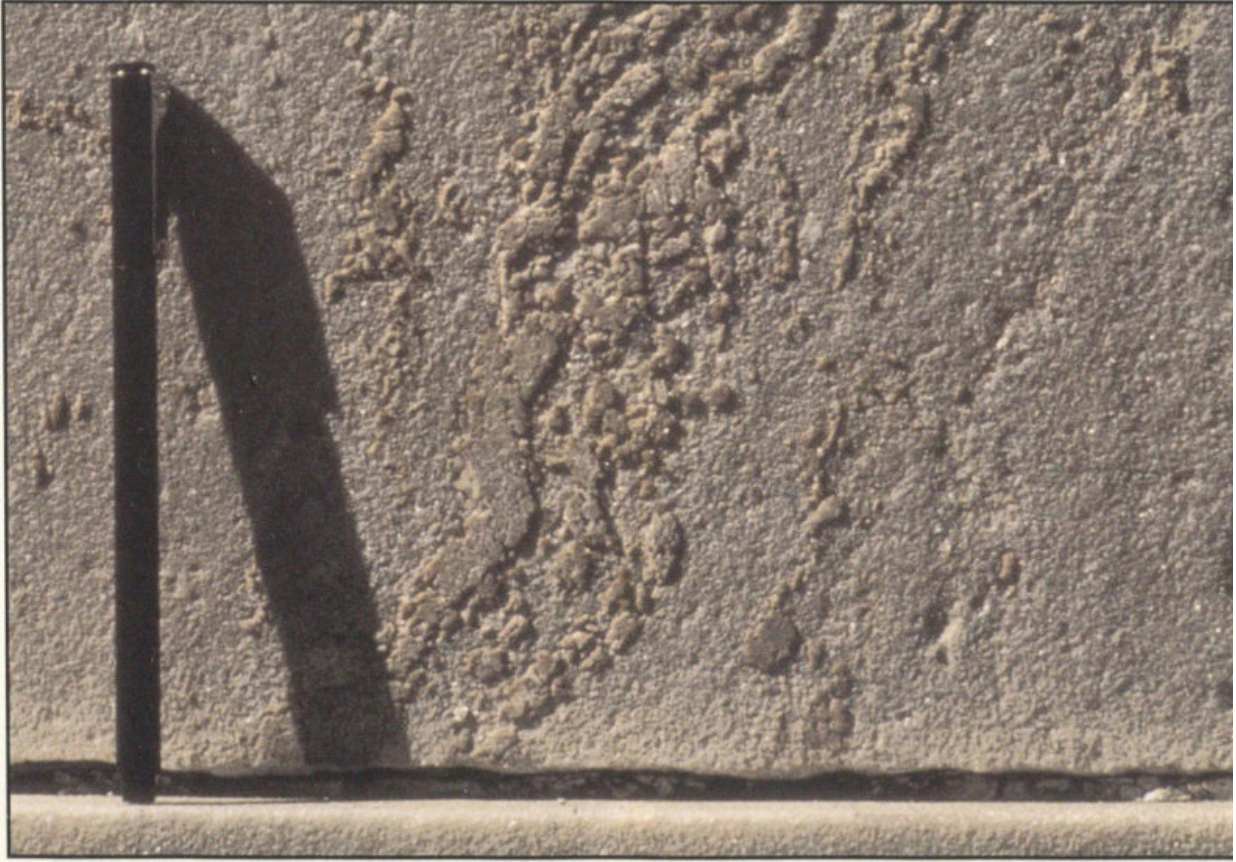
At the northeast corner of the Capitol building, the marble balustrade ends in square blocks like the ones we first examined. Here you can see an example of preferential dissolution where the silicate mineral inclusions remain and the calcite around them has been dissolved away. Also, on the north side of this block, examine the blackened grains on the top surface with a hand lens. Not all of the black material you see on stone is gypsum; some is of biological origin, probably algae or a fungus.

**A marble block that forms the northeast corner of the Capitol balustrade shows preferential erosion of the calcite around a silicate mineral inclusion.**

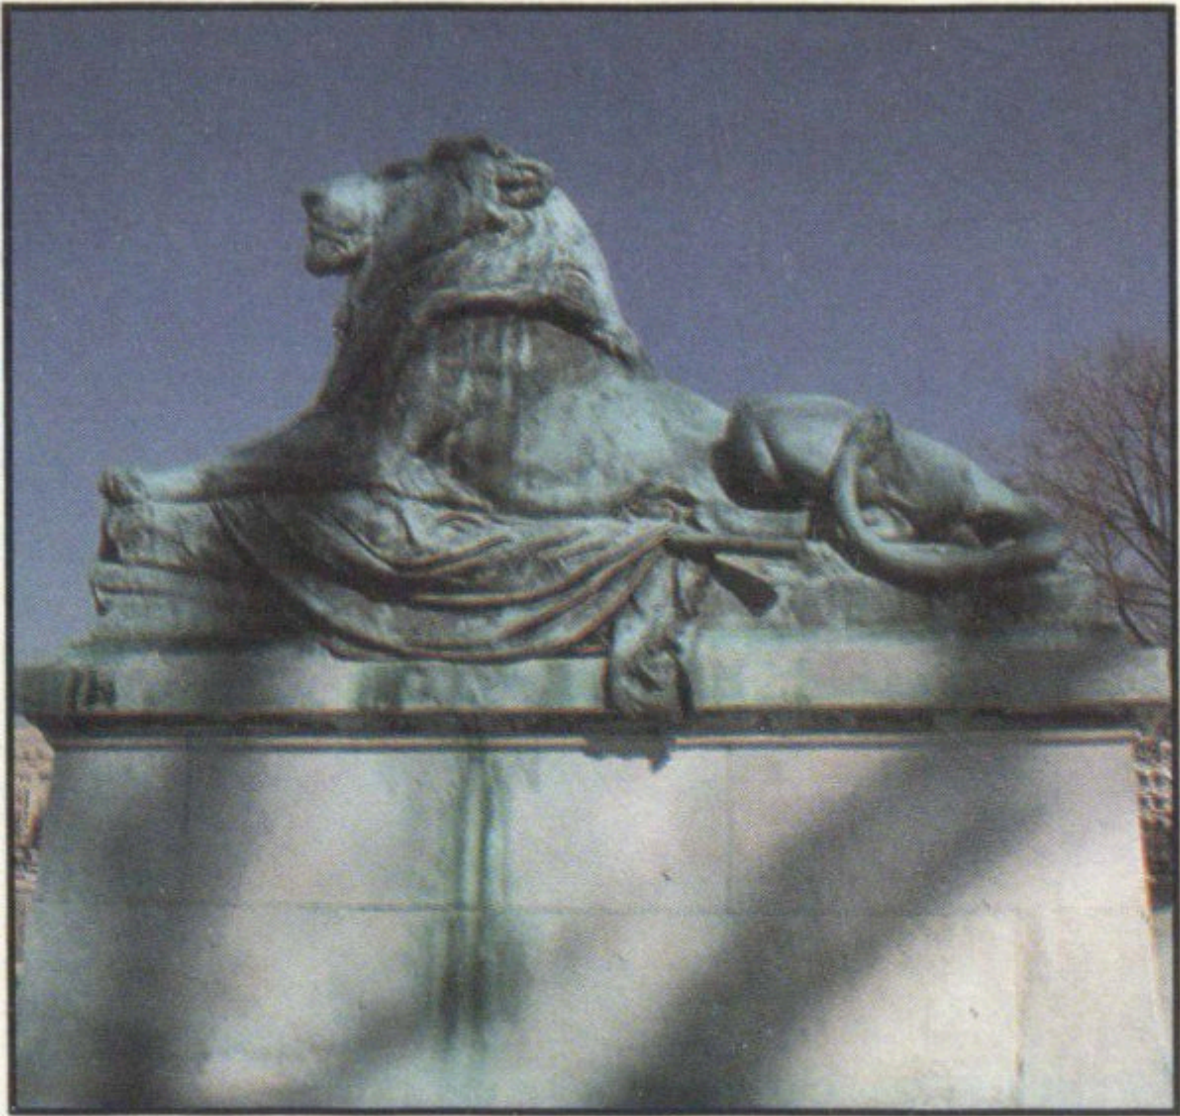
This memorial, dedicated in 1922, consists of a group of bronze sculptures mounted on marble bases. Bronze weathers outdoors if it is not cleaned and waxed regularly. Like stone, bronze dissolves where it is exposed to rainfall, developing a green color and a pitted surface, and it also alters in sheltered areas, with accumulation of a blackened layer. The most notable stone deterioration visible here is the green stain on the marble bases, caused by runoff from the weathered bronze. The green stain does not damage the marble, but it is unattractive, and there are no methods currently available to remove the stain without damaging the marble.

The light-green color on the bronze statues at the Grant Memorial is typical of the way bronze weathers when it is exposed to acidic rain; the rain dissolves some of the metal and causes staining of the white marble bases.

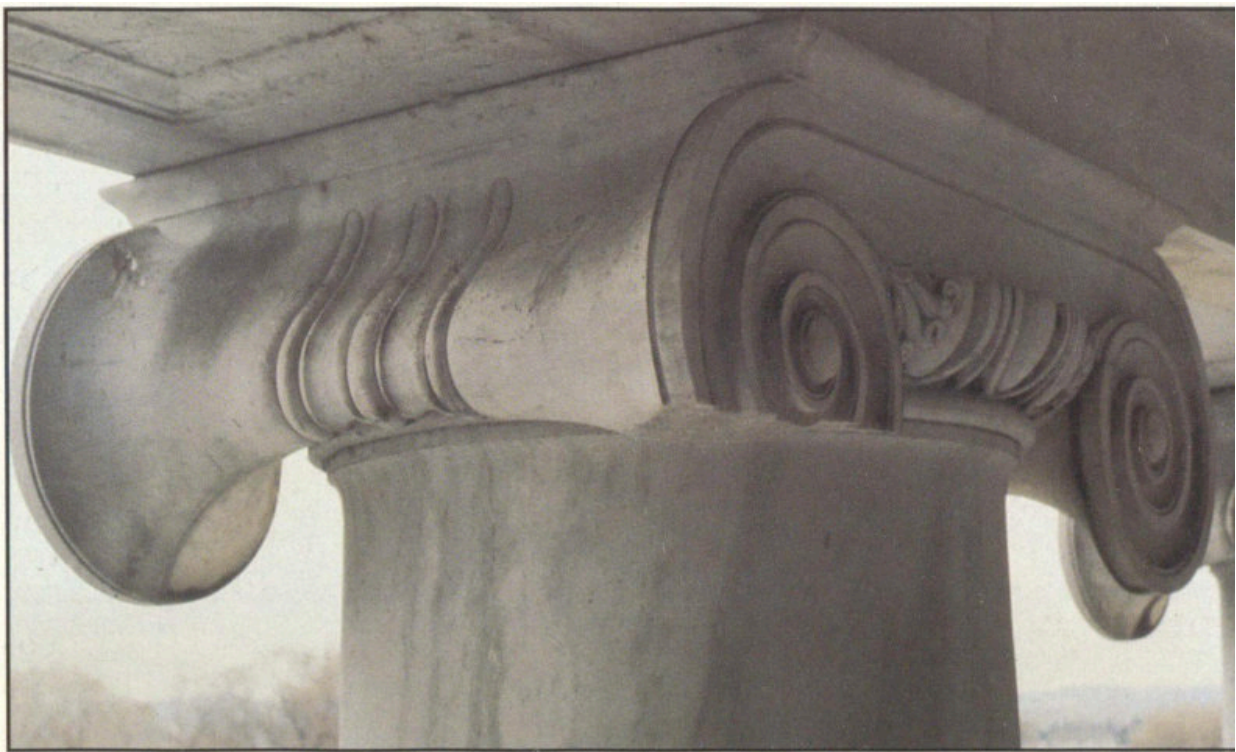
**Part of one of the column capitals at the Jefferson Memorial broke off and fell onto the portico in 1990.**

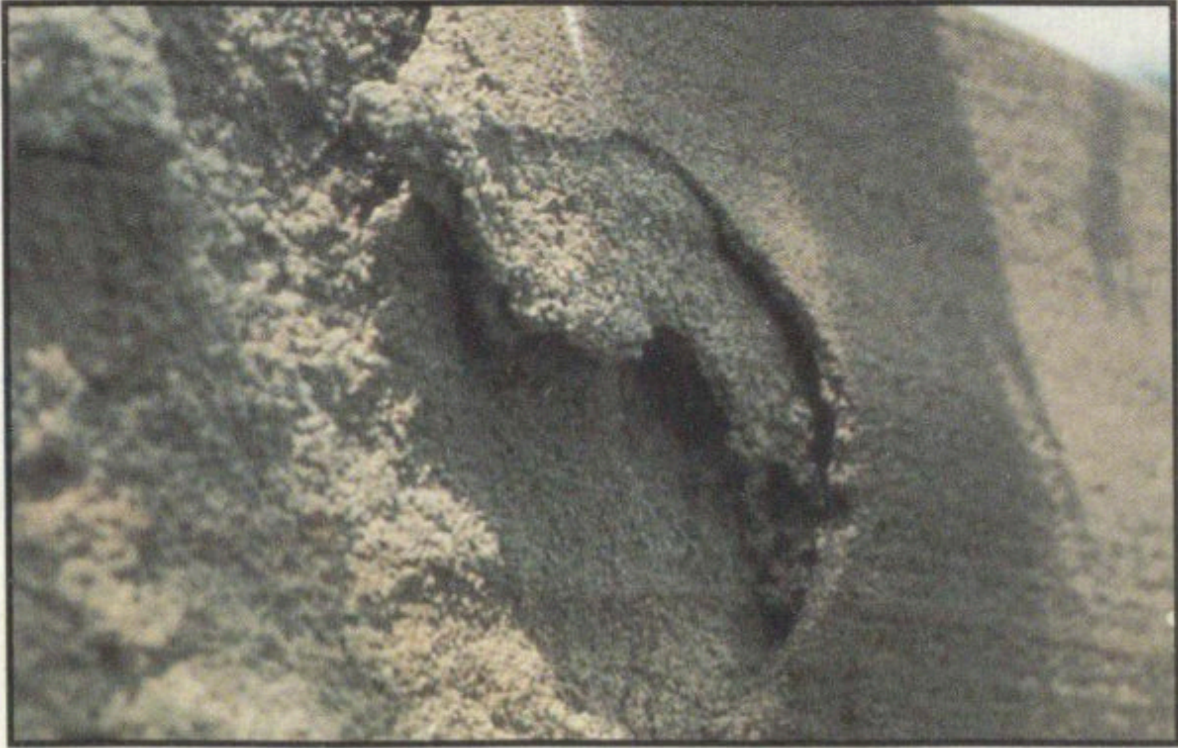
**This kind of sandstone was soon found to be a poor building stone because of its tendency to spall. (detail on Capitol Gatehouse)**

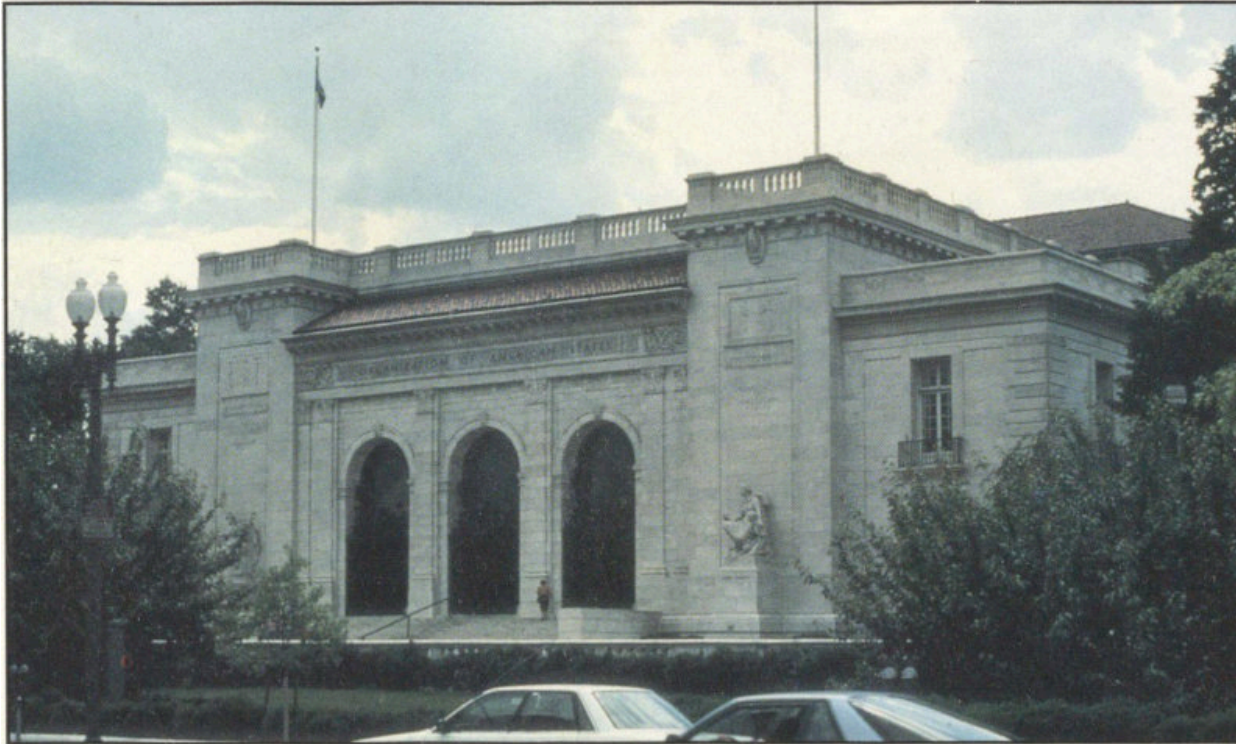
**The Organization of American States Building is made of marble and was dedicated in 1910.**

This marble building was dedicated in 1910. Two sculptures in the front of the building show some alteration crusts in sheltered areas and dissolution in exposed areas. In back of the building the marble balusters on the patio are covered with blackened crusts, especially on the sides facing the garden. In many places the crusts have blistered or spalled off, exposing new surfaces to alteration. In general, the patio sides of the balusters are in much better condition than the sides that face the garden, perhaps because washing of the patio has washed off the gypsum crusts on that side of the balusters.

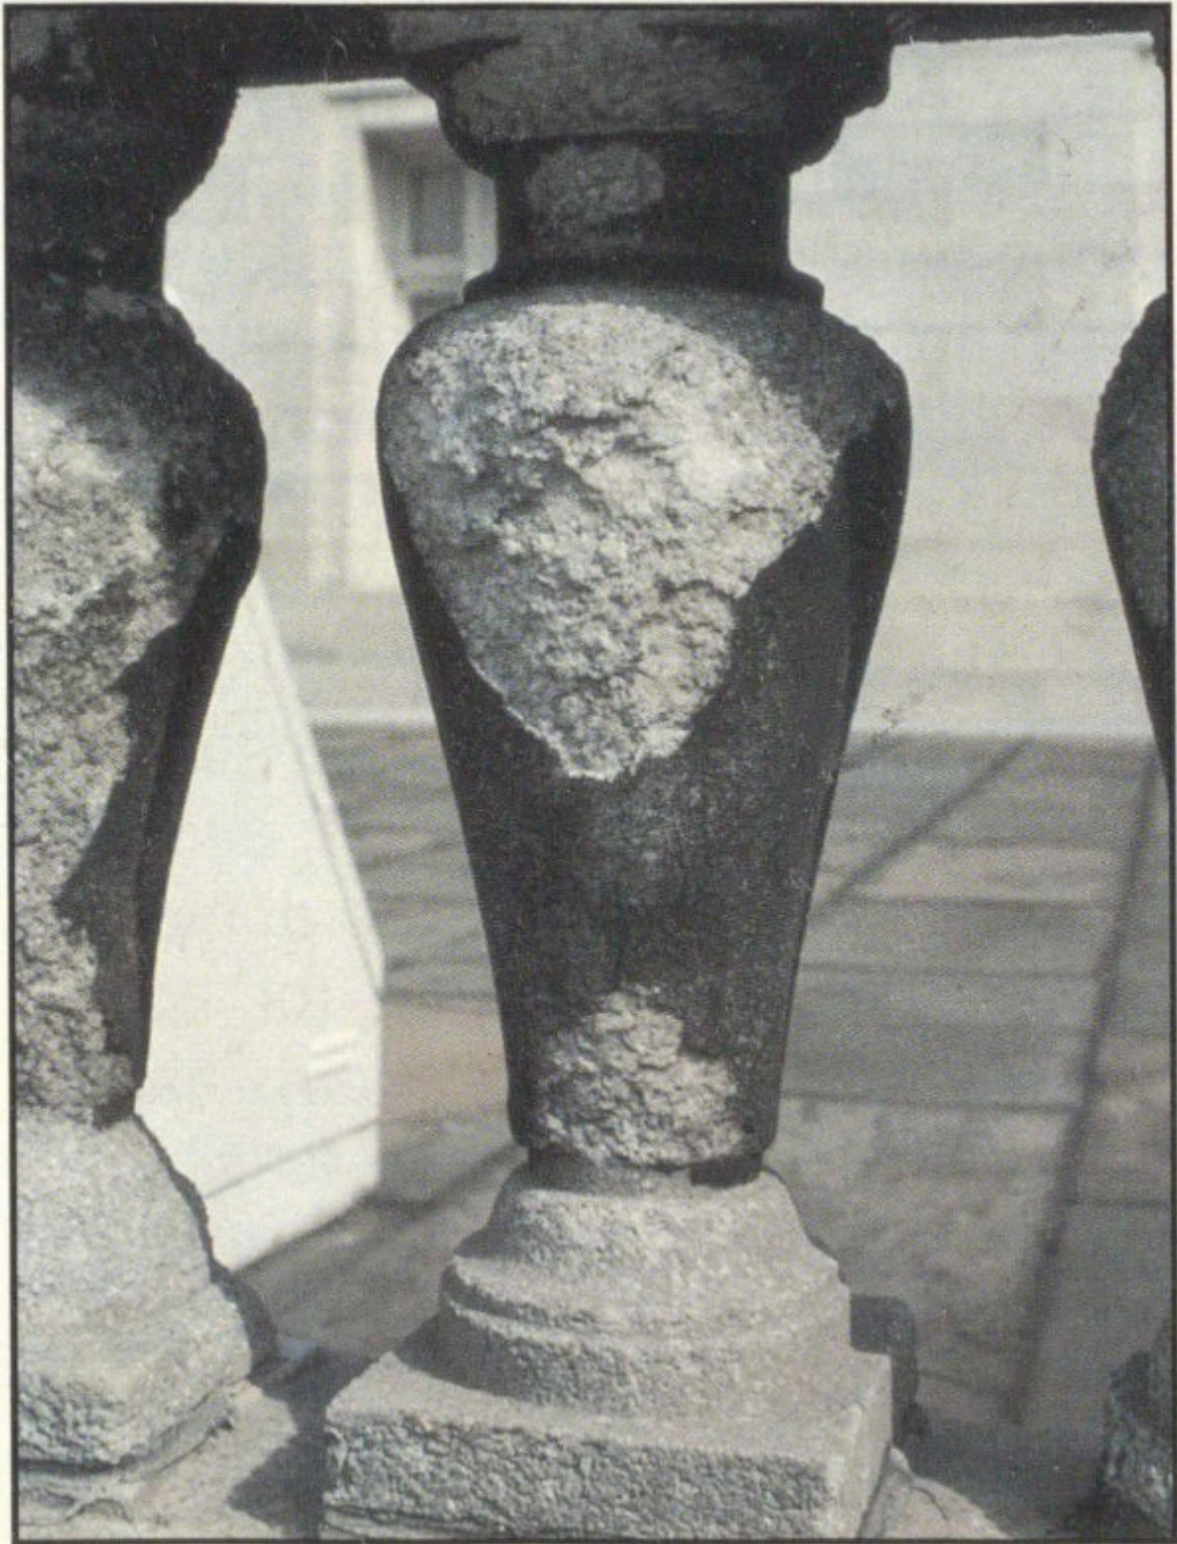
**Blackened gypsum crusts may blister and spall off, exposing a crumbling stone surface to further pollution.**

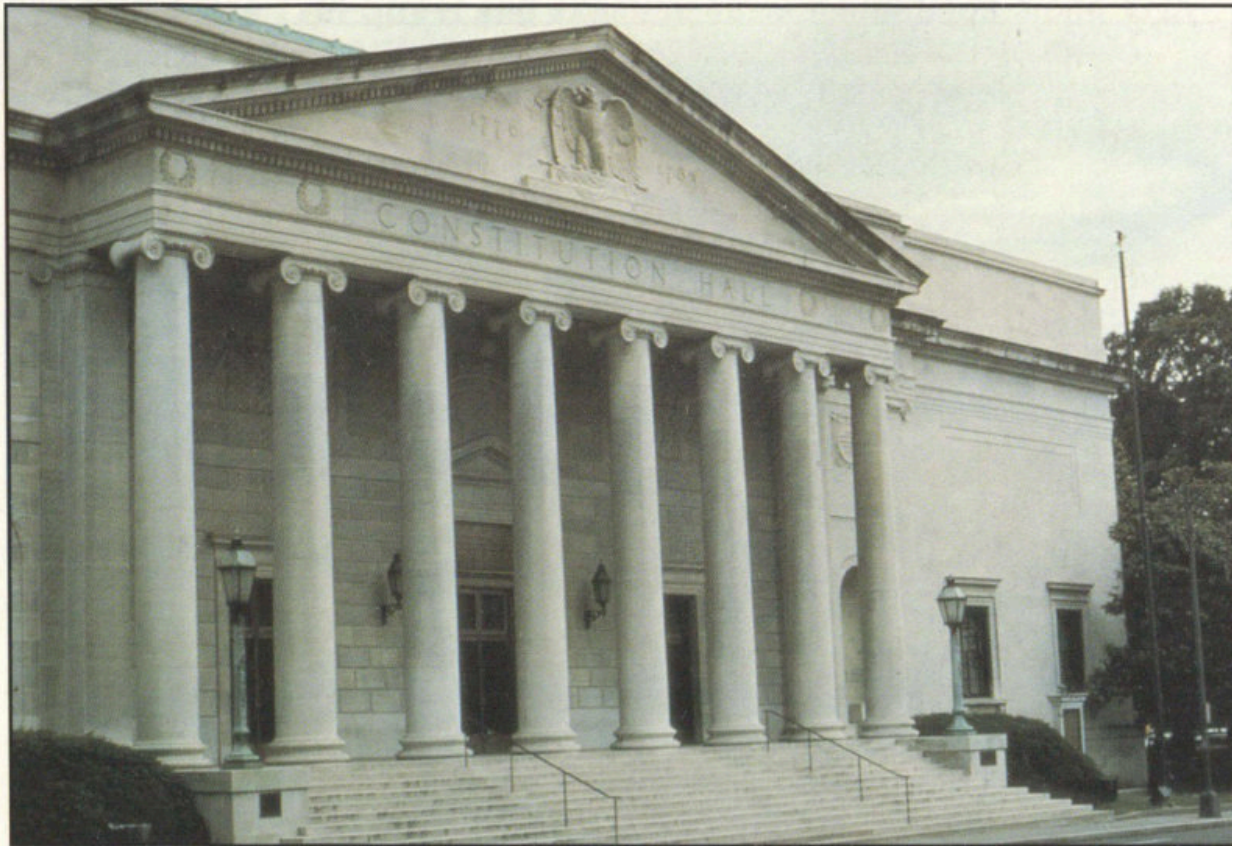
**DAR—Constitution Hall is made of limestone and was built in the 1930's.**

The main damage on this limestone building, built in the 1930's, is the blackening of the side balustrade from algae or fungi. The stone is porous and therefore retains moisture, thus encouraging growth of organisms. The limestone in this building is quite uniform and shows little preferential dissolution, except in a few places. On the top of the balustrade along C Street, for example, some of the calcite matrix has dissolved from around the fossil fragments, and some holes are filled with calcite crystals.

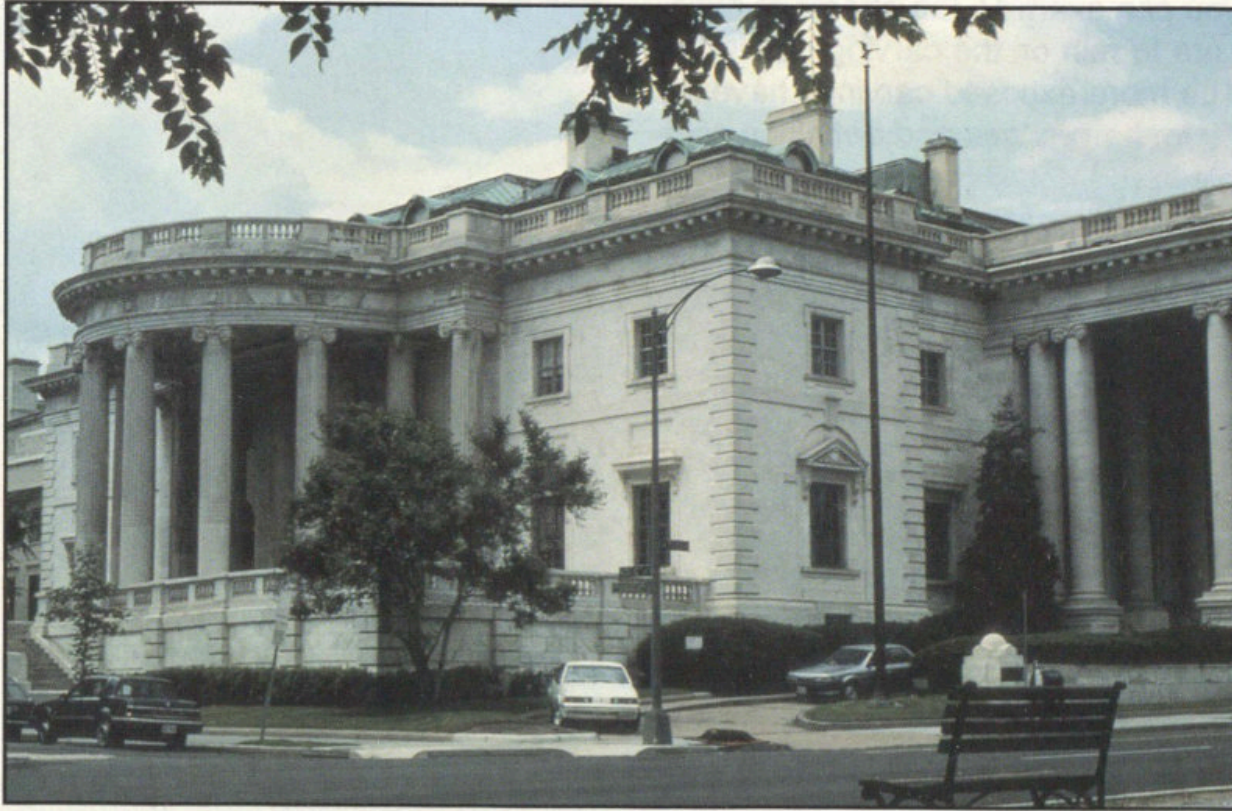
**Memorial Continental Hall, built in 1909, is part of the Daughters of the American Revolution building complex.**

The porch area on the south side of this marble building built in 1909 is a good place to look at some contrasts in marble deterioration. Parts of the balustrade have been replaced, as shown by differences in color and surface roughness of the stone. The exposed stone surface along the top of the balustrade is rougher than the surfaces in more sheltered areas. The columns on this porch are carved around the base, so you can examine the effects of exposure to rain on the carving details. The more exposed carvings have lost their sharp edges and definition compared to the sheltered carvings. The bases of the columns contain small amounts of pyrite, which is more resistant to weathering than is the calcite in the marble surrounding the pyrite. The sheltered part of the window-sill support on the west side of the porch shows an alteration crust, a dull gray accumulation on the stone surface.

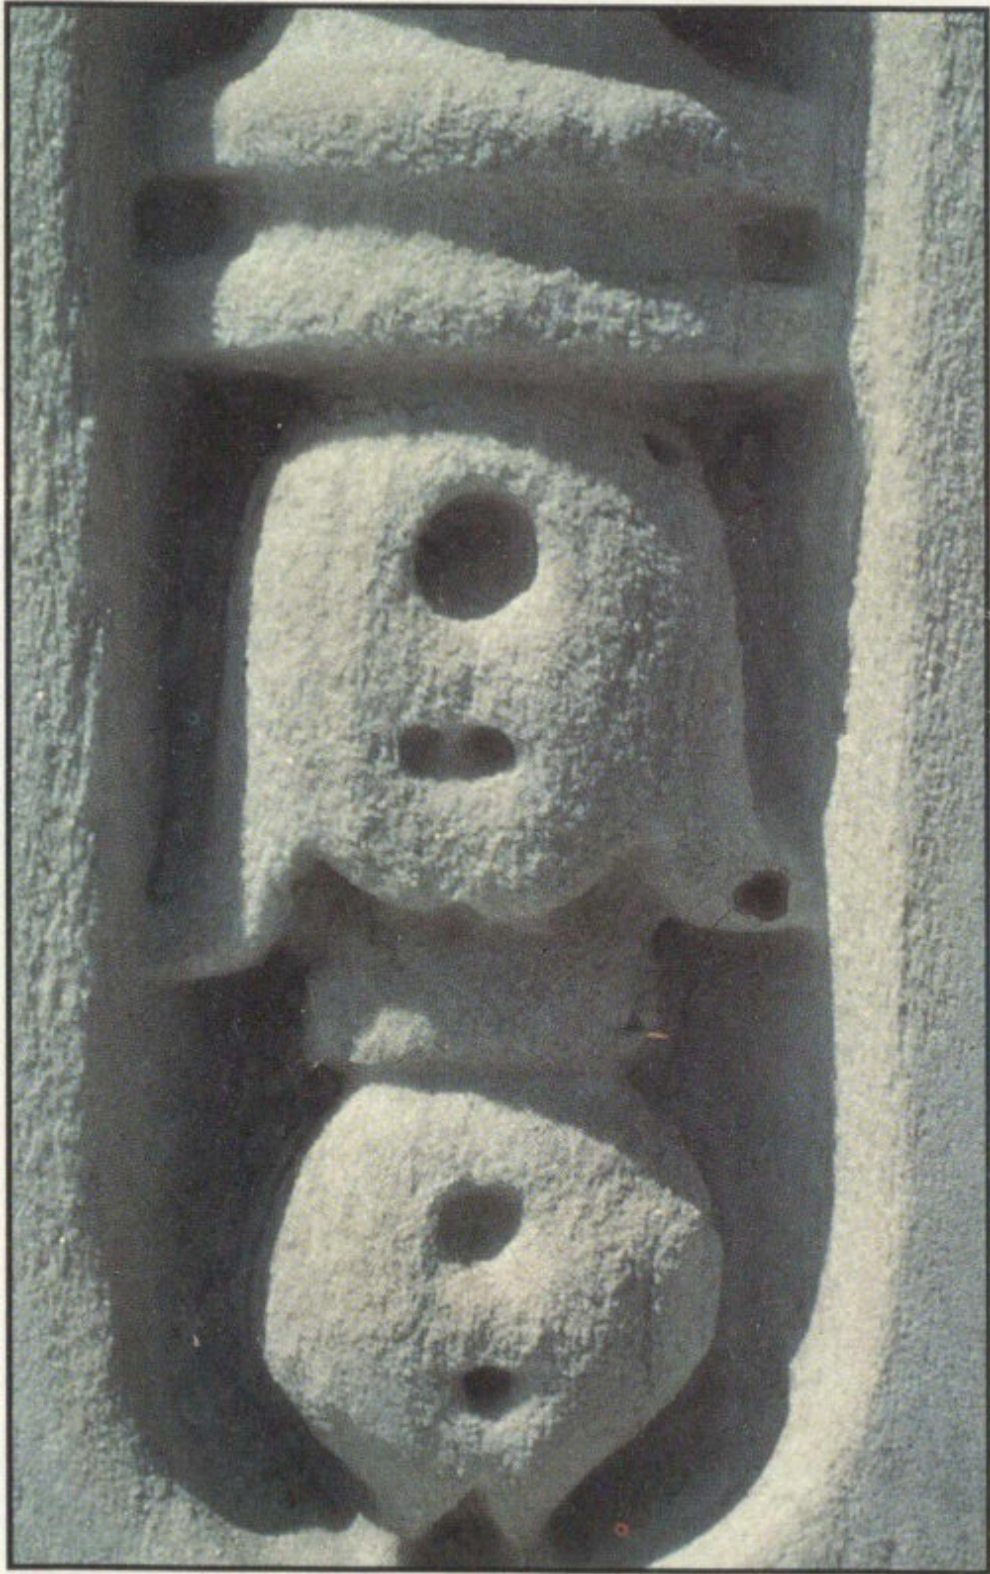
On an exposed portion of the carving on the columns at Memorial Continental Hall, the edges of the marble have rounded and the surface has roughened.
