# Acid Rain and Our Nation's Capital

*A Guide to Effects on Buildings and Monuments*

U.S. Department of the Interior/U.S. Geological Survey

*by Elaine McGee*

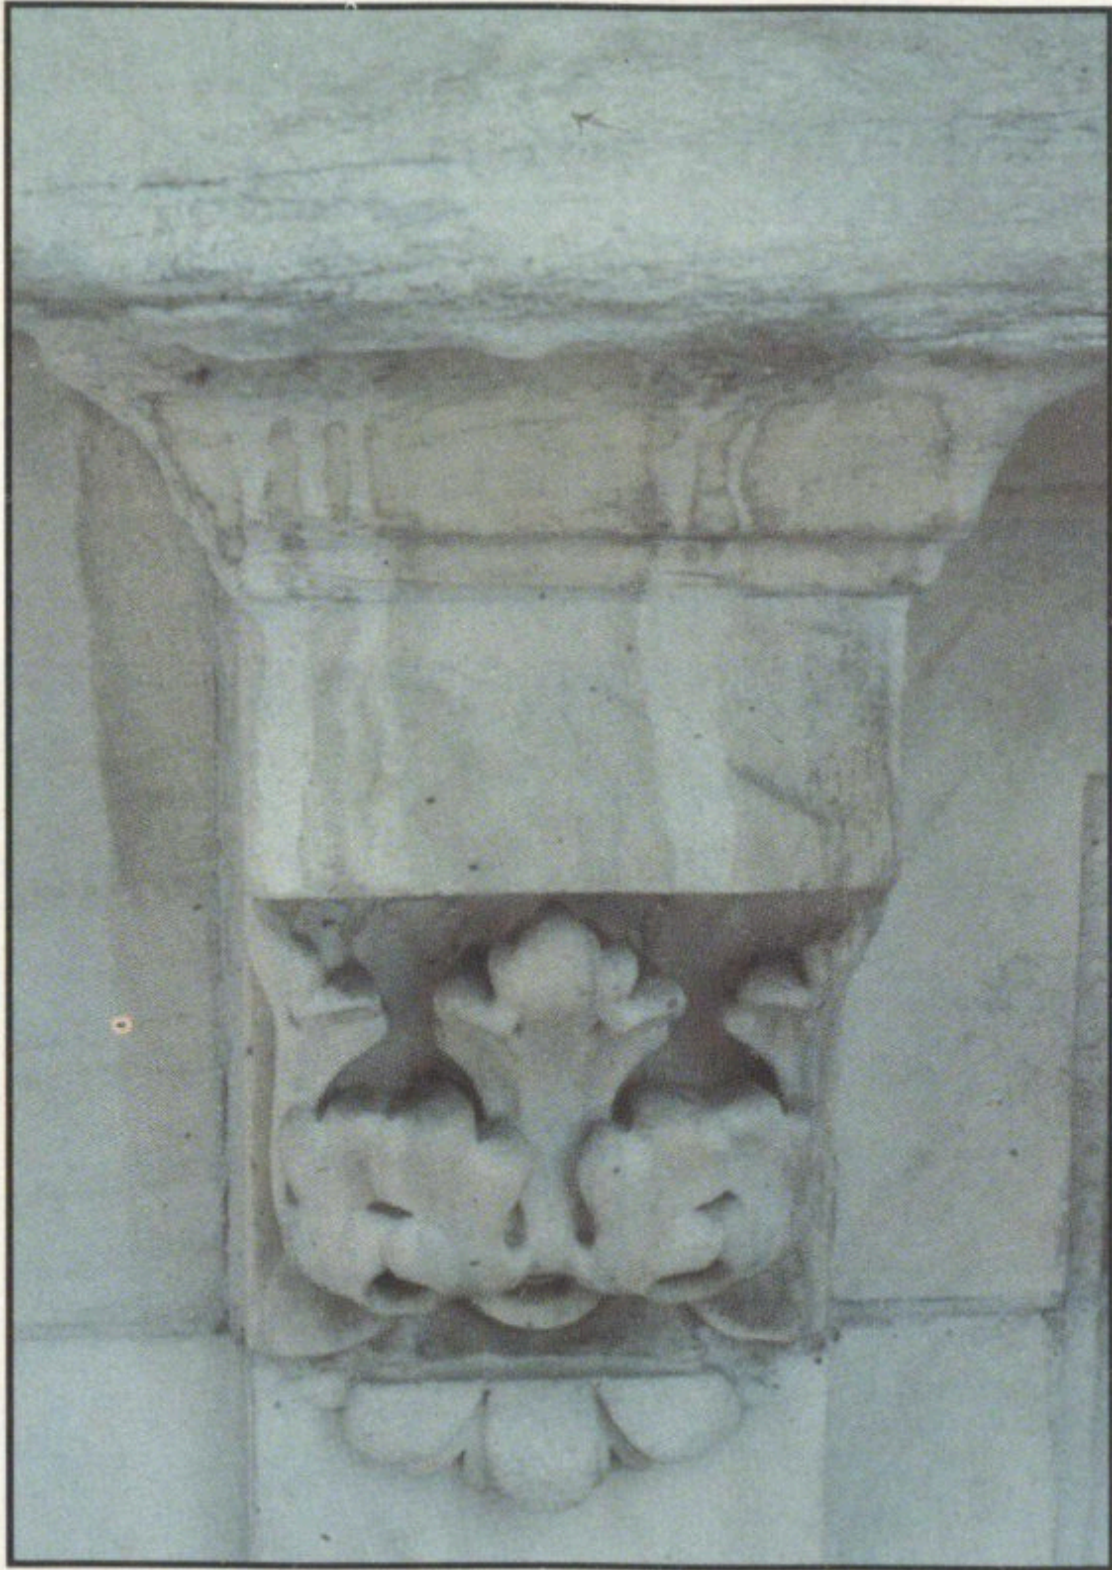
A dull gray surface on the marble on the window-sill support shows where an alteration crust is just beginning to develop.

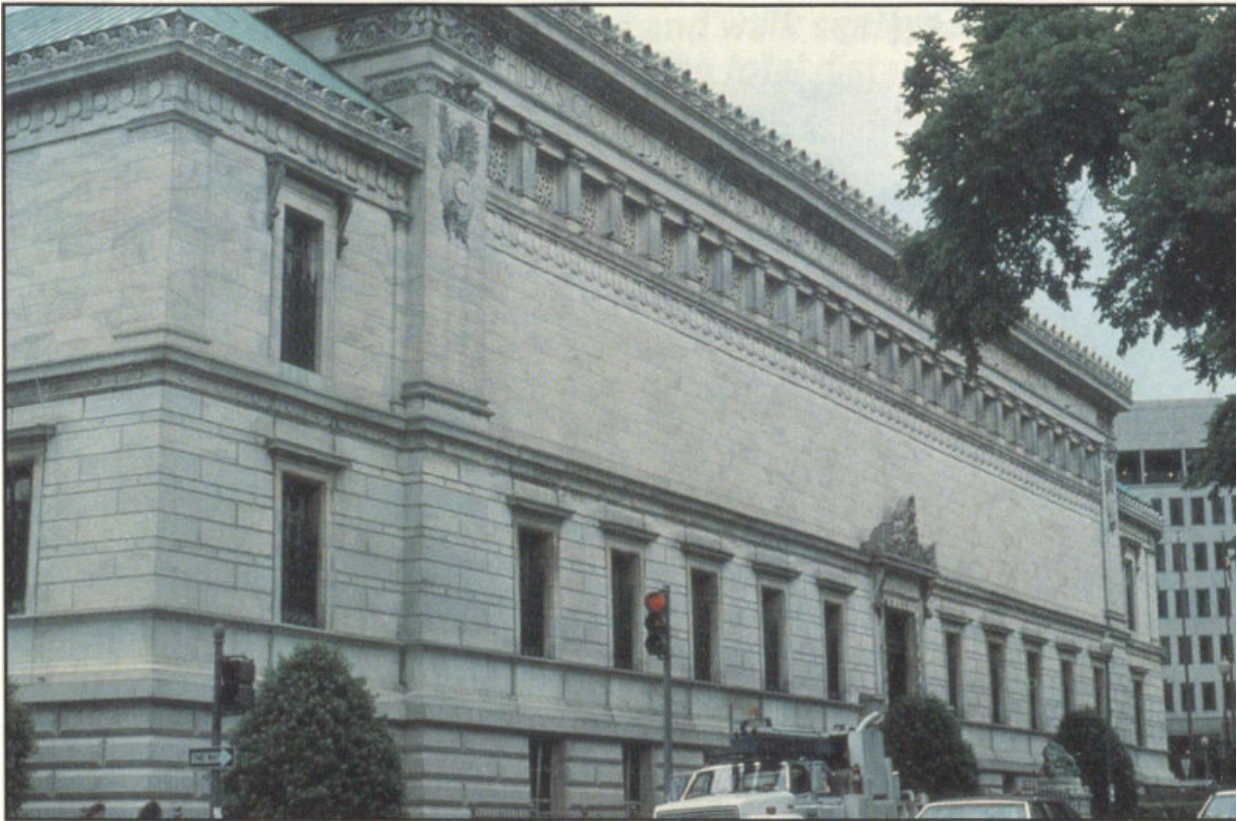
**The Corcoran Gallery is built mostly of marble.**

The Corcoran Gallery is marble with a granite base. It was built in 1879 and enlarged in 1927. Ornate carvings around the roof, doors, and windows have blackened crusts of gypsum, as do parts of the marble pedestals supporting the bronze lions at the front door. The marble bases also have inclusions that stand out above the surrounding calcite, which has been dissolved away.

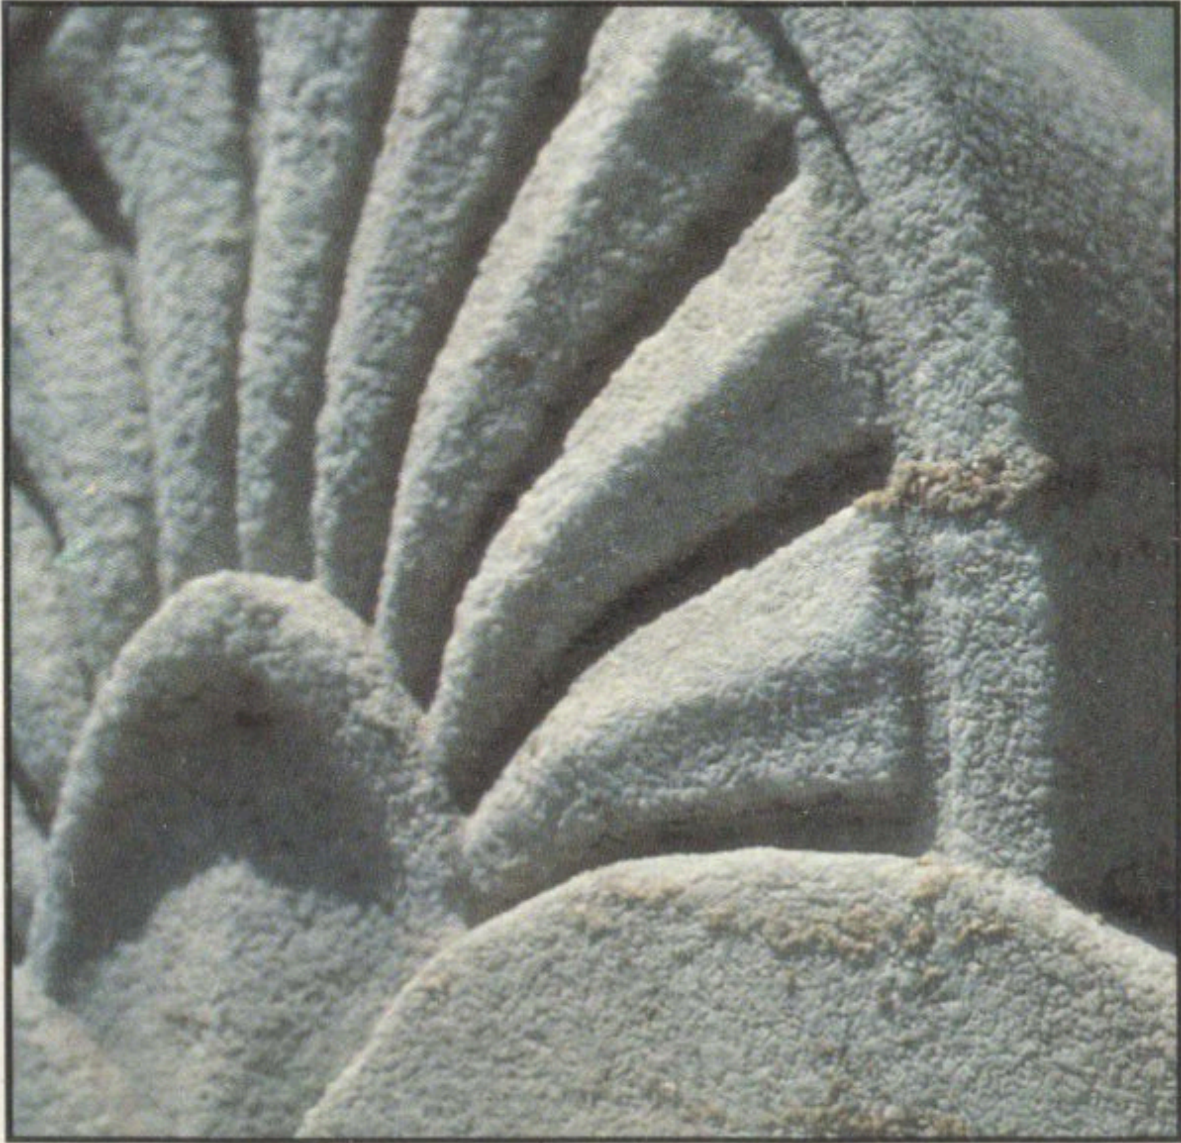
**Marble bases for bronze lions outside the entrance to the Corcoran Gallery have feldspar inclusions that stand in relief compared to the roughened surrounding calcite.**

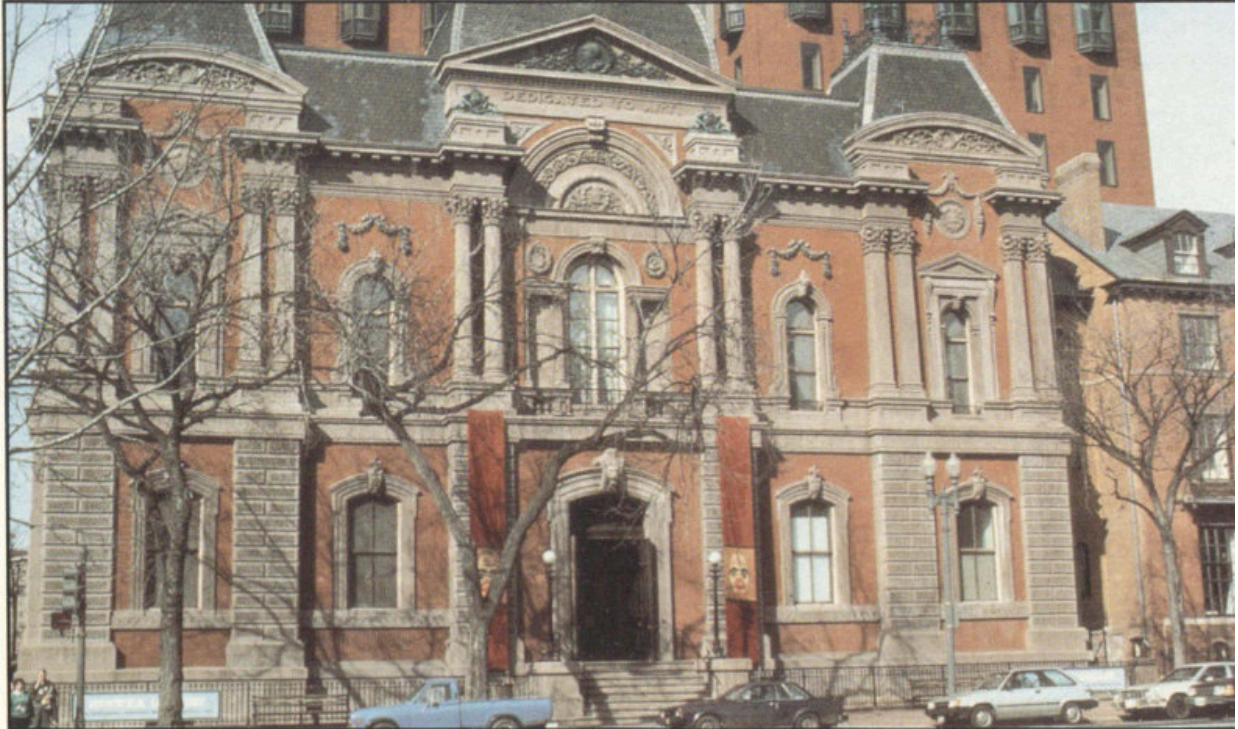
**The Renwick Gallery, made of brick and sandstone, was completed in 1859.**

This building of brick and sandstone, completed in 1859, is interesting from a stone preservation point of view. The decorative sandstone panels were badly deteriorated, so in 1968 the panels were saturated with epoxy to strengthen them. This treatment actually accelerated the deterioration because when water penetrated behind the epoxy-filled area, large portions of the treated panels spalled off. A second renovation attempt was therefore necessary two years after the first, and the present panels are cast sandstone. A post of the original sandstone stands at the southeast corner of the building.
