# ANTIQUITIES OF THE MESA VERDE NATIONAL PARK

## CLIFF PALACE

JESSE WALTER FEWKES

WASHINGTON  
GOVERNMENT PRINTING OFFICE  
1911

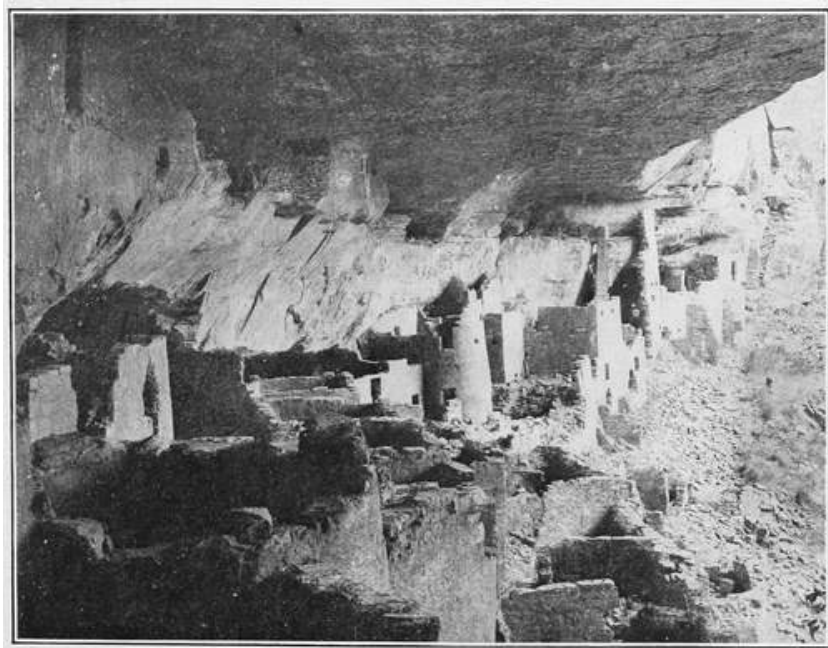
THE SOUTHERN END, AFTER AND BEFORE REPAIRING

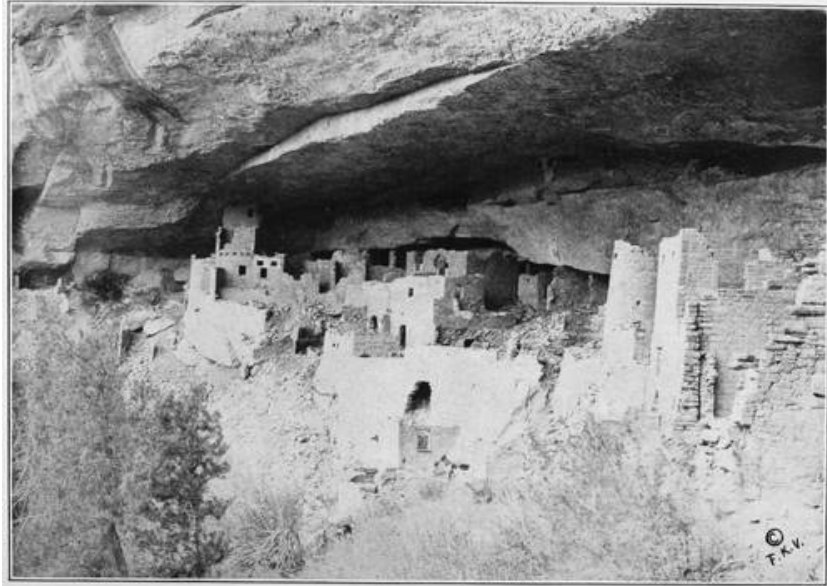
CENTRAL PART, BEFORE REPAIRING

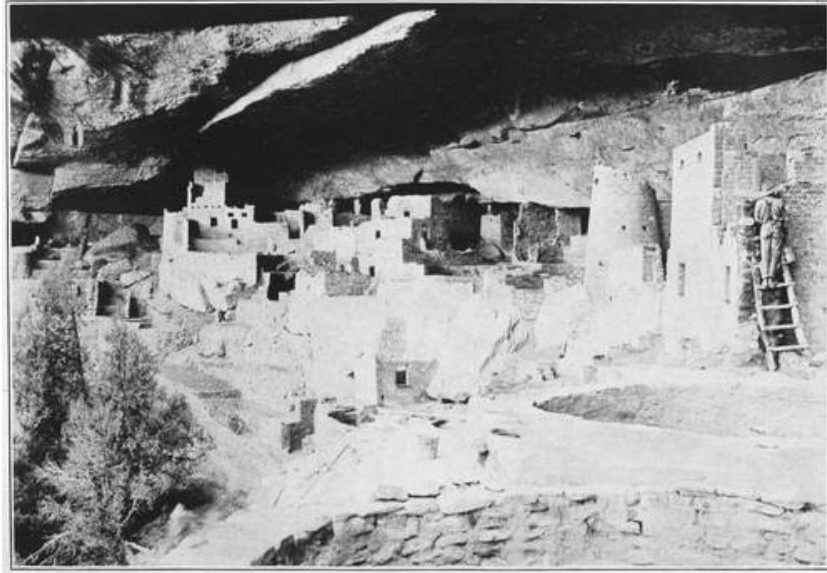
CENTRAL PART, AFTER REPAIRING

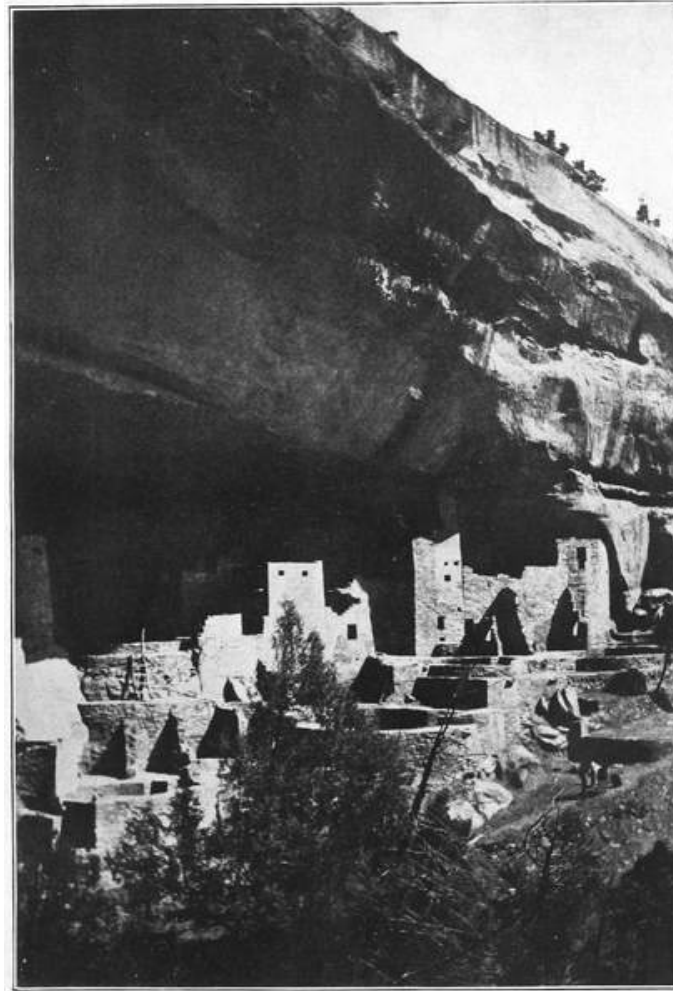
SOUTHERN END, AFTER REPAIRING

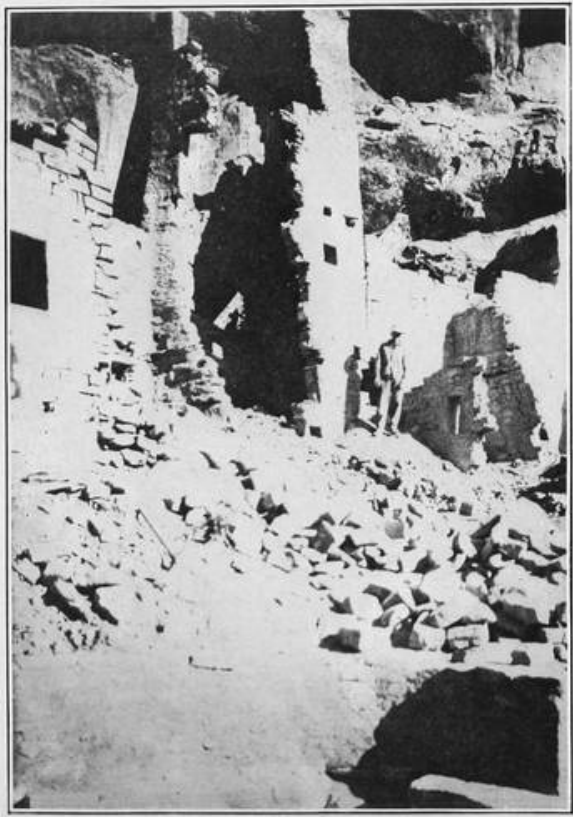
THE SQUARE TOWER, BEFORE AND AFTER REPAIRING

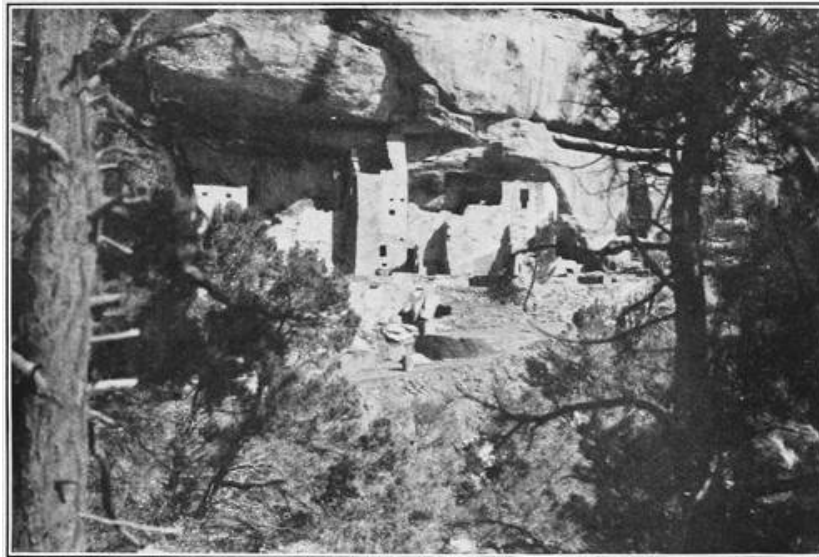
SQUARE TOWER, AFTER REPAIRING

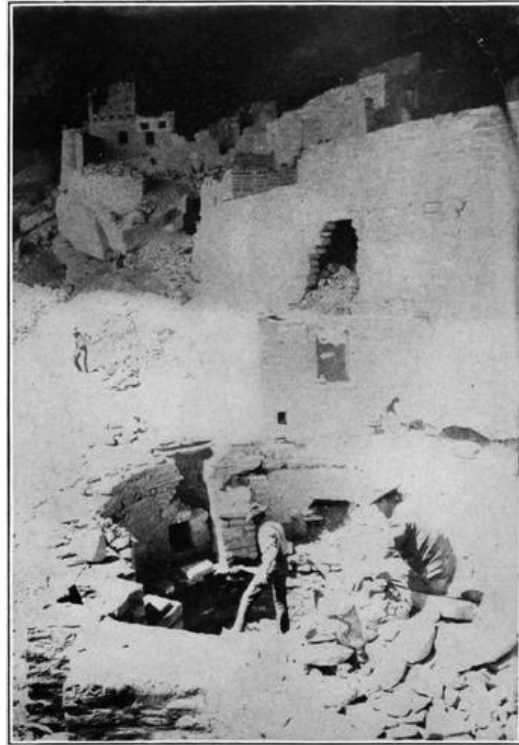
KIVA H, BEFORE REPAIRING

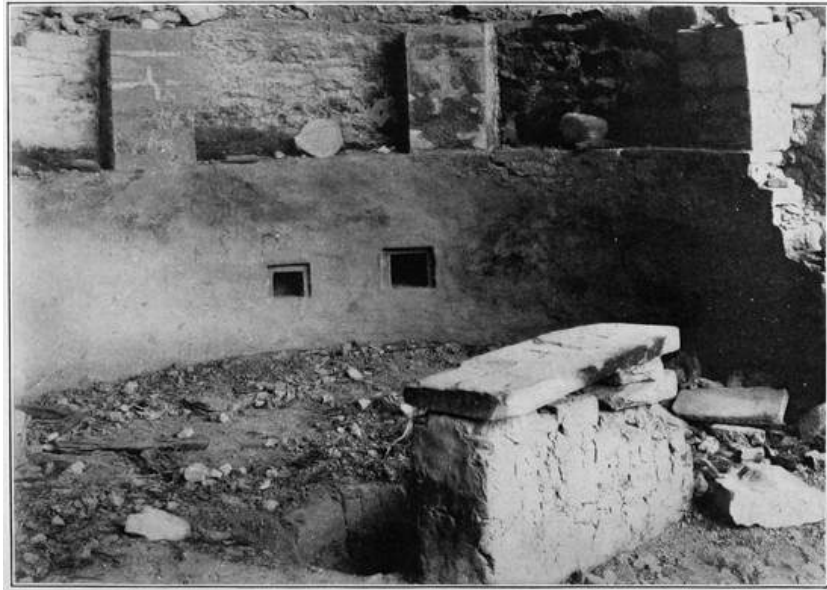
## SOUTHEASTERN WALL OF KIVA Q, BEFORE REPAIRING
