Paula Karina Śwituszak, MA  
Nicolaus Copernicus University in Toruń, Poland  
[paula.karina.swituszak@gmail.com](mailto:paula.karina.swituszak@gmail.com)

# Turning back time: Study, conservation, and exhibition of a XVII-century double-sided clock face

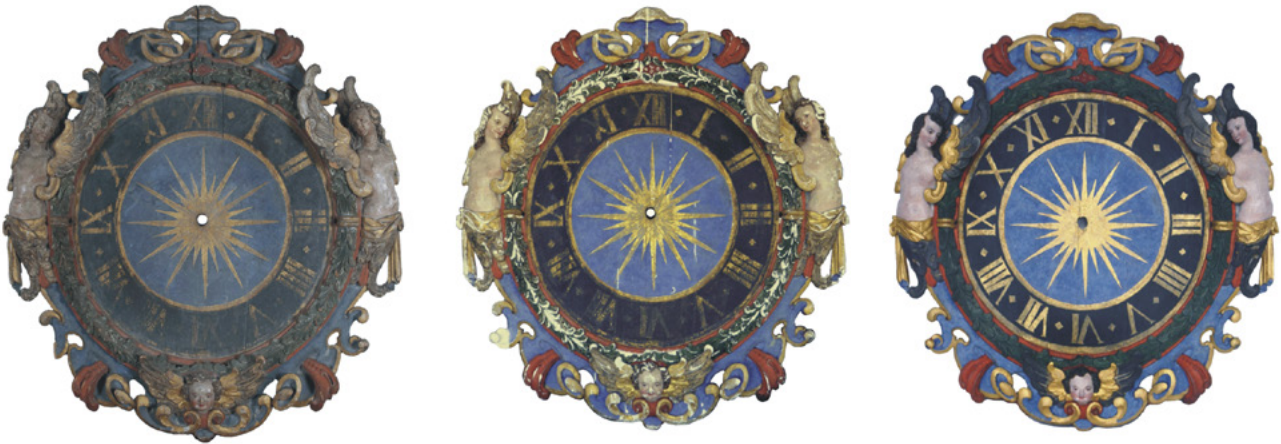
PHOT. 3 *Clockwork after conservation treatment.*

of clock-face. Aesthetic paint layer and gilding reintegration were achieved with pigments mixed with 20% acrylic binder Paraloid B27 in PGME, with PGME + DPGME thinner in a 4-to-1 proportion.<sup>13</sup> In regions where a primarily metallic foil was attached, silver and gold powder were used. The final protection layer was completed using the same satin spray varnish as before, and parts of the carnation and hair were gloss varnished by brush (*Royal Talens Amsterdam, Glossy Acrylic Varnish, no. 114*). The clock face's back, support mechanism, and wax paste was thinly applied to sideboard's back (Antiquaire Starwax, vaisz, közép tölgy), creating a hydrophobic barrier (Phot. 3).

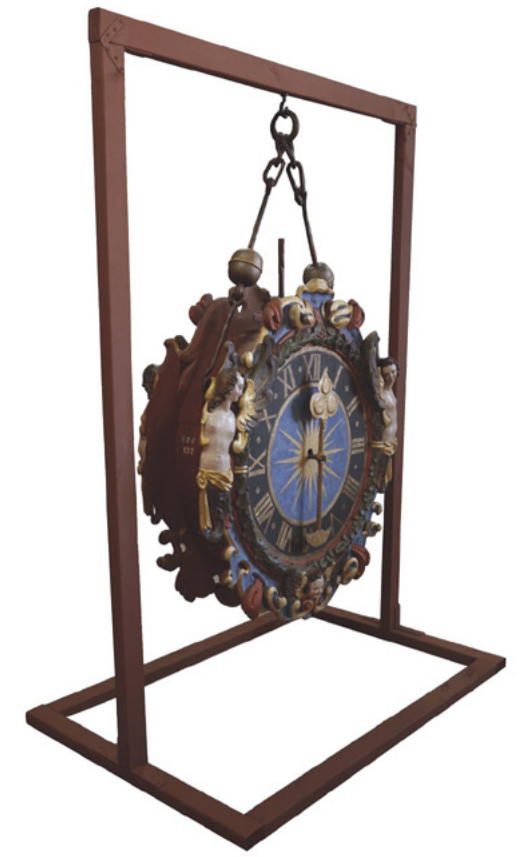
PHOT. 4 Clock face after conservation treatment.  
Paula Śwituszak

would have made the reassembly even more complex and made the exact fitting of the parts impossible. The original angles prevented the distance between the two clock faces from being changed at the top and bottom levels. To increase the stability of the overall structure and prevent the sideboards from falling out, an ochroma pad was installed. To stabilise the hanging clock face, the original bar element connecting the side of the clock face to the wall was reinstalled. A wooden support for the clock suspension was built (Phot. 4).

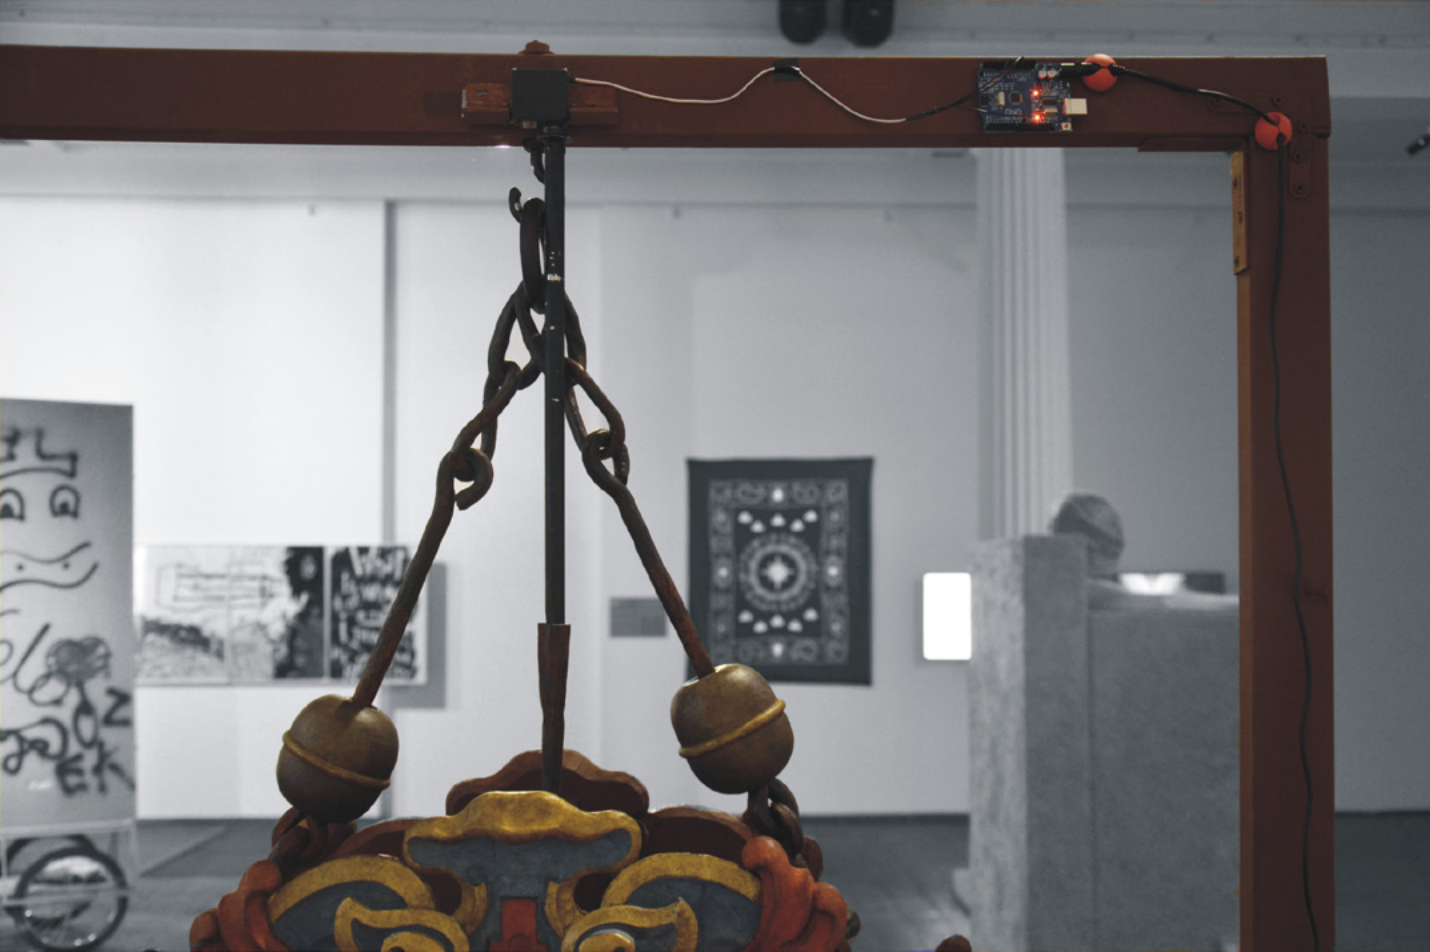
**PHOT. 5** A small engine and control platform are visible on one side of the frame from which the clock face is suspended.  
Paula Śwituszak

The clock's drive proposed by author was based on the idea of a combined system of a control box and a stepper motor designed by an electromechanical company to ensure the clock was always working during the exhibition. To test the possibility of using the original mechanism, a toy drive was made based on a control platform and servomechanism connected to the axis of the mechanism by a steel joint (Phot. 5). The mechanism can simply be plugged in and programmed to turn the clock hands every 30 minutes to indicate every full hour and half hour. This can be easily regulated by using an Arduino environment, to ensure that the clock works like it did in the beginning of the 17th century.
