## THE $M_w$ 7.0 HAITI EARTHQUAKE of JANUARY 12, 2010:

**USGS/EERI Advance Reconnaissance Team  
TEAM REPORT  
V. 1.0**

**February 18, 2010**

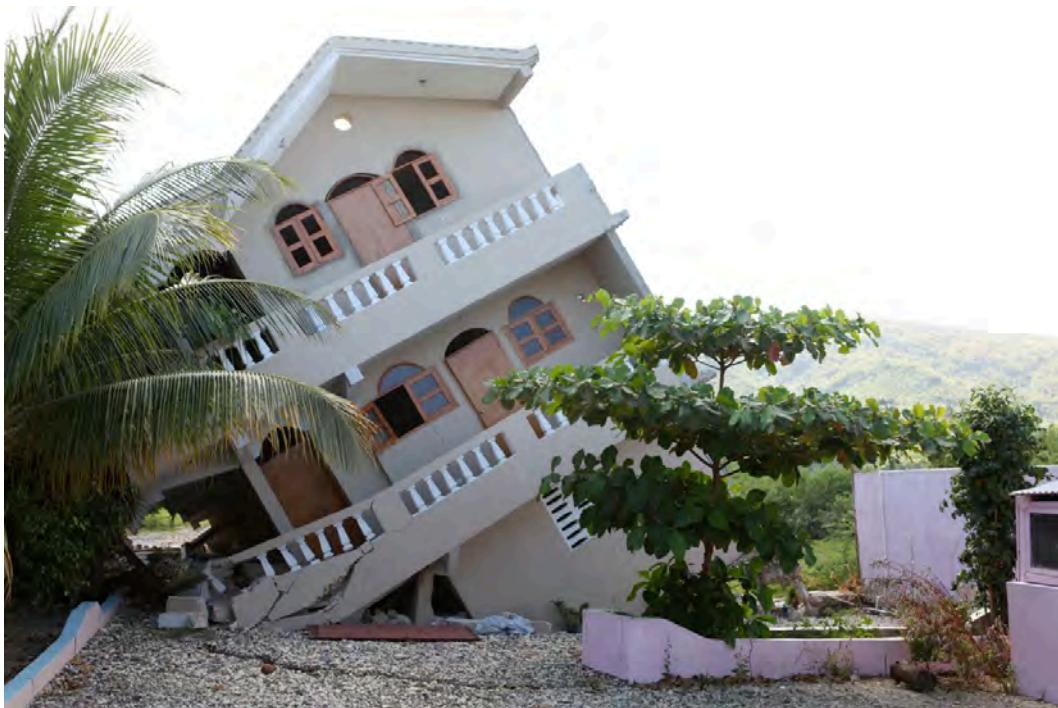
Other less severe liquefaction-related features were observed in the alluvial plain surrounding the city of Léogâne. Figure 6 shows the failure of a structure located about 75 m (246 ft) from the shoreline at 18.446323° N, 72.686259° W. There were several sand boils nearby; the largest of which measured approximately 4 m (13 ft) in diameter. Based on discussions with others who observed this structure (Ellen Rathje and Russell Green, personal communication), it is likely that a combination of structural and foundation failures contributed to the collapse of the structure.

*Figure 6. Combined structural and foundation failure southwest of Léogâne*

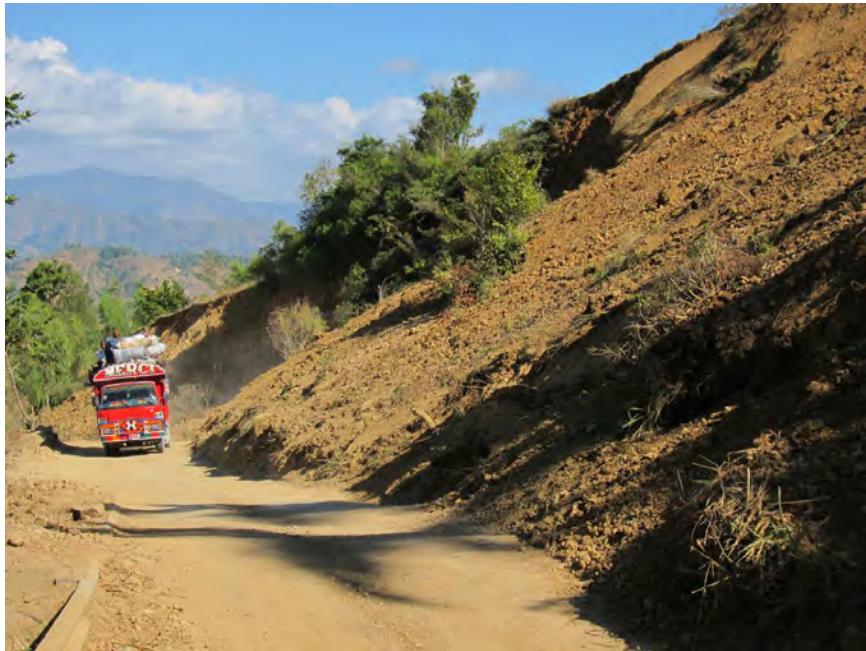
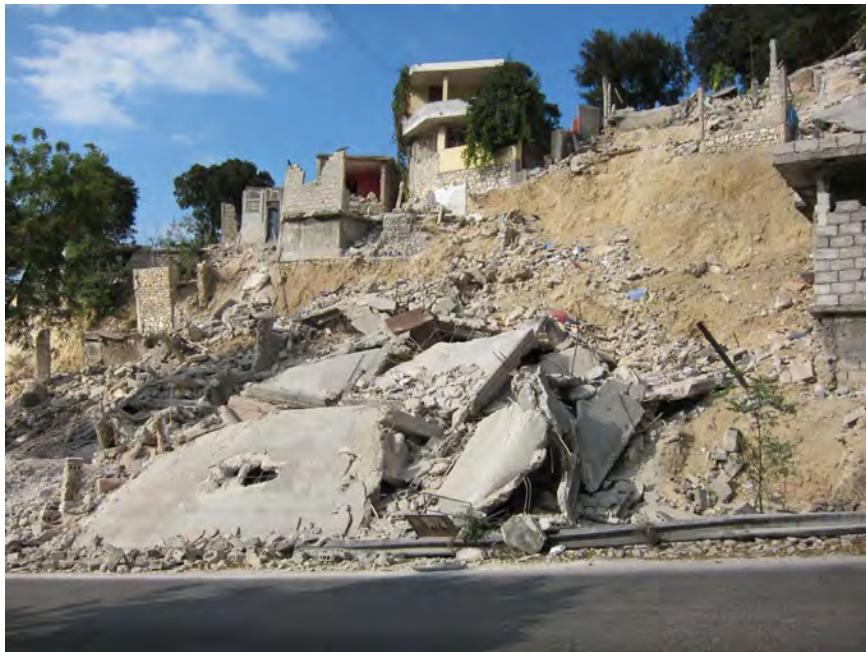
We observed a large number of landslides along Highway 204 in the mountainous area approximately 10-15 km southwest of the epicenter. Most of these landslides occurred in cut slopes along the highway (Fig. 7a). We did not observe many landslides in natural slopes away from the highway. We also observed several landslides in the foothills of the La Selle mountains between downtown Port-au-Prince and Pétion-Ville. Fig. 7b shows an example of one such landslide that destroyed several homes on top of the slope is shown in Fig. 7b.

Figure 7. Landslide (a) along Hwy. 204 and (b) near Pétion-Ville

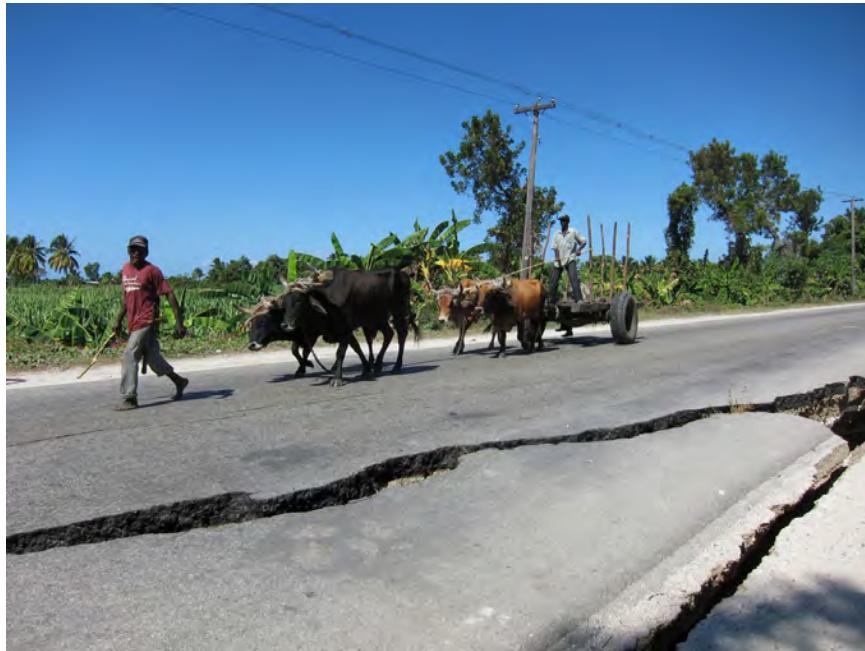
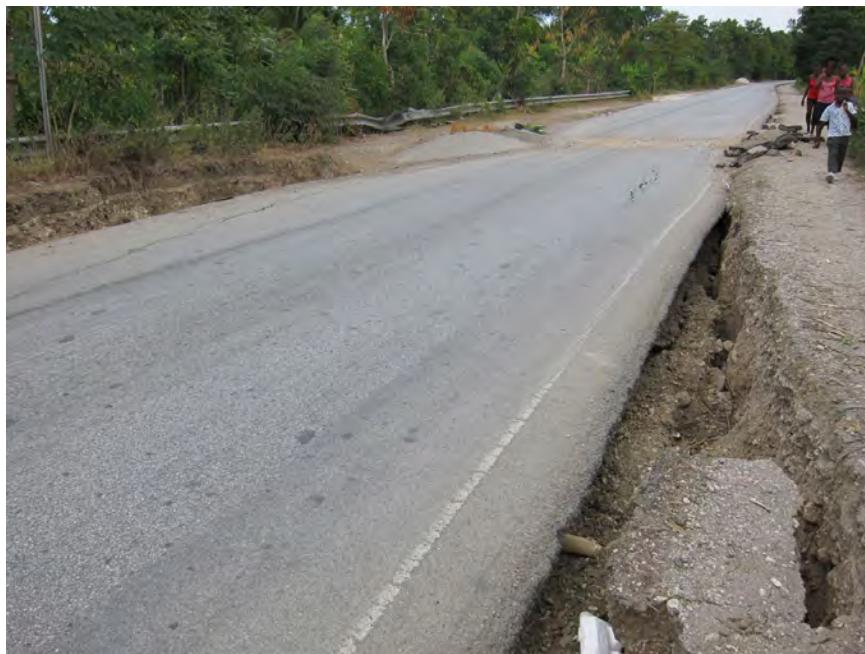
Two failures that caused damage to the pavement were observed along Nationale No. 2 west of the epicenter where the road is constructed on an embankment above low-lying coastal areas. In the first case (18.473550° N, 72.632383° W), the pavement damage appears to have been caused by a slope failure (Fig 8a). The cause of damage in the second case (18.423130° N, 72.724660° W) is more complex and may be the result of dynamic densification of the fill because the pavement has settled by approximately 1 m (3.3 ft) (Fig. 8b).

*Figure 8. Roadway embankment failures*

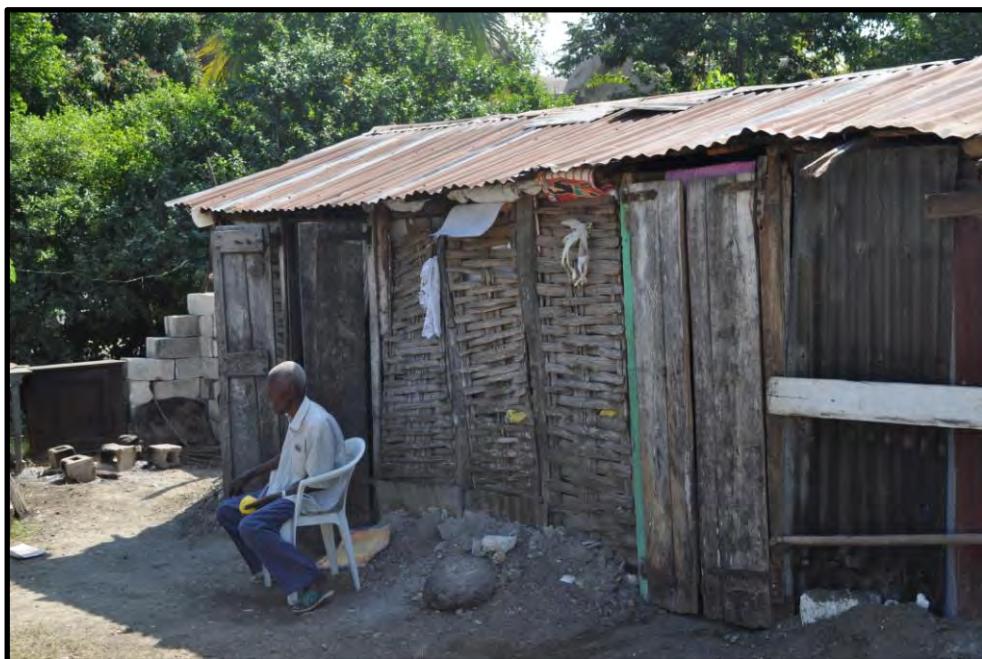
We did not see much damage or collapse in the first two categories of residential construction (Fig. 9). The lower weight of the building materials in these types of construction likely resulted in lower seismic inertial forces.

*Figure 9. Undamaged light-frame residential building*

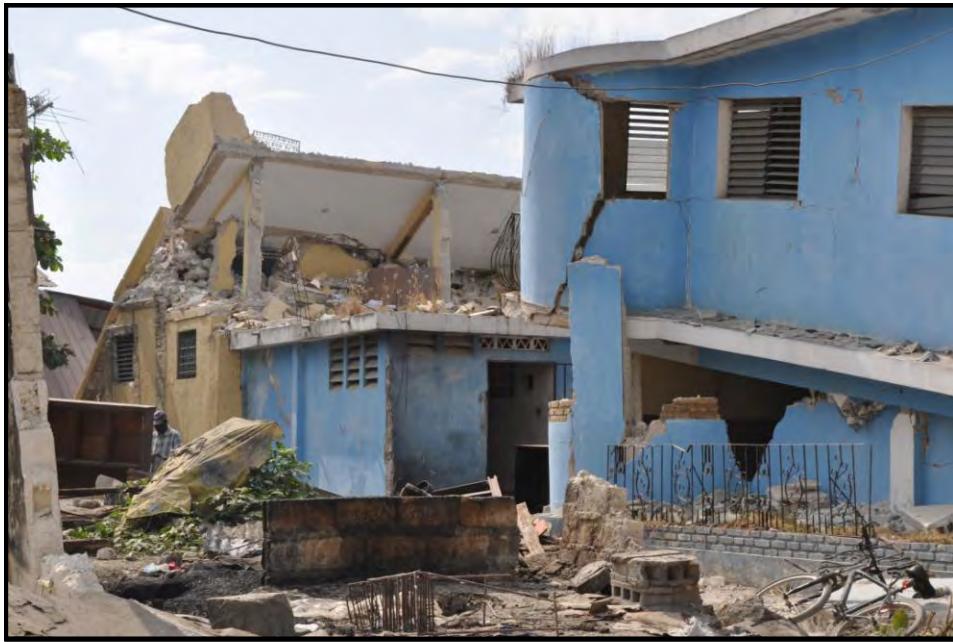
In contrast, there were numerous examples of severe damage and collapse to residences with the heavy concrete slab floors and roofs (e.g., Fig. 10).

*Figure 10. Partial collapse of residential building.*

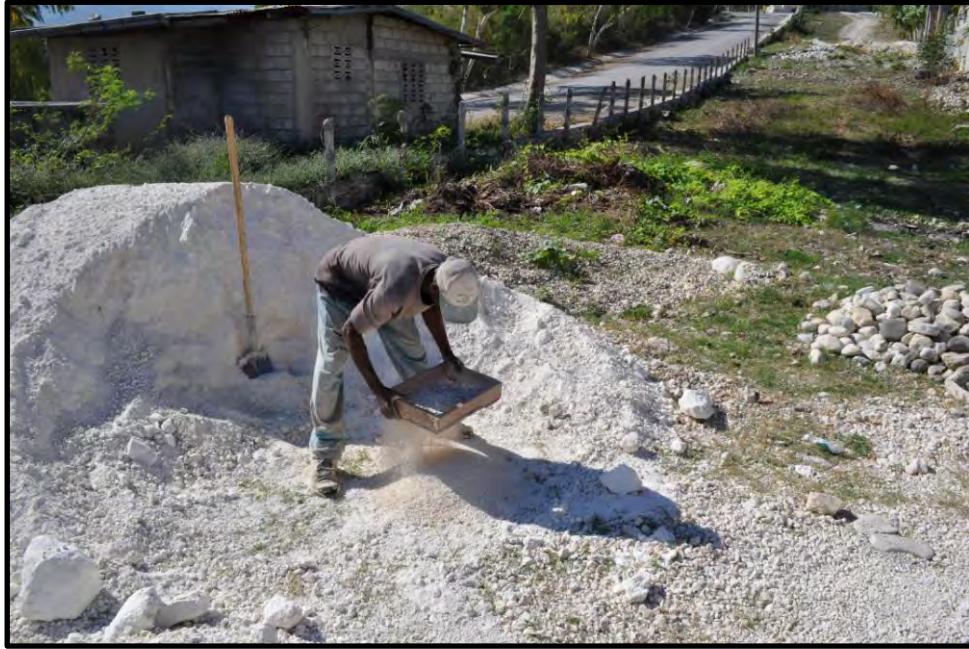
- We observed concrete and concrete block being made at several sites. The site materials appeared to be graded on site with a hand sieve to create the aggregate (Fig. 11), and mixed on the ground (or in a wheelbarrow) with cement and water to create mortar. It was not unusual to see pockets of loose aggregate in the concrete work indicating a stiff and/or poor mix. The concrete and mortar often appeared to be of poor quality.

Figure 11. Hand sieving aggregate on site for mortar.

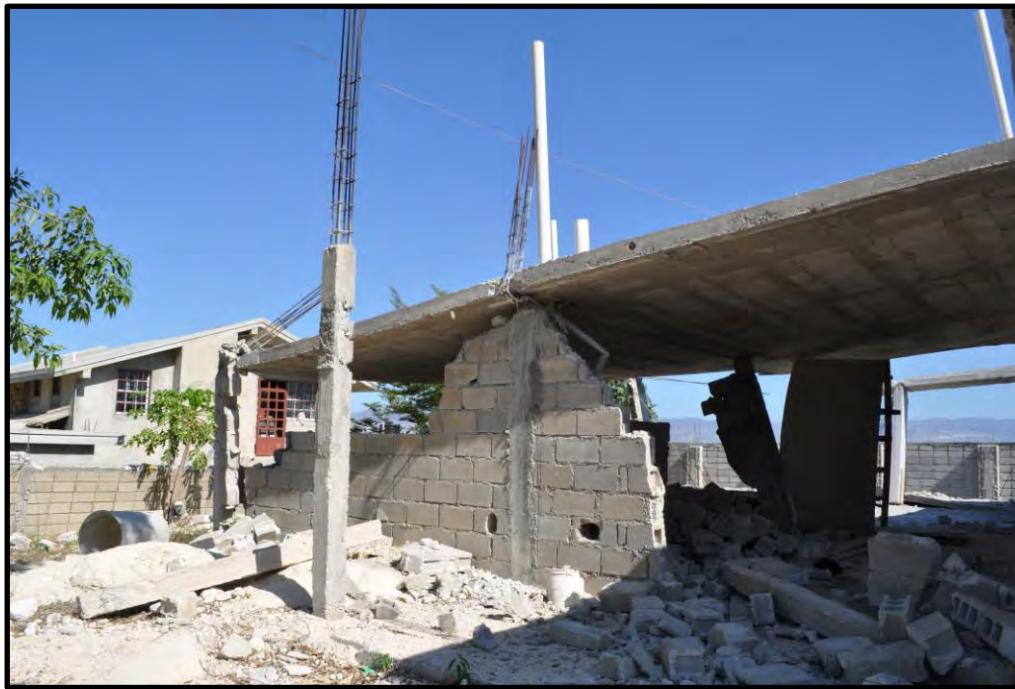
*Figure 13. Partial collapse of residential building under construction.*

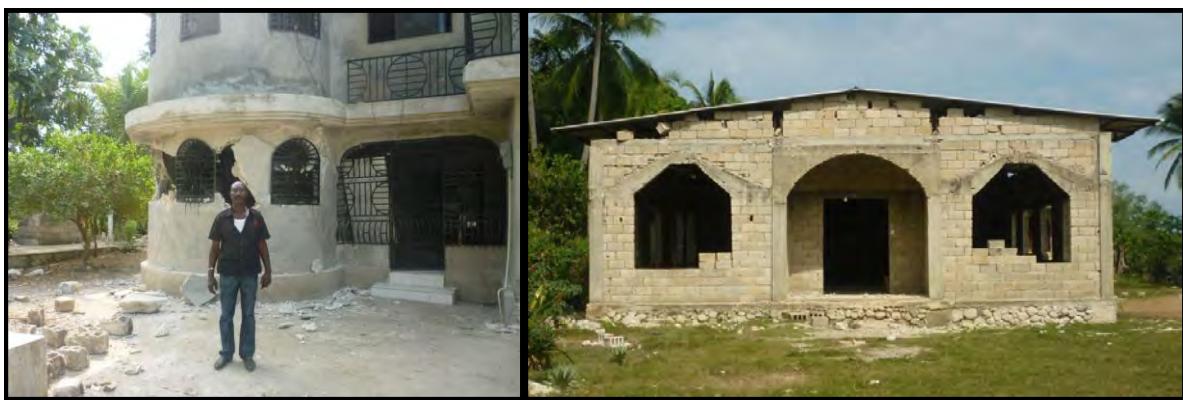
Two adjacent structures located in a hamlet near Léogâne ( $18.517586^\circ$  N,  $72.572742^\circ$  W) illustrate the important benefits of having a low seismic mass, particularly for relatively brittle structures built without consideration of earthquake performance. The first, a two-story, concrete bearing wall house (constructed by the owner), suffered severe damage to all of its first-story walls, particularly on the sides with multiple openings (Fig. 14a). The adjacent, one-story church, with a light-metal roof supported by masonry walls, appeared to be constructed with materials of poorer quality, but it fared much better during the earthquake (14b).

*Figure 14. Adjacent rural structures near Léogâne (a) concrete-bearing wall house and (b) church with masonry walls and light-metal roof.*

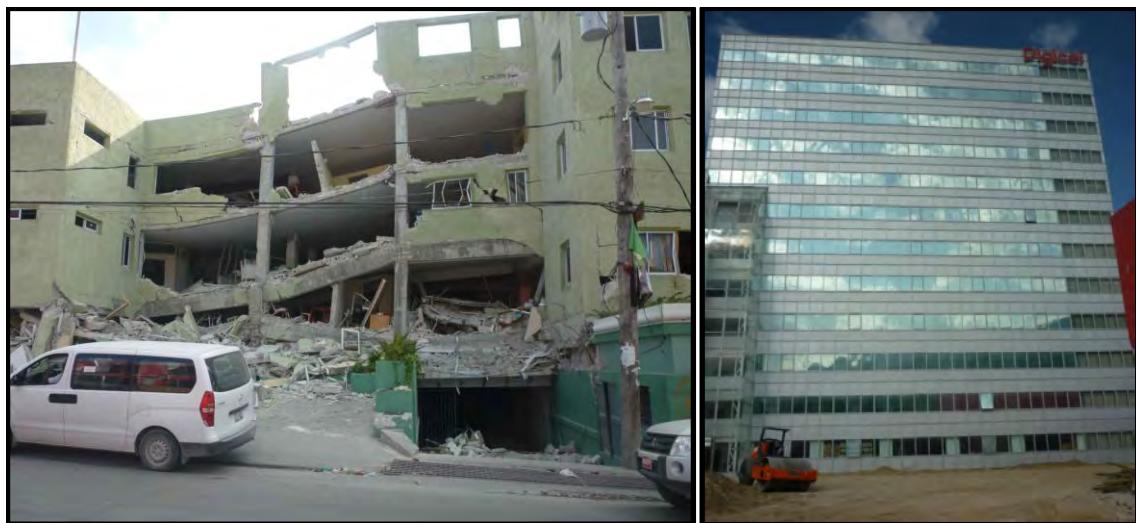
Figure 15a shows the collapse of a typical multi-story apartment building, whose lateral-force resistance was provided by a reinforced concrete frame with masonry infill. As with numerous other structures we observed, the columns and joints had little transverse reinforcement. The new Digicel building across the street appeared to be nearly undamaged ( $18.532729^\circ$  N,  $72.323235^\circ$  W), with slight damage to a few windows (Fig 15b). The fundamental period of the Digicel building was likely much larger than that of the apartment building, so the seismic demands would have differed also. Nonetheless, the stark difference in performance suggests that the severe damage to numerous buildings could have been avoided with greater attention to seismic performance.

*Figure 15. Damage to two structures across the street from one another in Port au Prince. (a) reinforced concrete frame with masonry infill, (b) new Digicel building under construction appears to be nearly undamaged.*

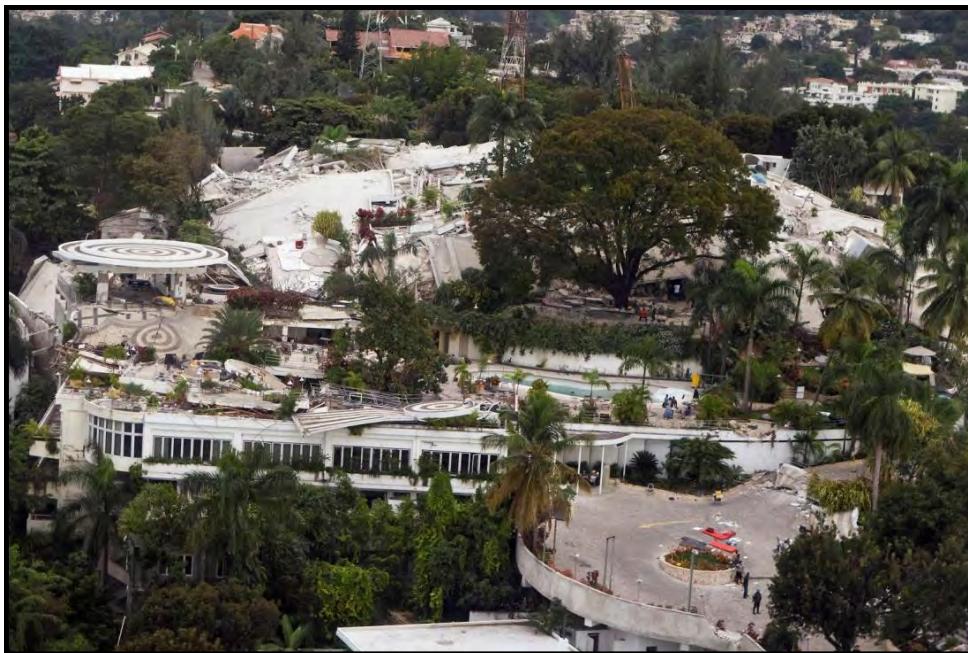
Pétion-Ville and provided beautiful views. The hotel collapsed catastrophically during the earthquake (Fig. 16).

*Figure 16. The Montana Hotel in Port-au-Prince on January 13, 2010. (AP Photo/The United Nations, Logan Abassi)*

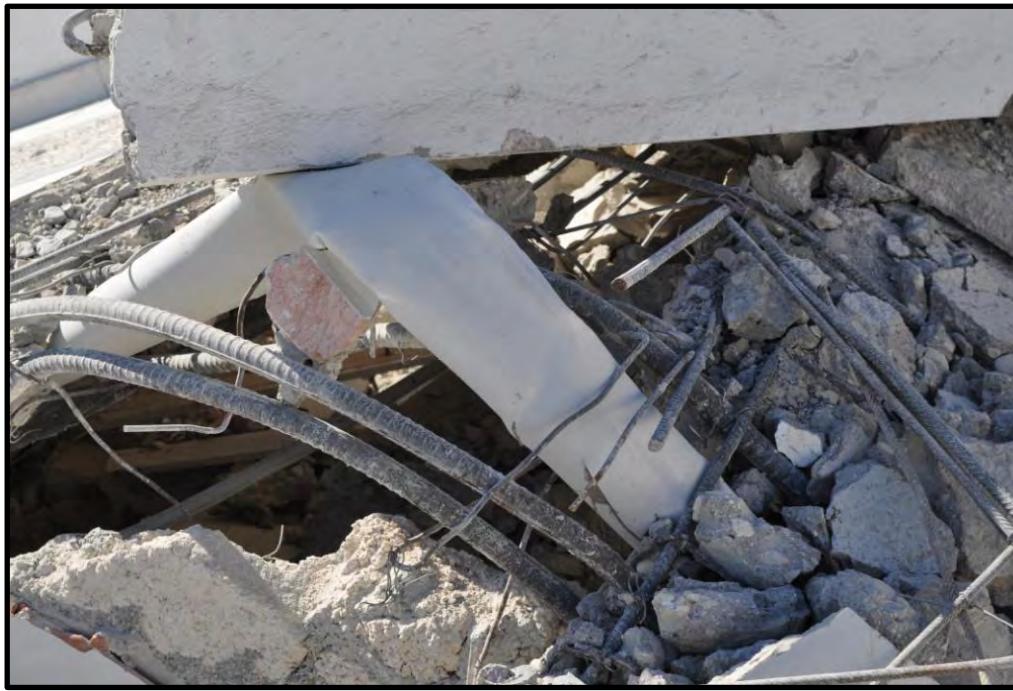
*Fig 17. Remains of the top of a column at the Hotel Montana – note the large embedded PVC pipe and the small #2 smooth column ties.*

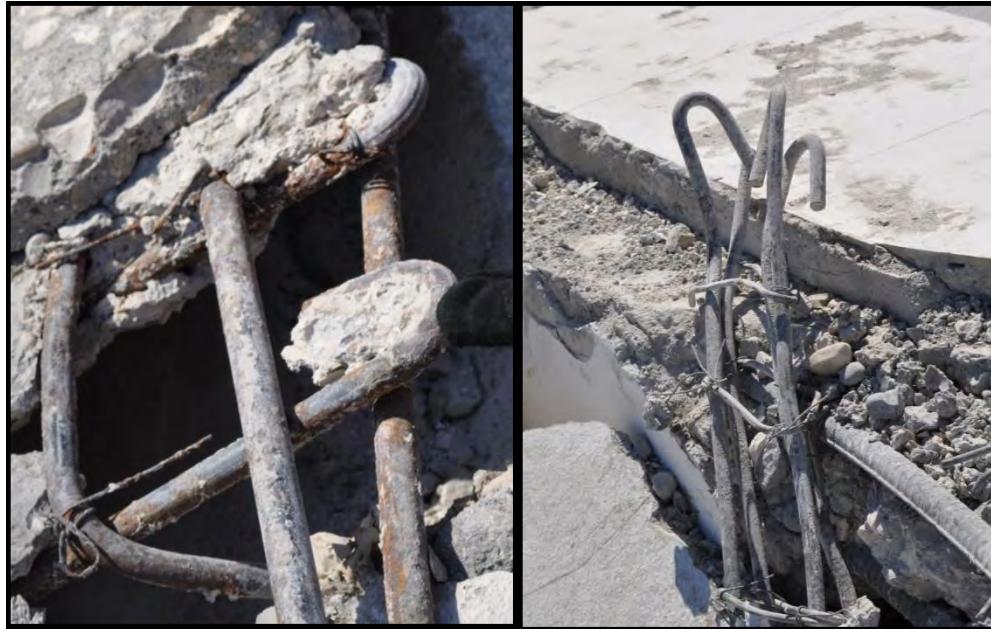
*Figure 18. Smooth reinforcing steel was used in both slabs (left) and columns (right). The hook lengths on reinforcing steel were only 50 to 60% of ACI required lengths.*

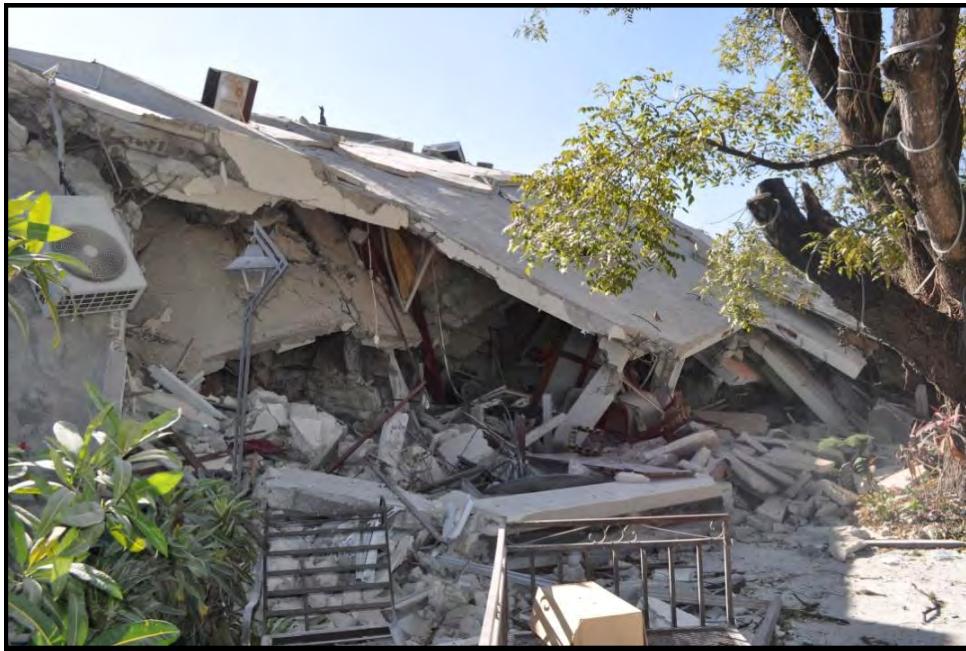
*Figure 19. Collapse was extensive throughout the guest wings of the hotel. It appeared that these wings were reinforced concrete with unreinforced infill concrete masonry walls.*

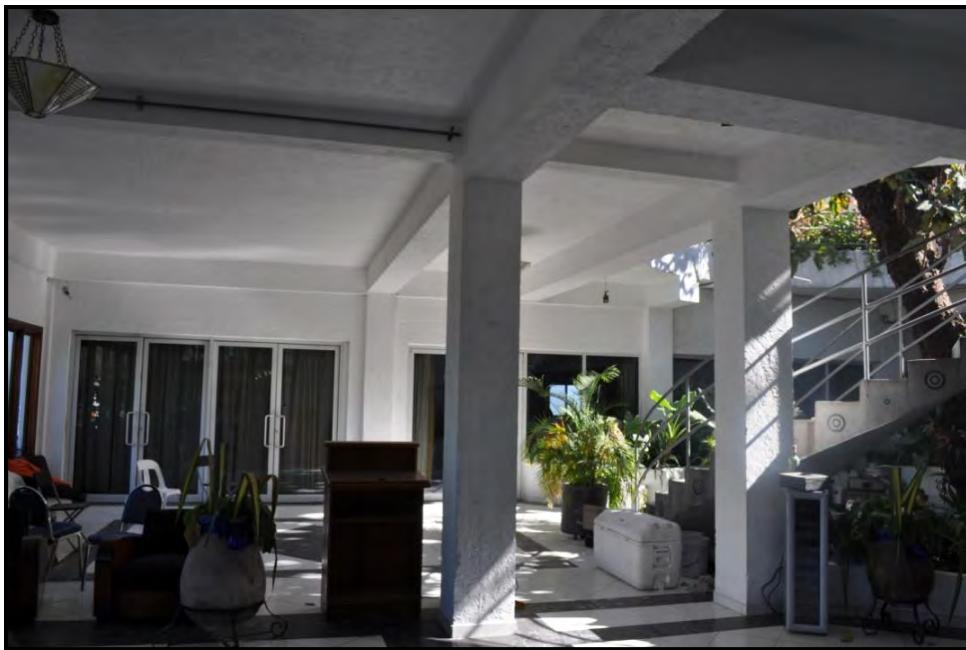
Although the Hotel Montana was a high-end property, it appeared to have many of the same vulnerabilities of other concrete construction in Haiti. Heavy, unreinforced concrete masonry walls added seismic weight to the structure but only minimal seismic resistance. Other shortcomings included a lack of ductile seismic detailing, smooth reinforcing bars with insufficient hook lengths, and questionable concrete quality (Figs. 17, 18, and 19). Samples of concrete and reinforcing steel from the Hotel Montana have been obtained for strength testing. Only small portions of the hotel remained intact (Fig. 20).

*Figure 20. Areas of the Hotel Montana lobby remained intact. It appeared that this region had reinforced concrete beams and slabs without extensive infill walls.*

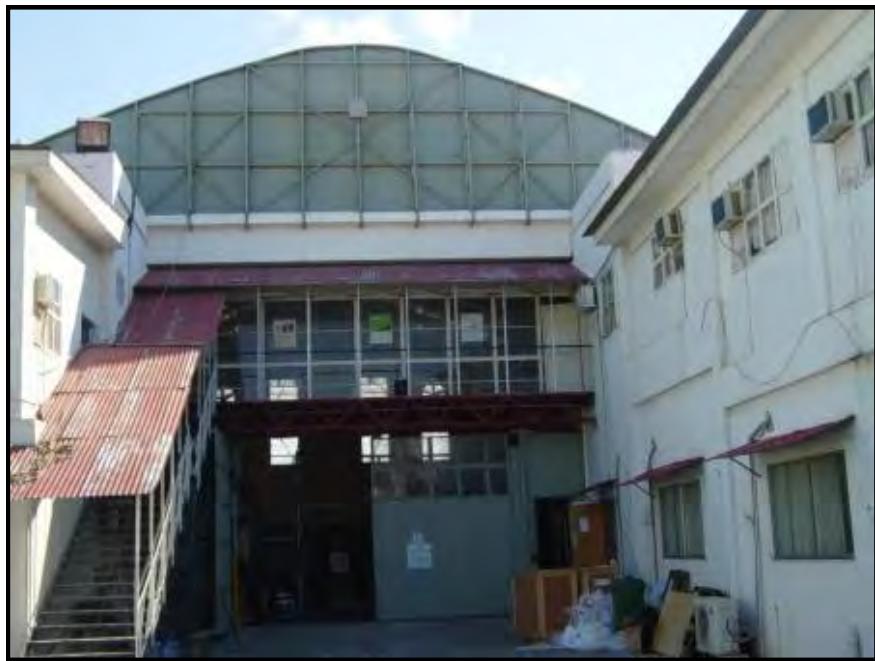
The attached steel-arch warehouse structure performed well. The only damage was non-structural; portions of 1.5-m (5-ft) tall concrete protective wall sections around the interior perimeter tipped over. The other building attached to the steel-arch warehouse (on the left side in Fig. 21), which appears to be of the same construction as the CITS building, experienced similar damage to the exterior wall.

Figure 21. Two-story CITS building (on right) attached to steel arch structure (in background).

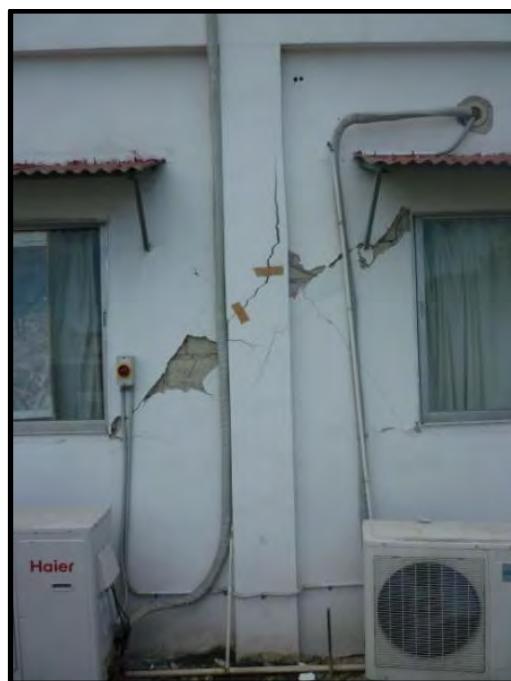
On the north side, the structure had diagonal cracks up to 6-mm ( $\frac{1}{4}$ -in.) wide across the walls and columns at the first floor between window penetrations on the north wall (Fig. 22). The north face appeared to have a residual displacement of about 3 mm (1/8 in.) to the east. On the northwest side of the structure, one of the columns had a residual flexural crack (3 mm, 1/8 in.) at its base. Only minor cracking was observed on the east and west walls. The south wall, which was solid, showed minimal signs of damage. Similarly, the interior columns and walls showed little distress.

This damage pattern and building geometry are consistent with a building responding torsionally during the earthquake. The north end (with its multiple penetrations) deformed much more (and had more damage) than the south end with its solid wall. Figure 23 is an interior close-up of the center column crack showing that the material in the column feature is the same as the masonry cover coat, indicating continuity of the wall. Based on this evidence, it is possible that the structure consists of interior concrete columns, possibly reinforced, and exterior unreinforced load-bearing masonry walls. Based on the shear cracking on the north side of the building, the building was evacuated.

Figure 22. Exterior wall cracking of first floor CITS building.

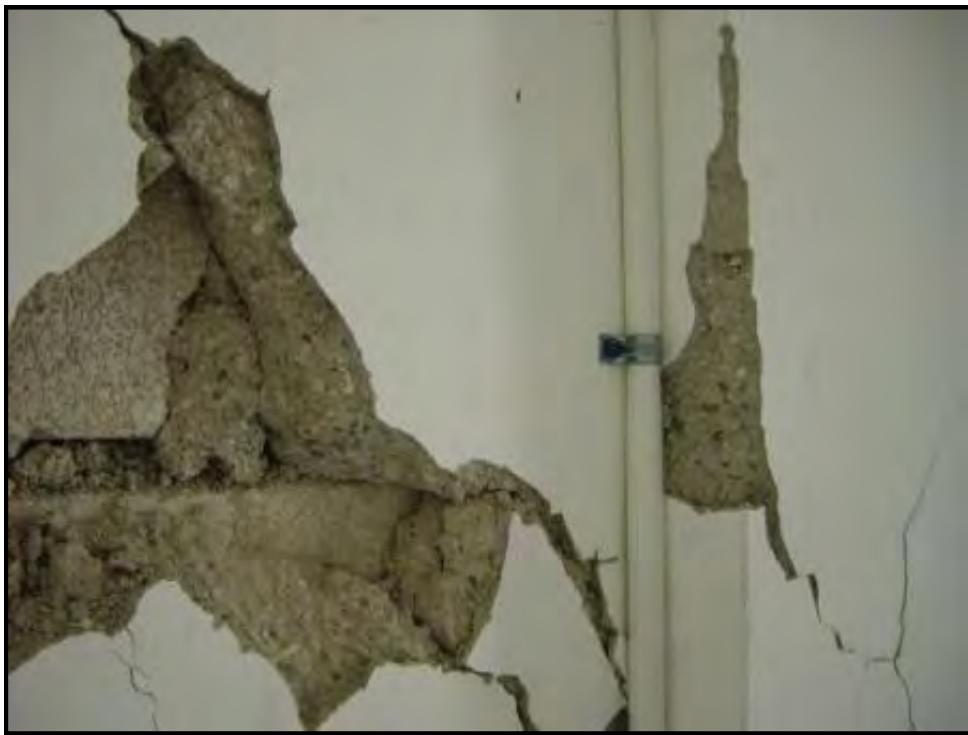
Figure 23. Interior close-up view of wall crack.

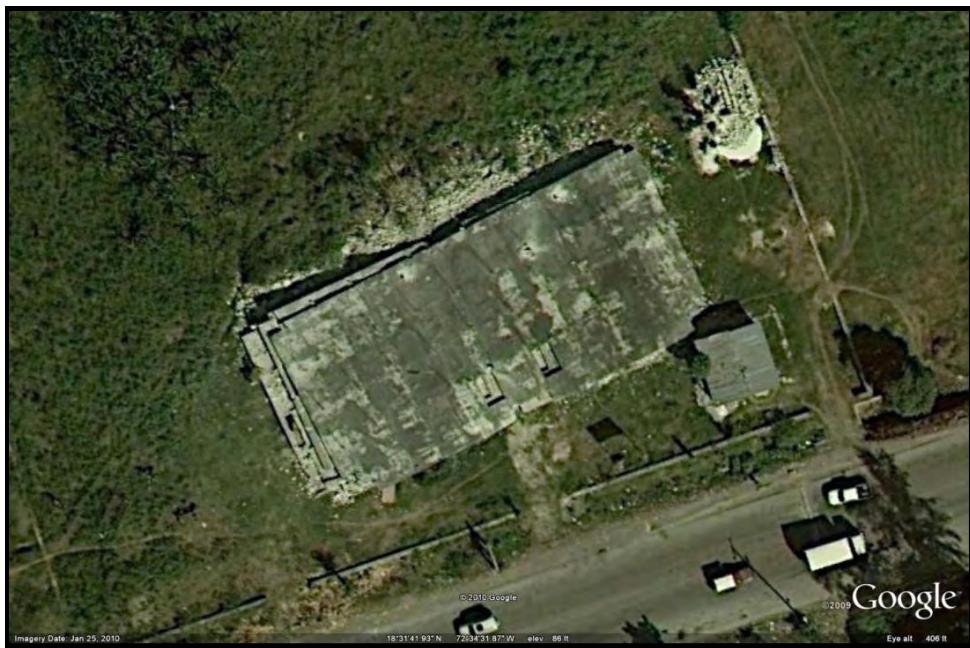
*Figure 24. Aerial view indicating that the building rotated slightly and moved to the east as it collapsed. (Google Earth)*

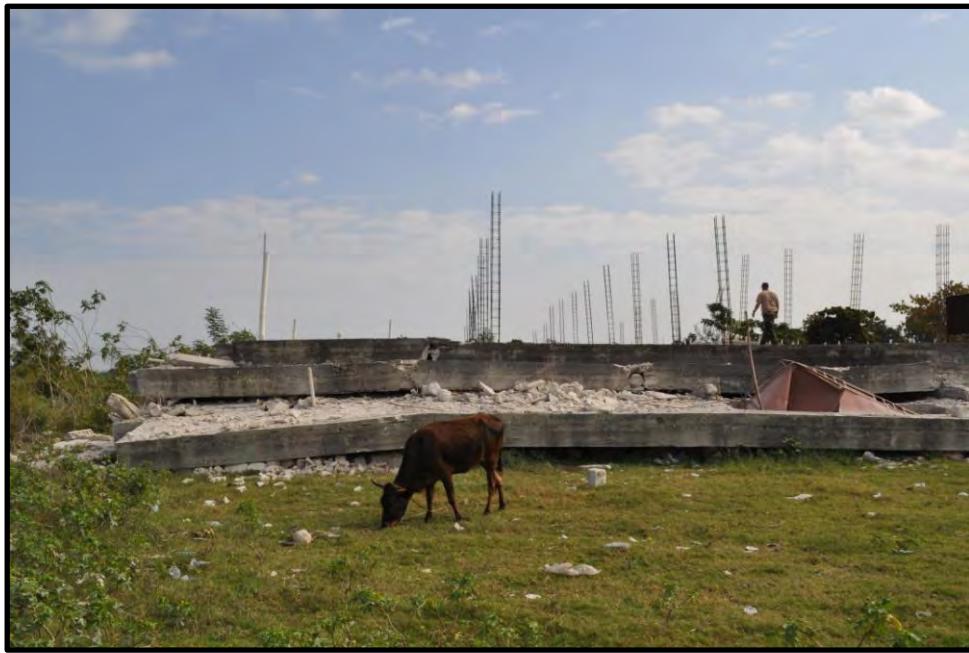
*Figure 25. A view from the west side of the building indicates that there was movement to the east (approximately half the height of the columns) during the collapse.*

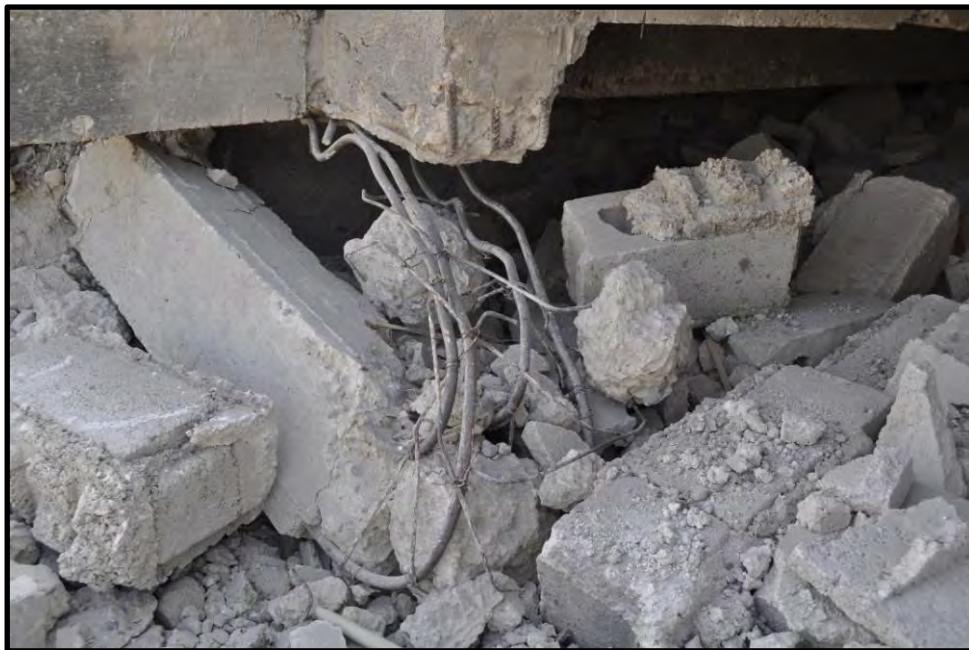
*Fig 26. Smooth reinforcing steel and minimal column ties were evident in some of the collapsed columns.*

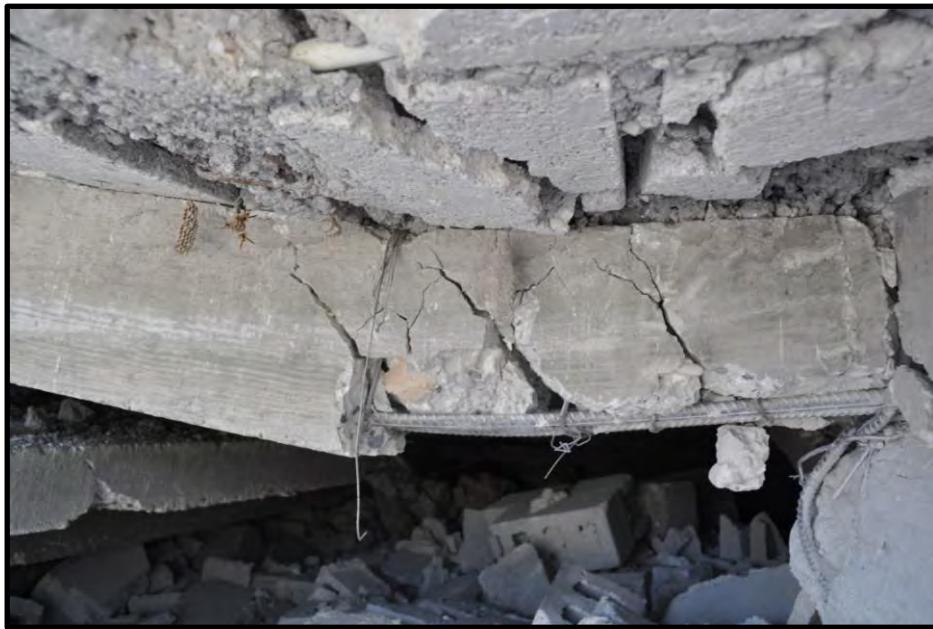
Figure 27. Failure in one of the structure's beams.

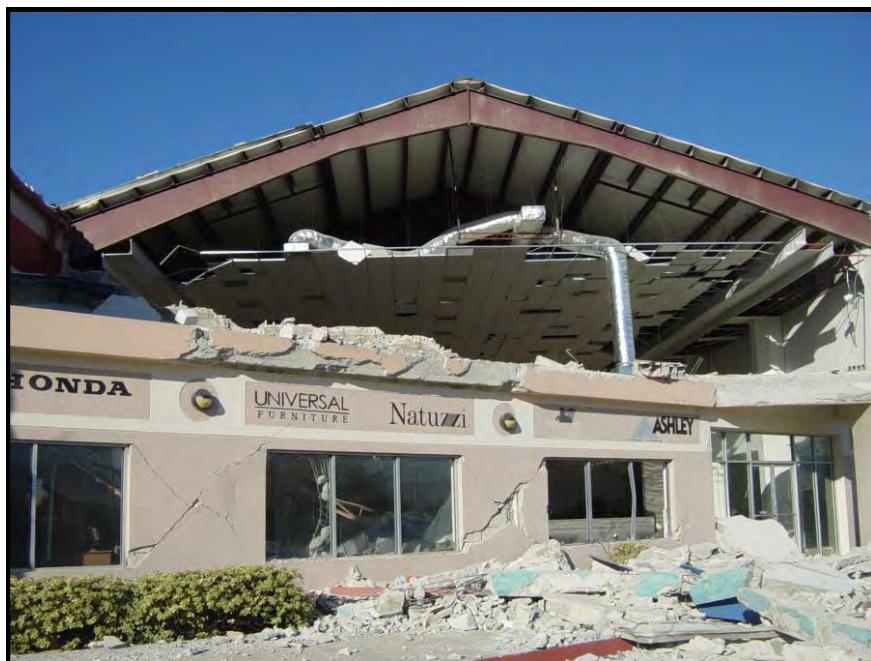
A negative aspect of the performance of the steel framed structures was the detachment of the non-structural masonry. The extent of the resulting damage varied. In one case, the failure of the masonry caused the roof below to collapse. Figures 30 and 31 show two typical examples of PEMB structures from Port-au-Prince, in which the masonry failed out of plane. We saw no evidence of ties between the structural steel and the masonry walls.

Figure 30. Infill masonry wall collapse of PEMB, Port au Prince.

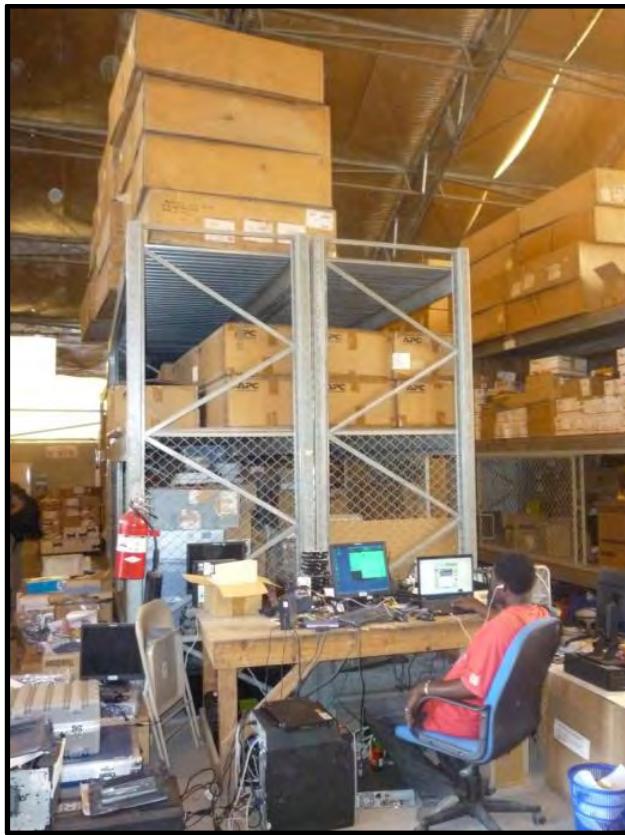
*Figure 32. Heavy boxes are perched precariously above a worker who had been displaced by damage to the CITS building.*

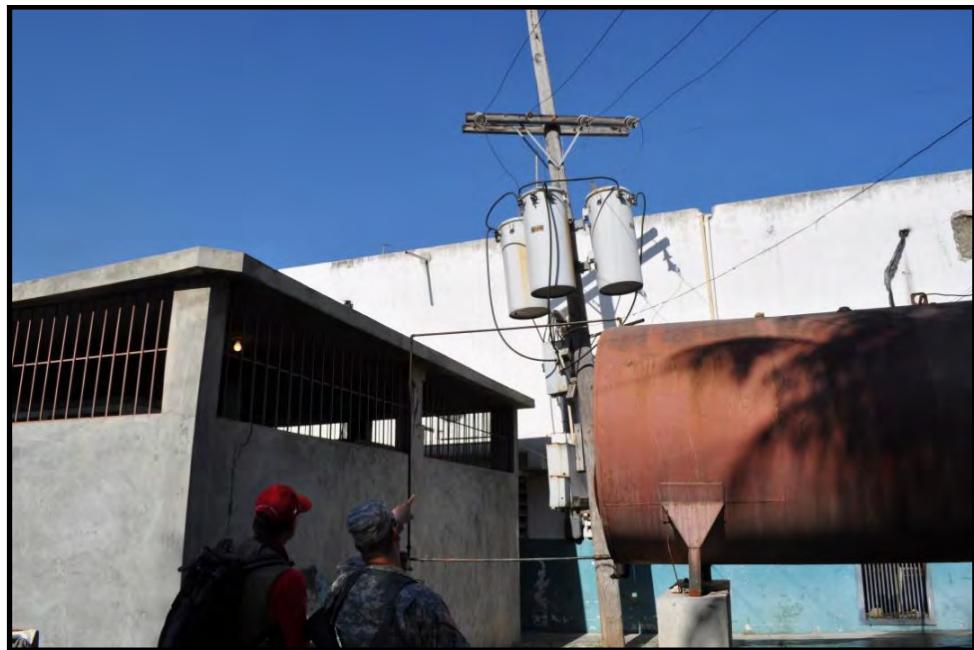
- As shown in Fig. 33, the power lines and transformers were located over and directly adjacent to the diesel fuel tank.
- the diesel fuel tank for the generators was not tied down to its supporting concrete foundation pedestals (Fig. 34).
- the power pole with its heavy transformers moved during the earthquake and is now leaning. The extent of the residual movement is shown in Fig. 35.
- A nearby non-structural wall is leaning towards occupied office space (Fig. 36).

*Figure 33. Hospital emergency power system, generator room and fuel tank.*

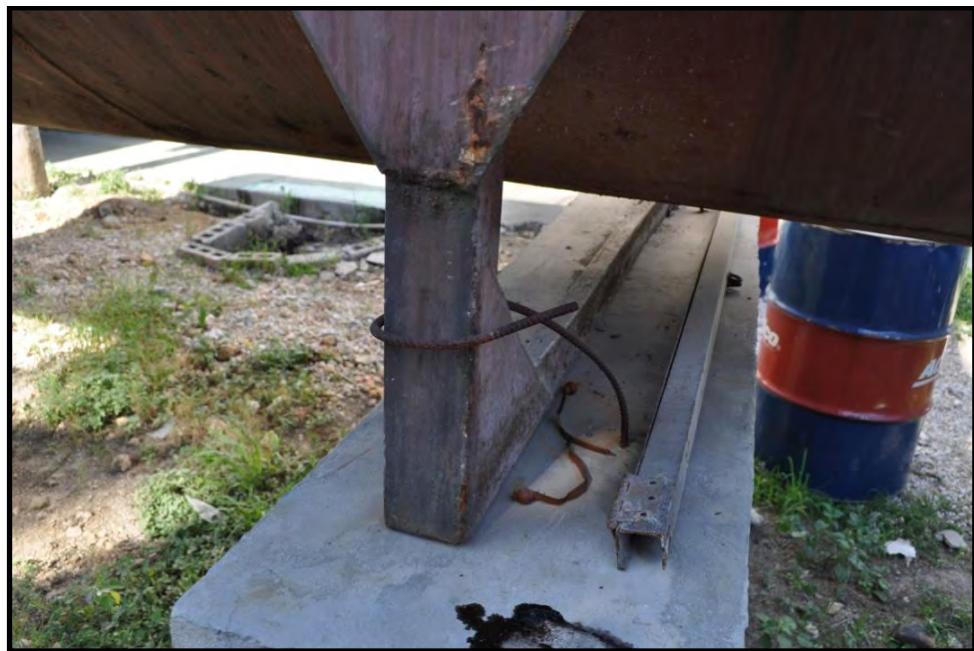
*Figure 34. Fuel tank is not tied to its pedestal foundation.*

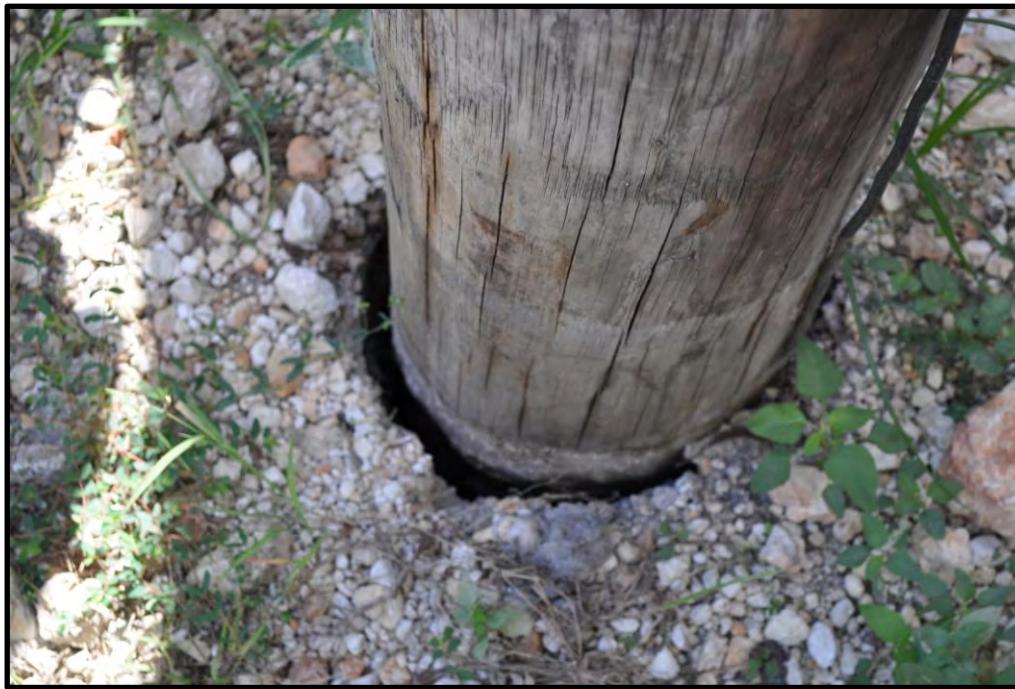
*Figure 35. Base of power pole indicates some of the movement that occurred during*

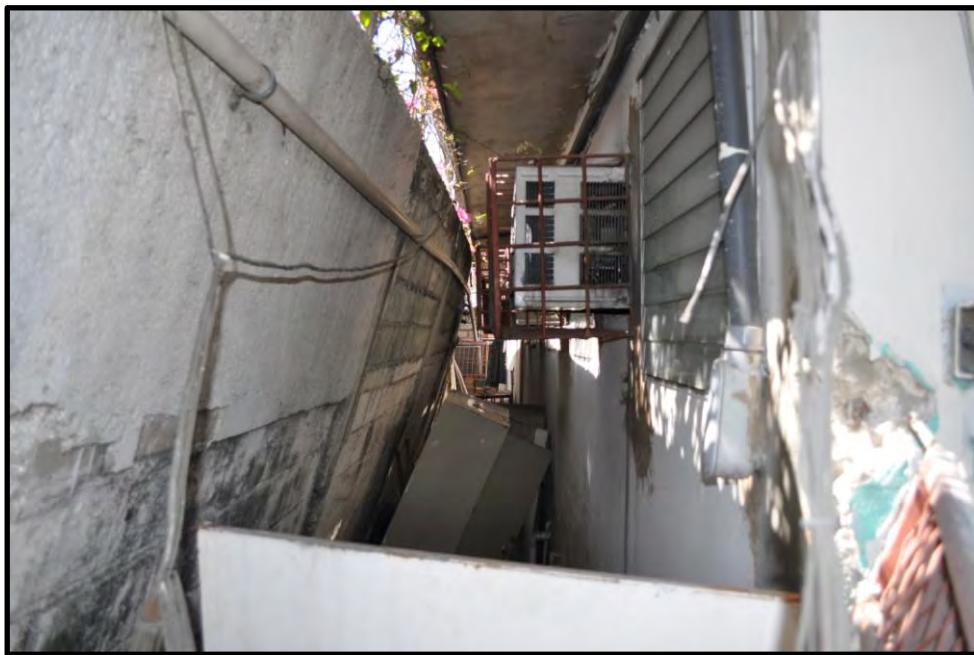
*Figure 36. As with many of the masonry walls, the earthquake caused it to lean. In this case the wall is leaning towards occupied office space.*

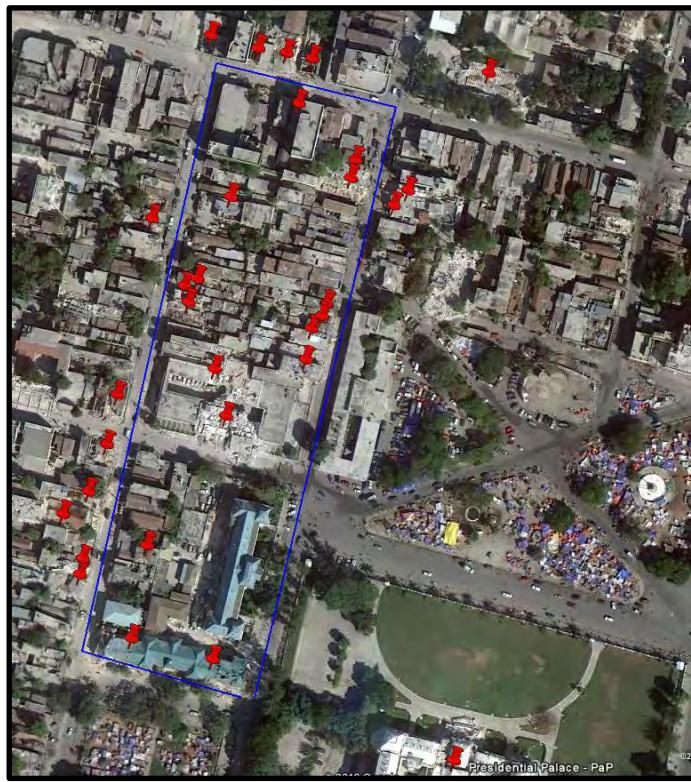
The Port-au-Prince downtown area was significantly damaged and many structures collapsed. Many of the streets were blocked by the rubble of collapsed buildings. In Port-au-Prince we surveyed 107 structures along a rectangular path with a long side of 350 m (1150 ft) and a short side of 110 m (360 ft). A total of 42 buildings were assigned damage level 1, 35 were assigned damage level 2, and the remaining 30 represent the number of collapsed structures (Level 3). In this section of Port-au-Prince, 28% of the structures collapsed, and 61% either collapsed or were damaged enough to require repairs. Figure 37 shows the damage map of the Port-au-Prince survey. The blue line shows the route. The southeast corner, adjacent to the National Palace, was where the survey commenced ( $18.543576^\circ$  N,  $72.339897^\circ$  W). The red pushpins represent damage level 3 structures. The National Palace was not included in our survey; it is just shown for reference.

*Figure 37. Damage map indicating collapsed structures along the surveyed route in Port-au-Prince (Source of base photo: Google Earth).*

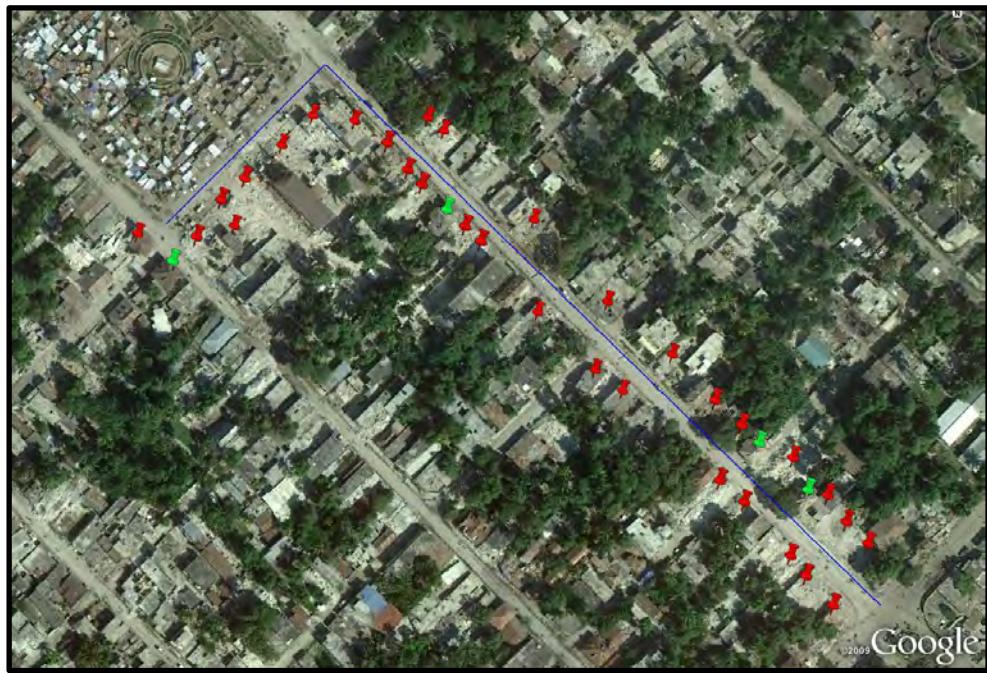
Léogâne is the closest significant population center to the epicenter of the earthquake (approximately 11 km or 7 mi.). In Léogâne we surveyed 52 structures along an L-shaped route with a long side of 380 m (1250 ft) and a short leg of 110 m (360 ft). In this area, only four structures met the criteria for damage level 1. Sixteen structures were classified as damage level 2, and the remaining 32 structures (62%) were collapsed to some degree. A damage map of the Léogâne route is shown in Figure 38. The green pushpin markers represent the level 1 structures. The red pins represent the partially or totally collapsed structures (damage level 3). The walking route, shown with the blue line, began at the southeast road intersection ( $18.508687^\circ$  N,  $72.629998^\circ$  W).

*Figure 38. Damage map indicating collapsed (red) and undamaged (green) structures along the surveyed route in Léogâne (Source of base photo: Google Earth).*

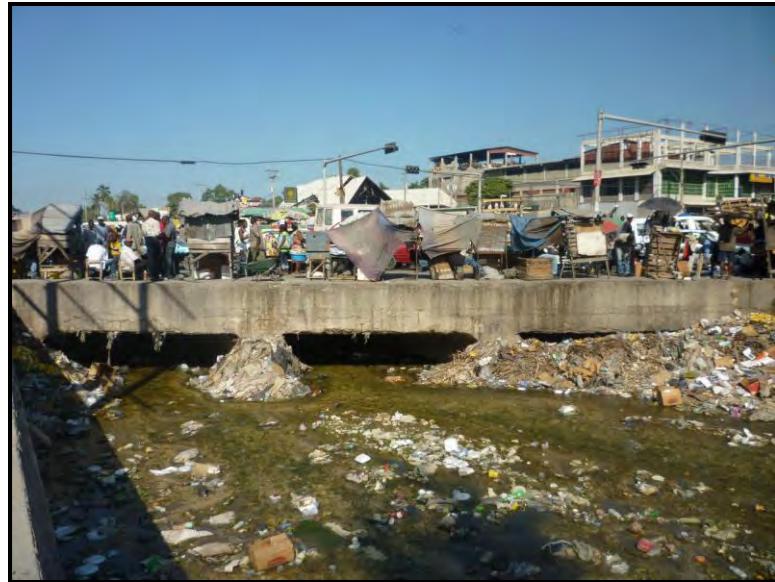
Within Port-au Prince, most of the crossings over streams were accommodated by 2-2.5m (6-8 ft) deep box culverts, which did not appear to be damaged. These crossings may nonetheless be hazardous in the future, because the large amount of garbage that has accumulated upstream of these culverts may combine with silt and debris to prevent water from passing through the culverts. Once rains return to Port-au-Prince, the overflow of these culverts may pose a health hazard to displaced residents, some of whom are living on or near these culverts (Fig. 39).

*Figure 39. View of box culvert in Port-au-Prince, looking downstream.*
