## THE $M_w$ 7.0 HAITI EARTHQUAKE of JANUARY 12, 2010:

**USGS/EERI Advance Reconnaissance Team  
TEAM REPORT  
V. 1.0**

**February 18, 2010**

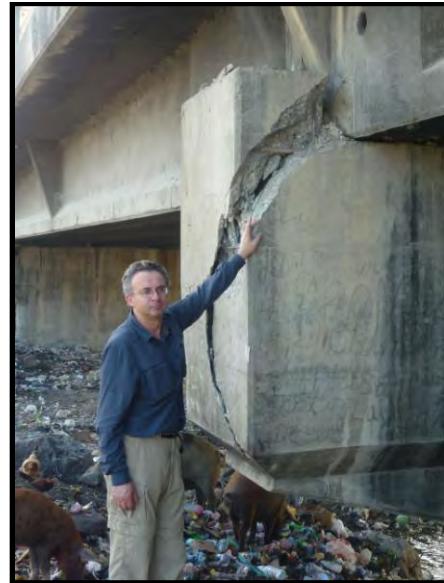
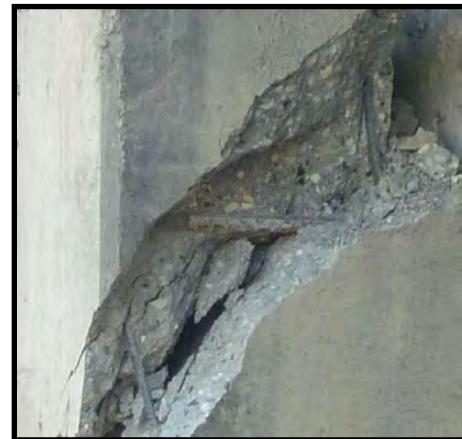
*Figure 41. Damage to shear key at intermediate support: (a) overview, and (b) pull-out of beam reinforcement.*

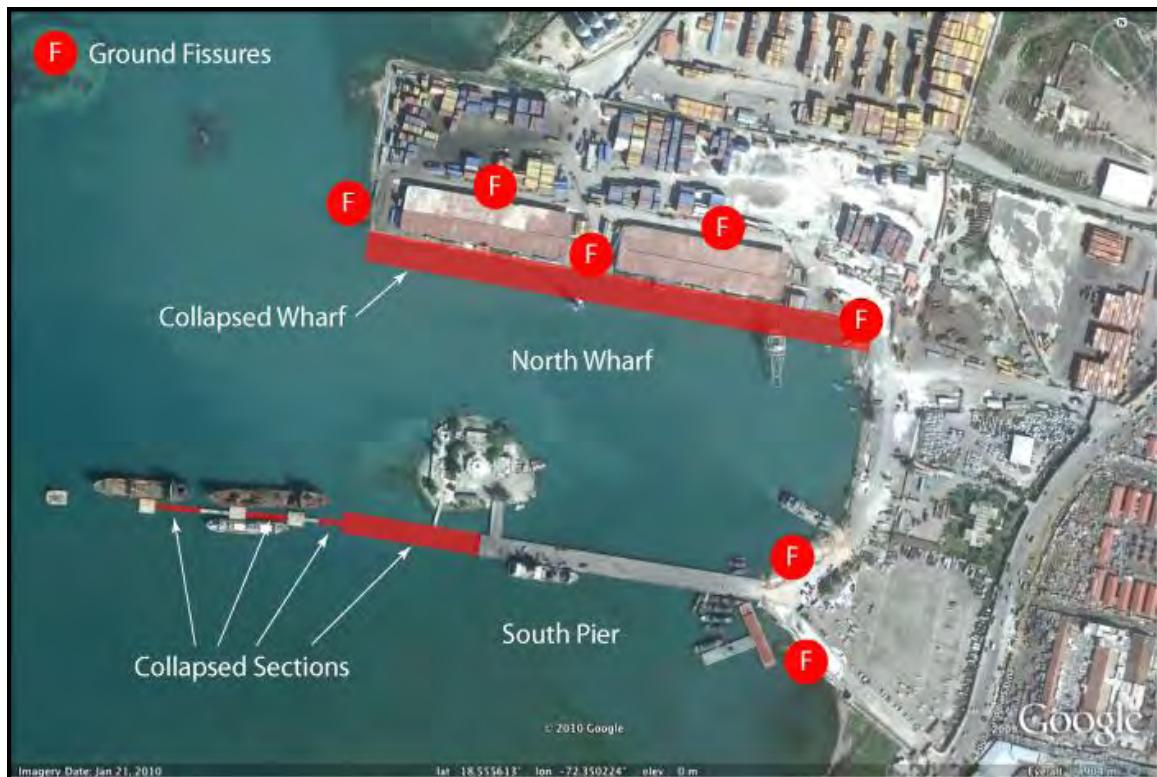
Figure 42. Annotated aerial image of Port de Port-au-Prince (Google Earth).

The North Wharf collapsed, most likely due to liquefaction-induced lateral spreading. Numerous surface manifestations of the liquefaction are present in the vicinity of the North Wharf. Light-colored areas in Fig. 42 are sand boils and can be seen in the eastern half of the container storage yard and behind and between the two warehouses. The locations where large lateral spreading fissures were observed are shown in Fig. 42 with symbols. Figure 43 shows two examples of these fissures at the eastern and western ends of the wharf area, respectively.

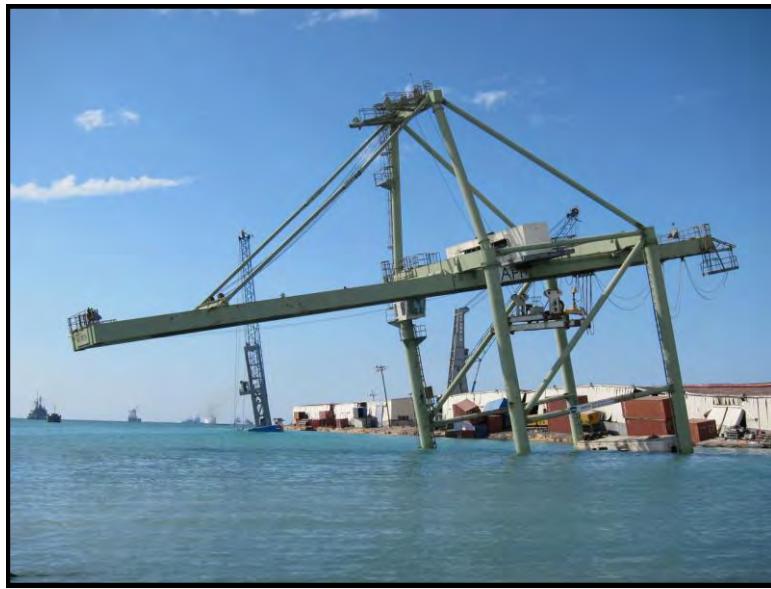
*Figure 44. Submerged 15-m gauge container crane (foreground) and mobile crane (background).*

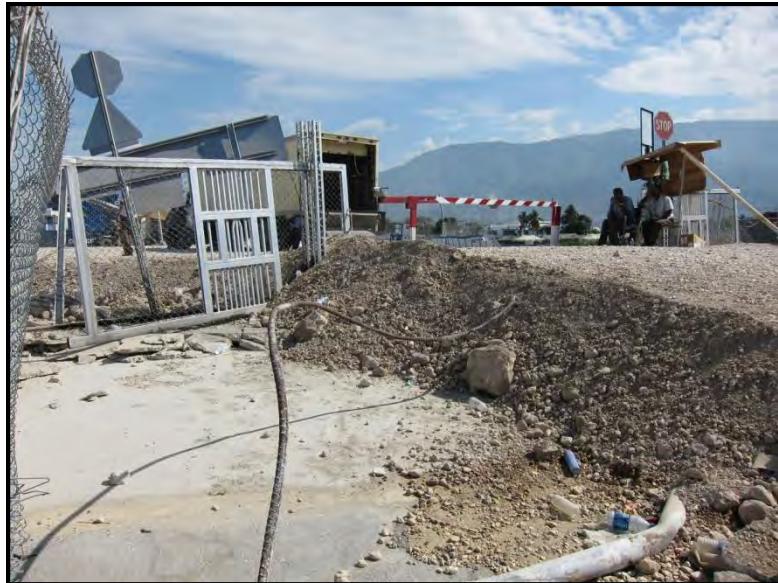
In addition to the damage to the piles supporting the South Pier, the abutment also experienced liquefaction-induced lateral and vertical displacements. Approximately 1 m (3.3 ft) of fill was required to re-level the approach to the pier, as shown in Fig. 46.

*Figure 46. Approximately 1 m (3.3 ft) of fill was required to level the approach to the South Pier.*

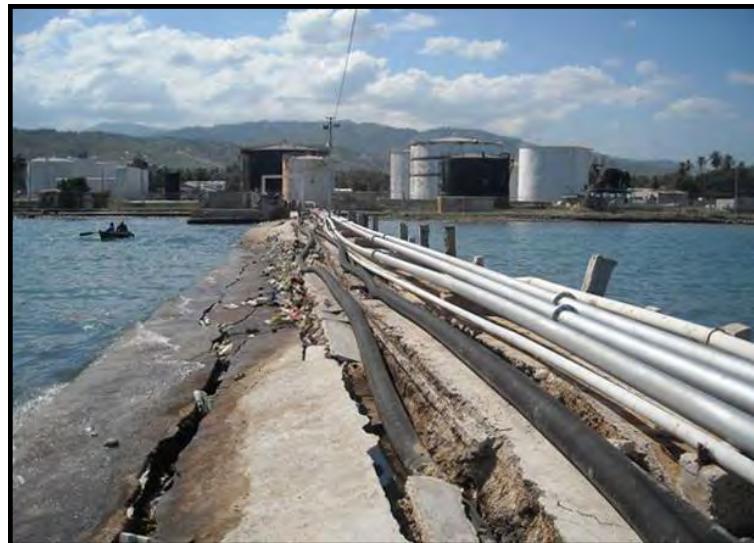
At the Thor marine oil terminal ( $18.540528^\circ \text{ N}$ ,  $72.385710^\circ \text{ W}$ ) one portion (approximately 230 m or 1500 ft long) of the pipelines used to offload petroleum products is supported on an embankment constructed out into the water, and a second portion (approximately 120 m or 400 ft long) is supported on piles. The pile-supported portion was undamaged, but the embankment-supported portion experienced some damage due to vertical displacement of the embankment, as shown in Fig. 49 (Scott Chodkiewicz, personal communication). The damage was not serious enough to prevent

*Figure 49. Embankment-supported petroleum pipelines at the Thor marine oil terminal (Source: Scott Chodkiewicz, USACE)*

usage of the pipelines following the earthquake.

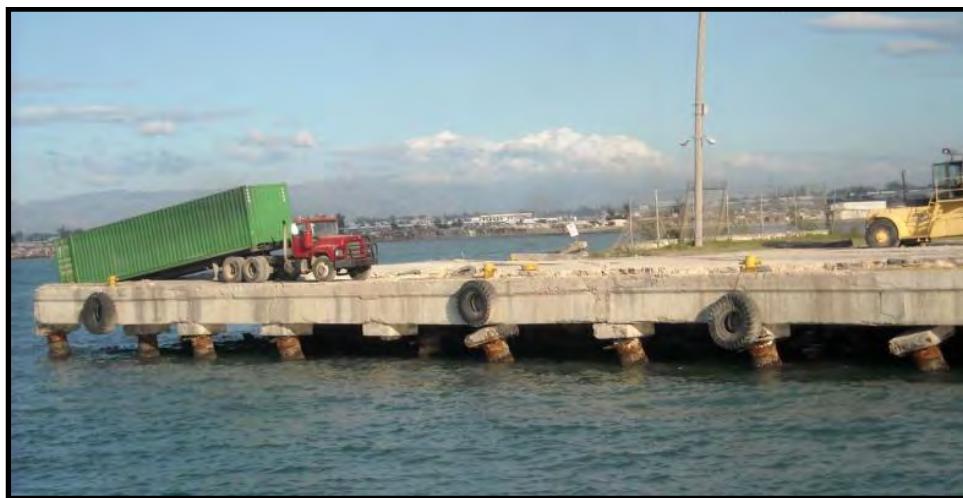
At the Varreux terminal ( $18.573944^{\circ}$  N,  $72.346119^{\circ}$  W) a pile-supported pier collapsed during the earthquake, killing approximately 30 employees who were working on the pier (Scott Chodkiewicz, personal communication). A photo of the remaining portion of the pier is shown in Fig. 51.

Figure 51. Remaining portion of pile-supported pier at the Varreux terminal (Source: Scott Chodkiewicz, USACE).

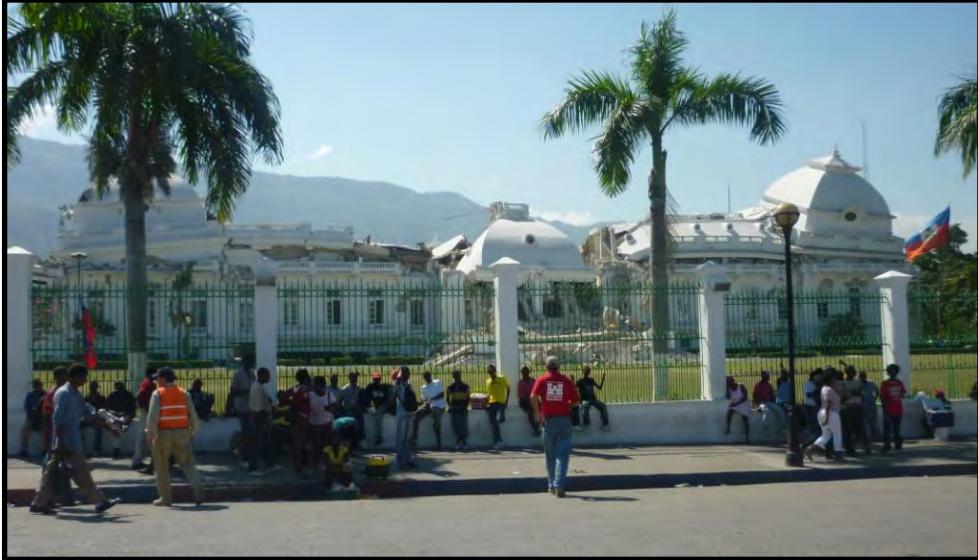
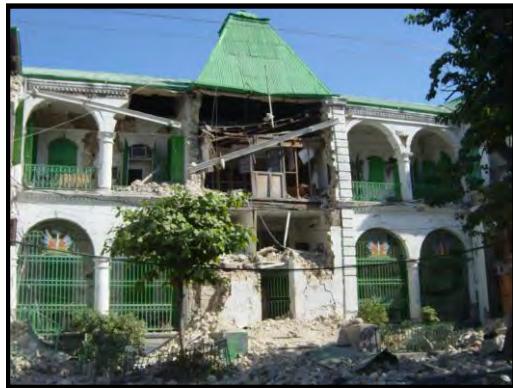
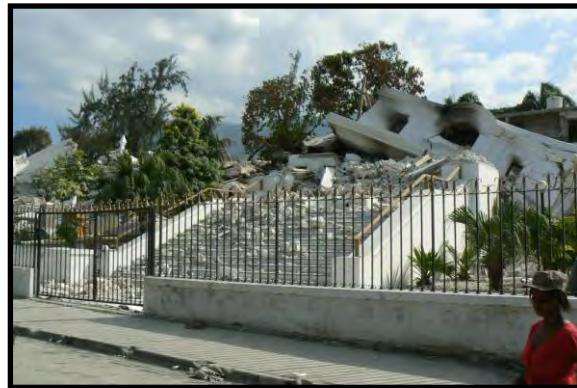
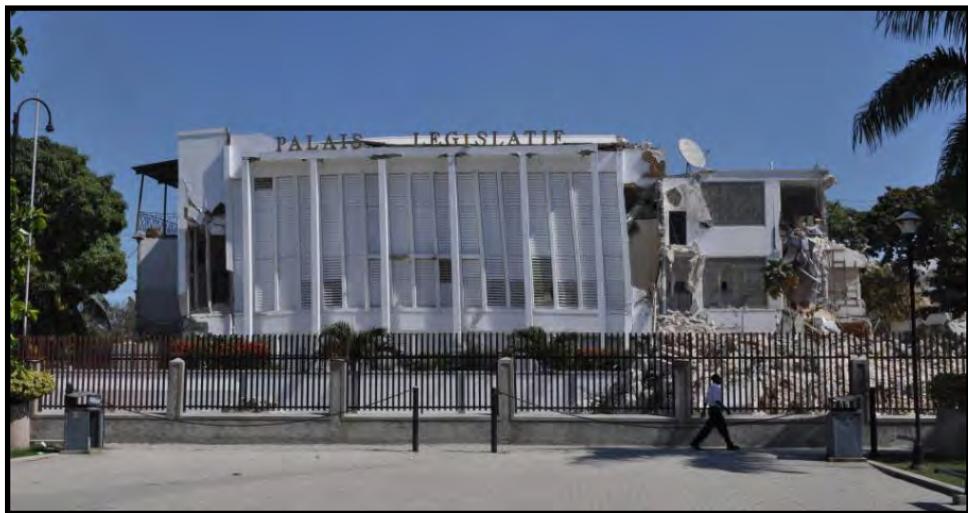
In addition to disrupting the operations of numerous clinics, hospitals, police stations, schools, and universities, the earthquake caused serious damage or the collapse of:

Figure 52. National Palace, Ministry of the Interior, and the Judicial and Legislative Palaces.

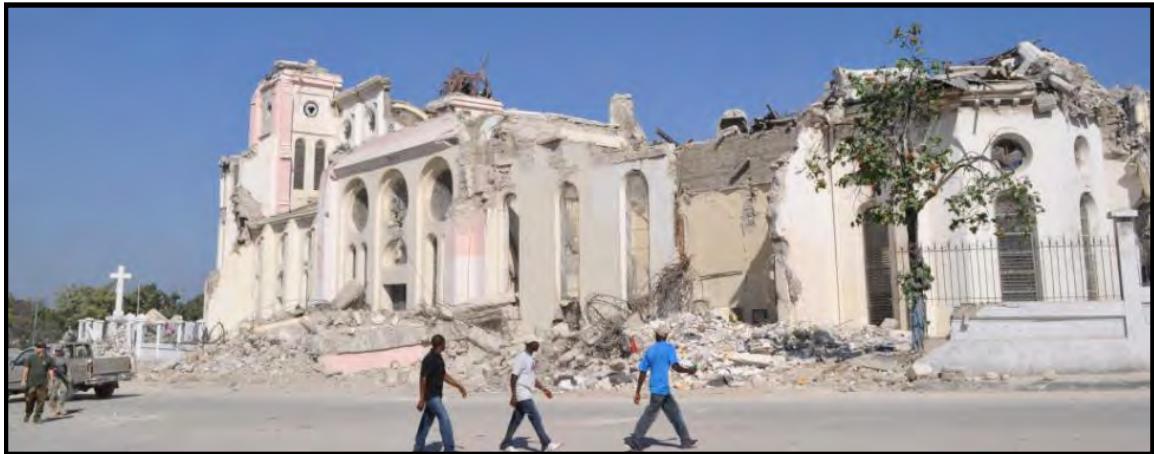
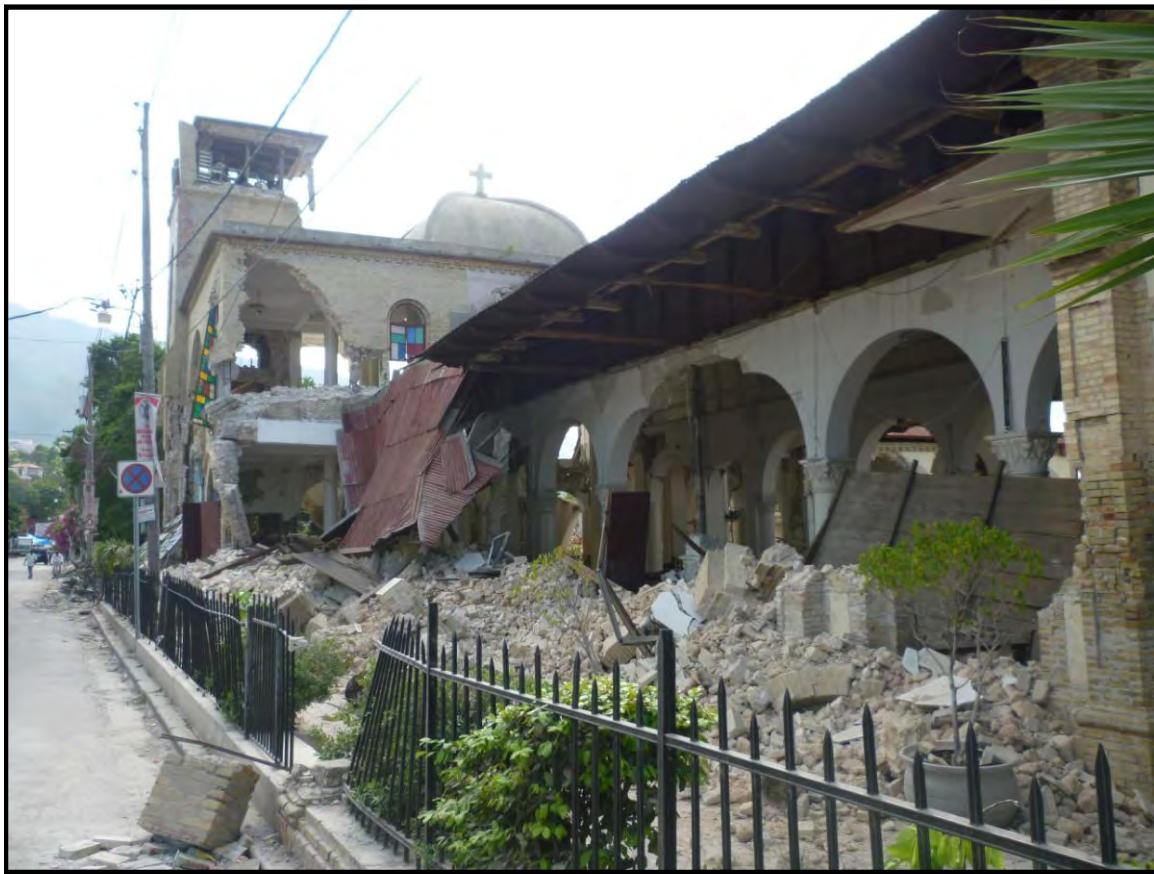
Figure 53. Damage to religious structures in Port-au-Prince: (a) Grand Cathedral and (b) Church of the Sacred Heart.

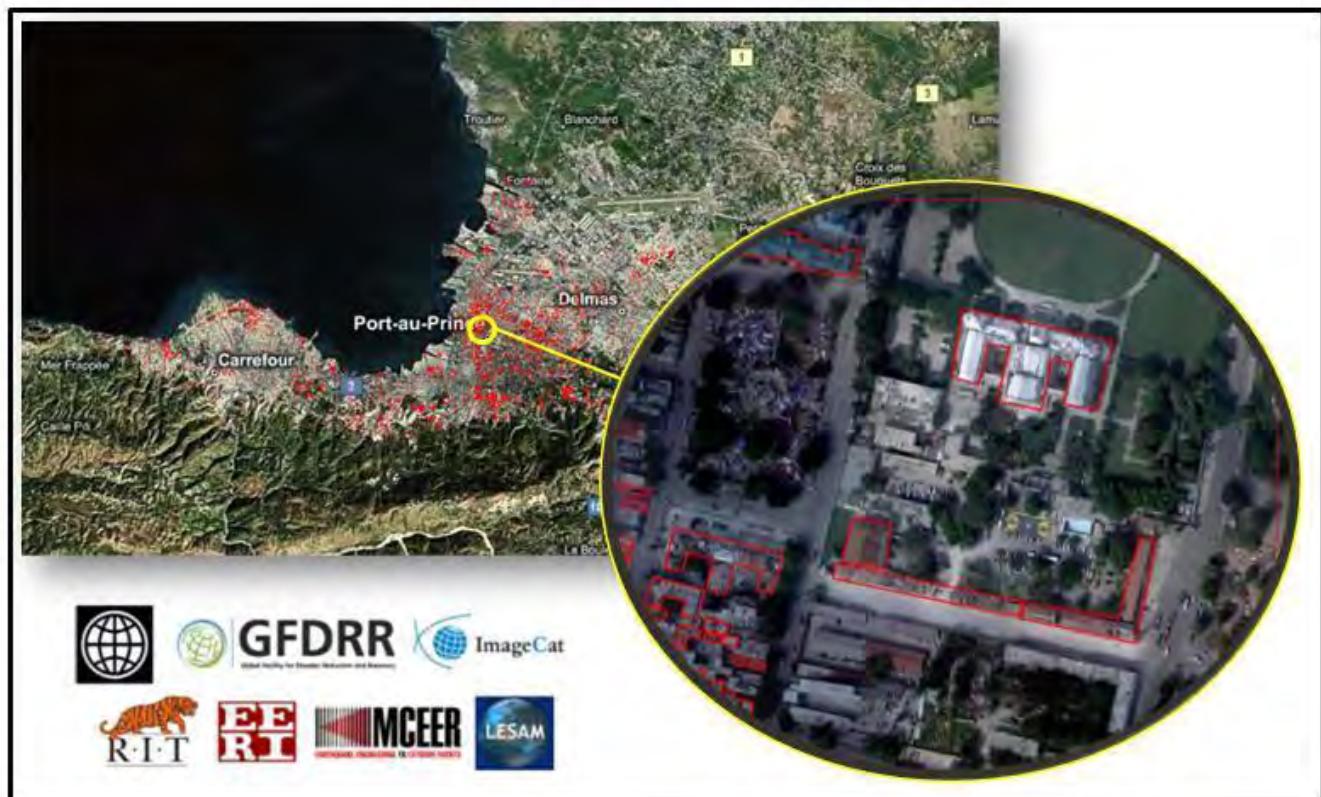
Figure 54. Sample of Damage Assessment Map.
