90 Degree USB Connector Adapter

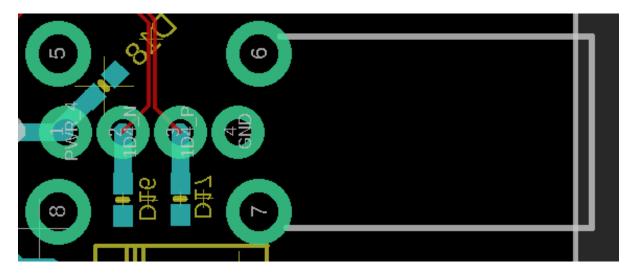
Purpose: The original footprint was incorrectly routed as shown in figure 1. So, I had created this adapter as a temporary fix. To allow me to continue testing the project for other issues. However, the corrected connections can be seen in figure 2.

Figure 1: Connections on USB connector are reversed. "Adapter was used to correct this"

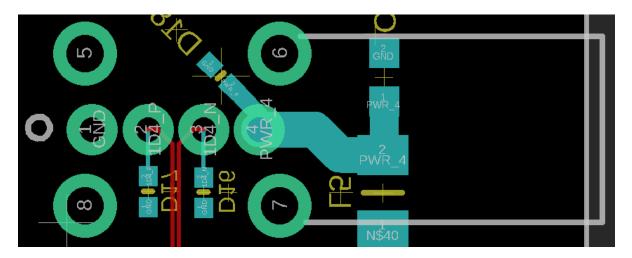
Figure 2: Connections are now correct.
