The Failure of Masonry Walls by Disaggregation and the Masonry Quality Index

Abstract: The visual method for assessment of the structural behaviour of historic masonry walls, known by the acronym MQI (Masonry Quality Index) was introduced in 2002 by a team of researchers from the University of Perugia, Italy. This is based on a visual survey of the faces and the cross section of a wall panel, and it aims at verifying if a wall complies with the “rules of the art”. Based on this analysis, it is possible to calculate a numerical index: numerous tests, carried out on site by the authors to validate the method, have demonstrated that the index is able to provide useful information about the mechanical characteristics and structural response, in general, of the analysed wall panel. The failure mode of a wall panel under the action of an earthquake is a critical aspect. In general, the failure modes can be categorized in two classes: masonry disaggregation and the development of a local or global mechanism of wall elements (macroelements). Several theoretical models and numerical simulations only consider the latter. In this paper, application of the MQI method is further investigated,

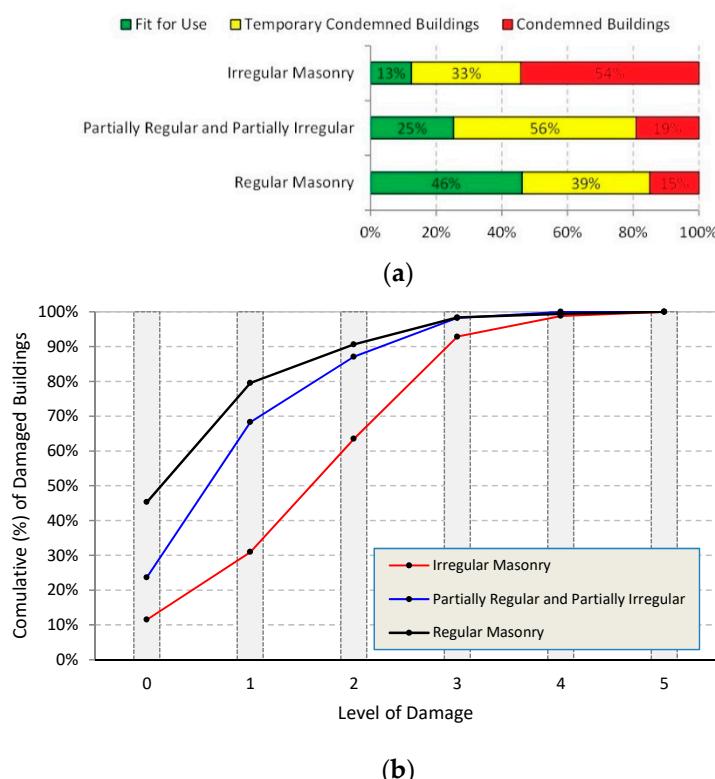
Unfortunately, the situation we face is more complex: it is difficult to be placed inside well-defined relationships and we cannot say that the only reason for these collapses was the masonry low quality. For example, in addition to the low masonry quality, ineffective wall-to-wall connections, presence of horizontal out-of-plane static forces (for example, due to arched or vaulted structures), and other seismic vulnerabilities were often noted in collapsed buildings. However, a statistical analysis based on a large number of buildings and using the reports of the damage suffered by masonry buildings after the 2016 central Italy earthquake clearly demonstrated that the influence of the masonry quality is critical (Figure 1).

Figure 1. Results of the post-earthquake assessment of the existing building stock of Norcia, Italy (city centre): (a) classification in terms of masonry typology and (b) cumulative percentage of damaged/collapsed buildings in terms of level of damage (0 = no damage; 5 = building collapse).

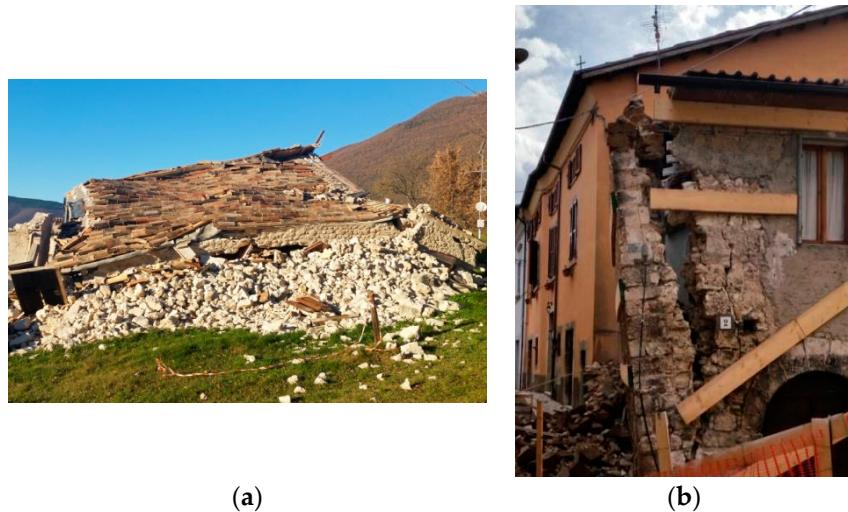
Figure 2. (a) Example of masonry disaggregation of a low-quality masonry in Campi Basso (Perugia, Italy), Italy, after the 2016 Central Italy earthquake and (b) an out-of-plane mechanism of a wall panel of a building in Norcia (Perugia, Italy), Italy (2016 Central Italy Earthquake).

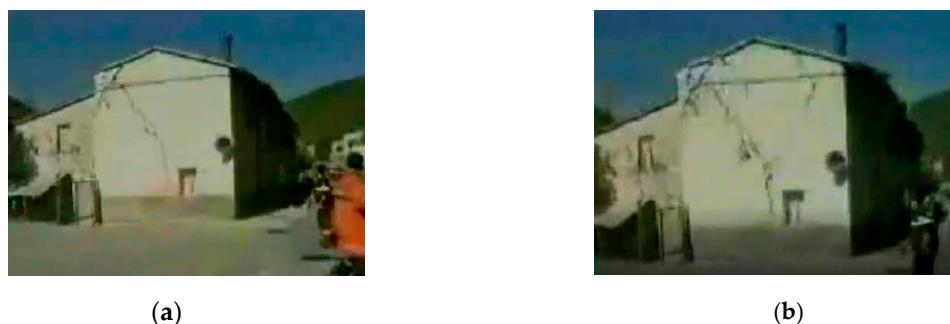
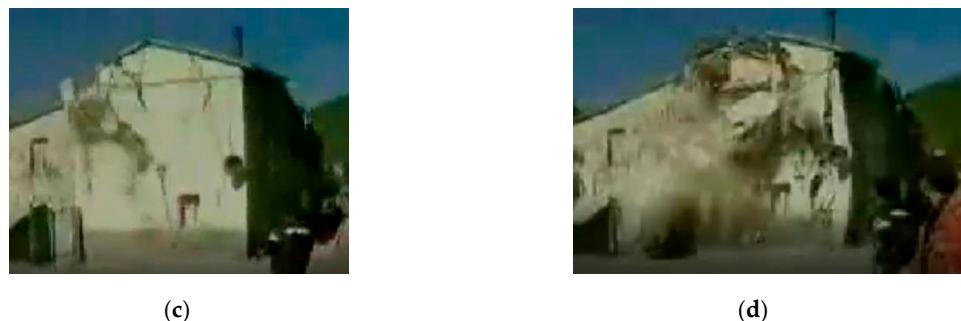
As an example, Figure 6 shows 4 slides of a video of the collapse of a masonry building located near Foligno, Italy, during the 1997 earthquake. Initially, it can be noted (Figure 6a) that the façade cracked and several wall macroelements formed. This is typically a collapse mechanism according to the theory of kinematic chains (Figure 6b). The rotation of the wall (on the left) appears to suggest a rocking (out-of-plane) mechanism of this wall (Figure 6c). However, the very low quality of the masonry does not allow this mechanism to develop further, and several masonry portions of the building become unstable and collapse. It is the façade wall of the first floor on the front that fails first. Subsequently, the wall on the left and the entire building collapse (Figure 6d).

Figure 6. Photographs of the collapse mechanism of a building located in Foligno, Italy during the 1997 earthquake: (a) masonry starts cracking; (b) wall macro-elements develops; (c) rocking (out-of-plane) mechanism of wall façade (on the left); (d) masonry disaggregation

It is evident that the structural response of the building under the action of the earthquake highly differs from the theory of macroelements with well-defined collapse mechanisms. These mechanisms cannot further develop because of disaggregation of the masonry.

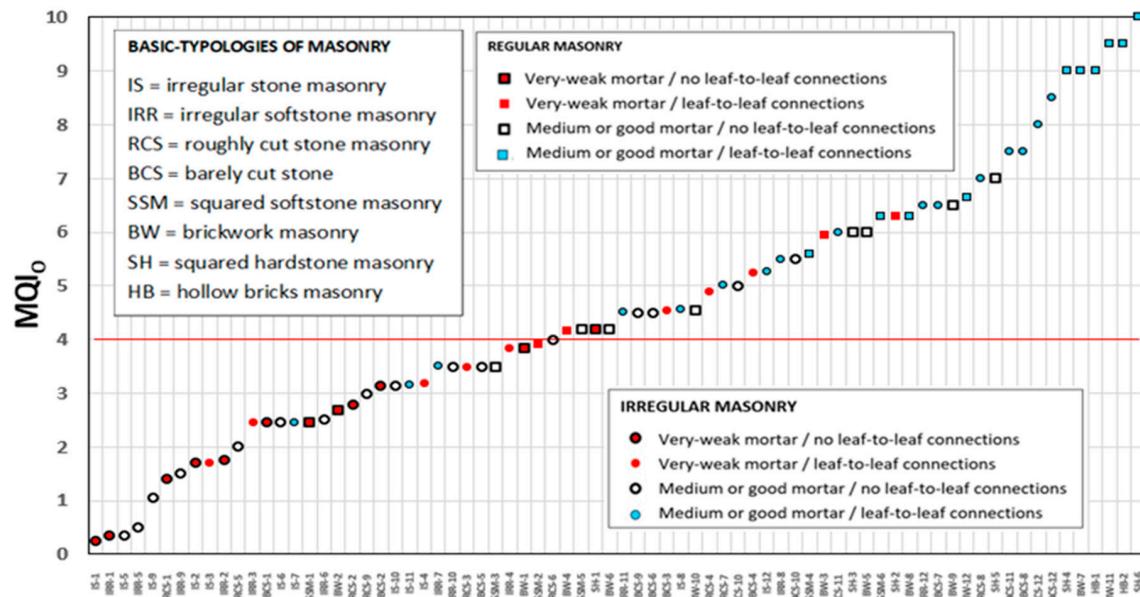
Figure 7 shows the MQI_O values of the masonry typologies considered in the Italian Seismic Code. In addition to the MQI_O , the figure specifies the quality of the mortar, the masonry arrangement (regular or irregular), and the level of connection between the wall leaves (for multi-leaf walls). A red line for a value of 4 of the MQI_O divides the graph in two regions. It can be noted that the masonry typologies characterized by a very weak mortar, unconnected wall leaves, and an irregular arrangement are usually below this line. For these masonry typologies, we believe that it is likely to fail by disaggregation under the action of an earthquake. Oppositely, the MQI_O values of masonry typologies, both regular and irregular, and characterized by a non-weak mortar and connected wall leaves is typically higher than 4 (Figure 7).

Figure 7. MQI_O values for the masonry typologies suggested by the Italian Seismic Code: each masonry typology is identified by an abbreviation and by a number that corresponds to the description reported in Tables 4–10.

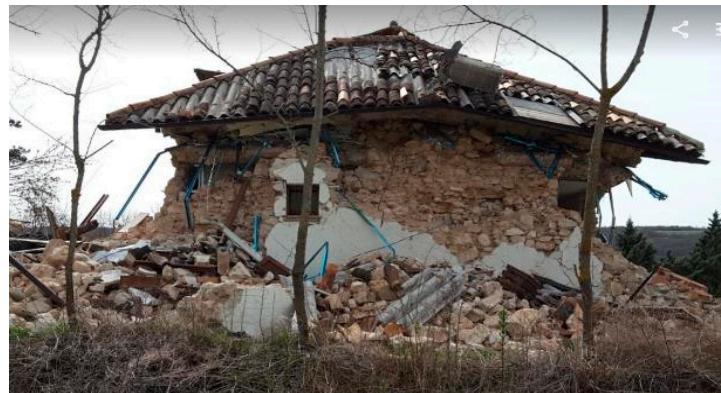
Figure 8. A collapsed building in Campi Bassi, Norcia, Italy: The masonry (combination No. 1 of Table 4) of this building disaggregated during the earthquake.

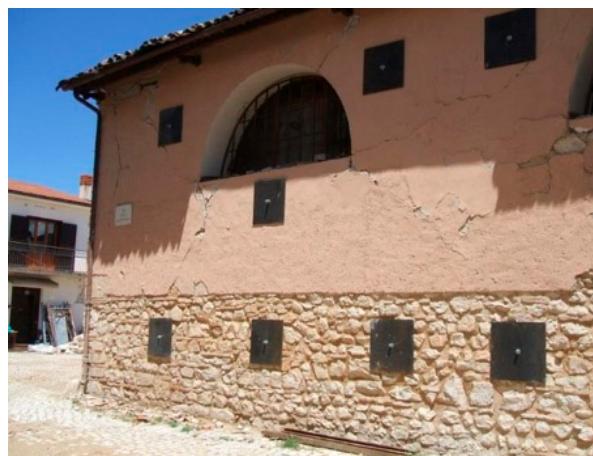
Figure 9. Stonework building in Onna, near L'Aquila in Italy: the arrangement of the stonework is uniform, and the masonry texture is well-organized (homogeneity of the stones and random presence of bricks to improve the overall wall's stability) (combination No. 12, Table 4). It can be noted that this wall was consolidated using a deep repointing the mortar joints. The medium dimensions of some stones suggest a good connection between wall leaves. The masonry material of this building did not disaggregate during the 2009 Aquila earthquake. It should be also highlighted here that most historic masonry buildings of Onna, typically made of a masonry of lower quality, disaggregated during the 2009 earthquake [28].

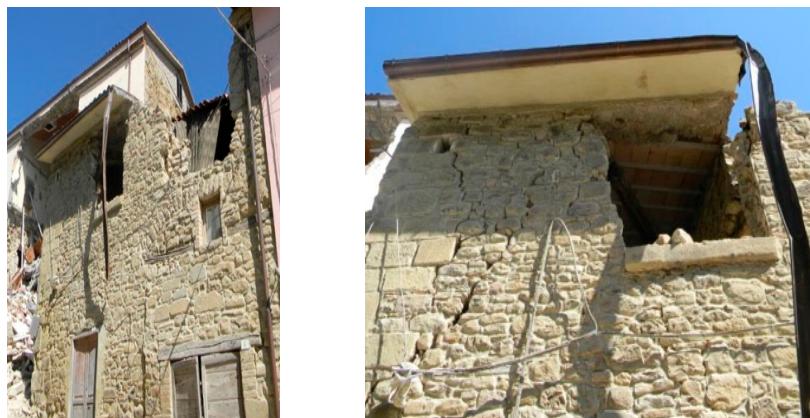
Figure 10. A building in Accumoli, near Rieti, in Italy: a large number of large cut stones was used here. This highly increased the level of connection between the wall leaves (combination No. 7, Table 5: cut stone masonry, medium-quality mortar, and effective connection between wall's leaves). For the upper part of this building, the quality of the masonry is lower and the wall leaves seem unconnected (combination No. 5, Table 5: cut stone masonry, medium-quality mortar, and non-effective connection between wall's leaves). The masonry of the upper part of this building disaggregated during the 2016 Central Italy earthquake.

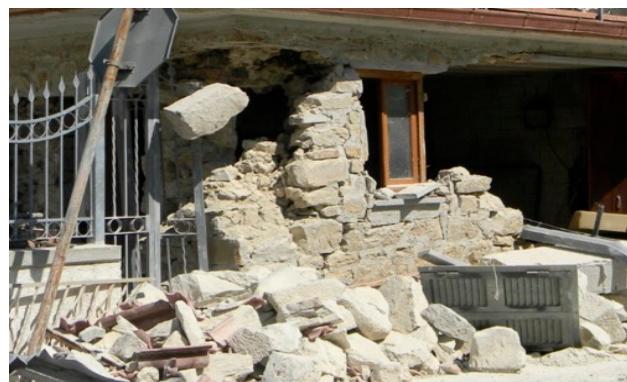
Figure 11. Pescara del Tronto, near Ascoli Piceno, in Italy. This is an example of cut-stone masonry, very weak mortar, unconnected wall's leaves (Combination No.2, Table 6). The building failed due to masonry disaggregation.

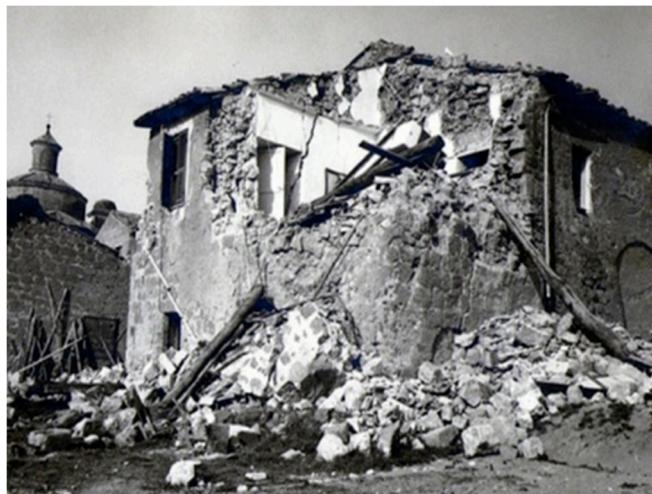
Figure 12. Tuff stone building in Tuscania, Italy, after the 1971 earthquake: the masonry typology can be classified in combination No. 1 of Table 7: irregular stones, non-horizontal bed joints, unconnected wall leaves, and very weak mortar. The failure mode is by disaggregation.

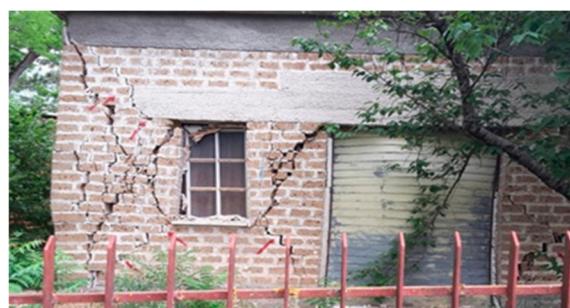
Figure 13. Tuff block masonry of a building in Norcia, Italy: the quality of the mortar is good (combination No. 6, Table 8). The 2016 earthquake caused the shown failure mode: it can be noted that cracks diffusively opened in the tuff blocks, while this is very rare if the mortar quality is weak. Masonry disaggregation usually does not occur for this masonry typology.

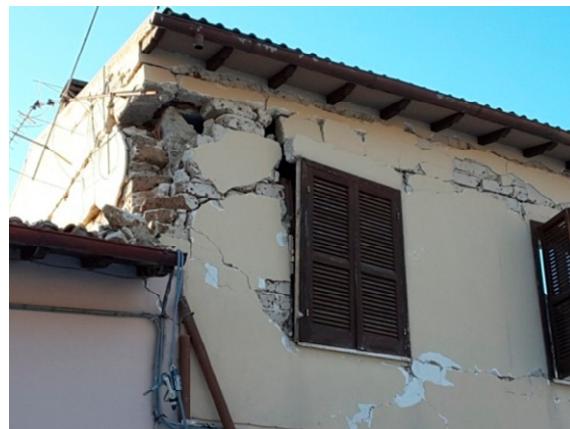
Figure 14. A tuff masonry building in San Pellegrino (Norcia, Italy): the masonry was made of squared tuff blocks and a very weak mortar (combination No. 2, Table 8). Cracking mainly occurred in the bed joints. The 2016 Central Italy earthquake caused a failure mode by horizontal sliding of the upper part of the building, likely activated by significant vertical component of the seismic action. The phenomenon of masonry disaggregation can be noted at the corner.

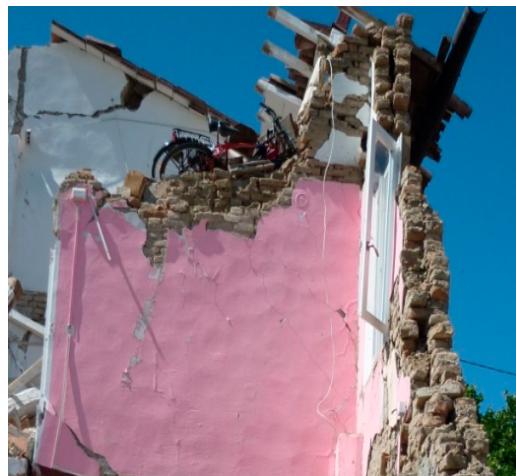
Figure 15. Brickwork building damaged by the 2012 Emilia earthquake: load-bearing walls were made of two unconnected leaves and a very-weak mortar (combination No.2, Table 10). The disaggregation of masonry is evident.

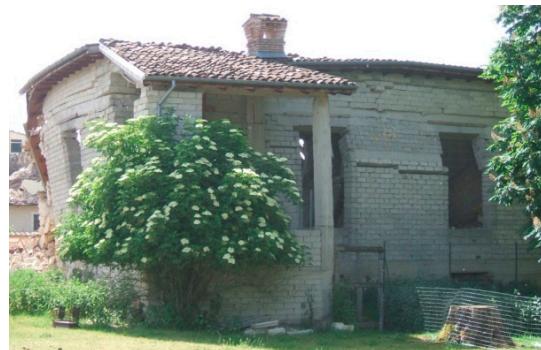
Particular situations are not rare, and these are not considered by the Italian Seismic Code. As an example, Figure 16 shows a building in Onna, Italy, where the load-bearing walls were made of two different types of masonry: some walls were made of irregular stone masonry (pebbles, and erratic and irregular stones) (combination No. 1, Table 4). For other walls of the same building, solid concrete blocks were used. During the 2009 Aquila earthquake, the irregular stone walls disaggregated while the concrete block wall diffusively cracked, without falling apart. The MQI_O index of the stone walls is very low (0.35), while it reaches the value of 9 for the concrete block ones.

Figure 16. A building made of concrete block and irregular stones in Onna, Italy.

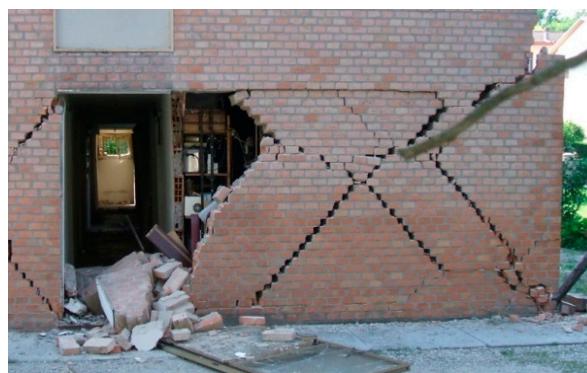
Another interesting case study is shown in Figure 17. Again, the masonry typology cannot be assigned to one of the types suggested by the Italian Seismic Code. This is a brickwork building located in San Possidonio, in Emilia Romagna. The mortar is made of cement, and the type of bond is heading bonding pattern. The 2012 earthquake caused in-plane shear cracking without masonry disaggregation phenomena. The MQI_O is 8.5.

Figure 17. Failure mode of a building made of bricks and cement mortar (San Possidonio, Italy).
