# Pavement Damage Report

Date: 2025-03-28

Location: Springett Staff Lot (Rear)

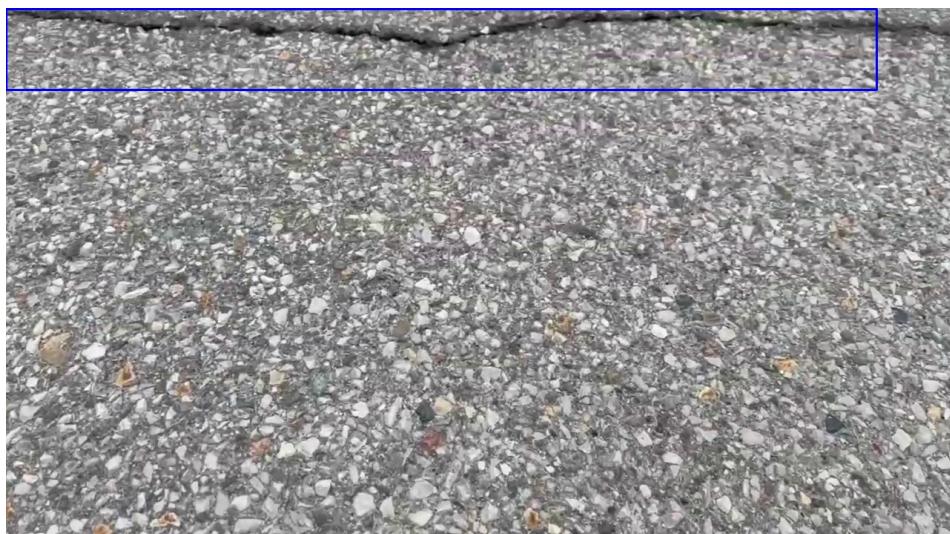
Defect Number: 1

Suspected Defects: transverse cracking: 55.73%

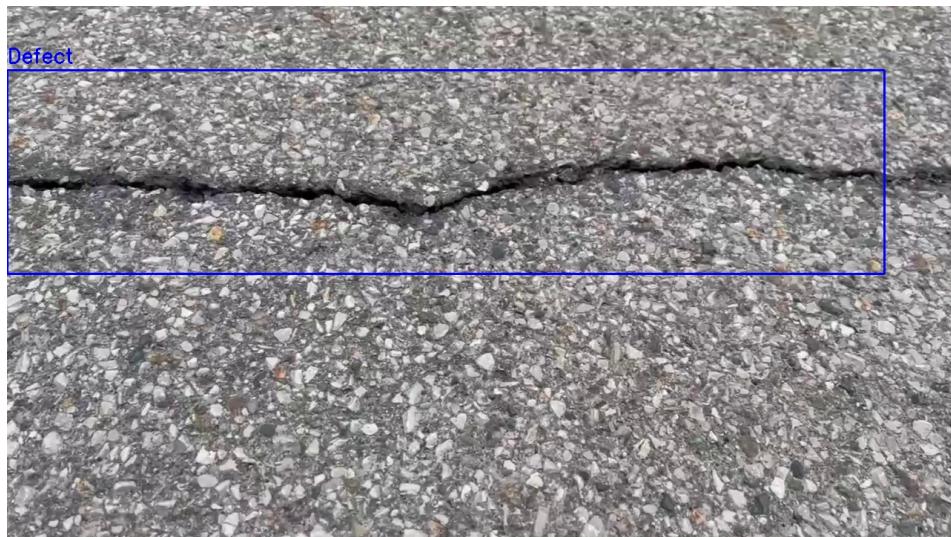
Defect Number: 2

Suspected Defects: transverse cracking: 41.22%

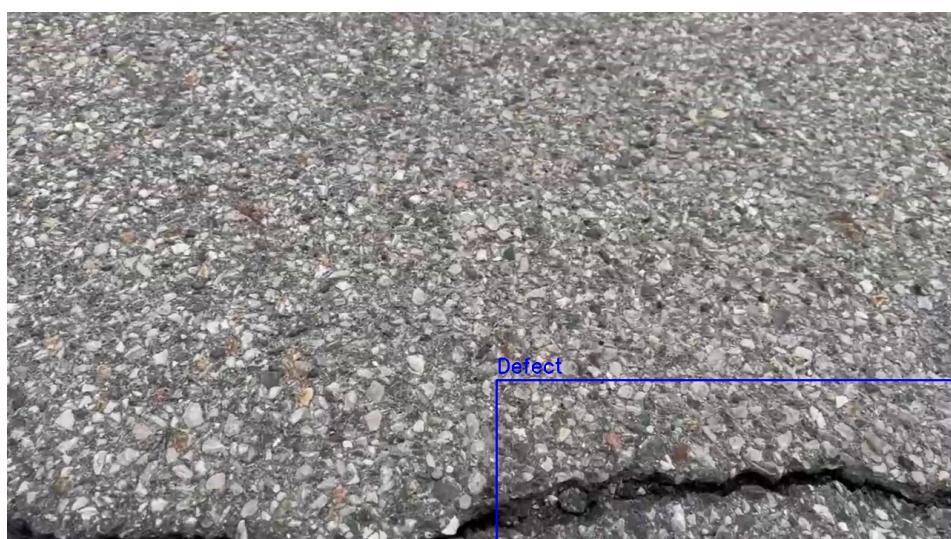
Defect Number: 3

Suspected Defects: transverse cracking: 72.06%

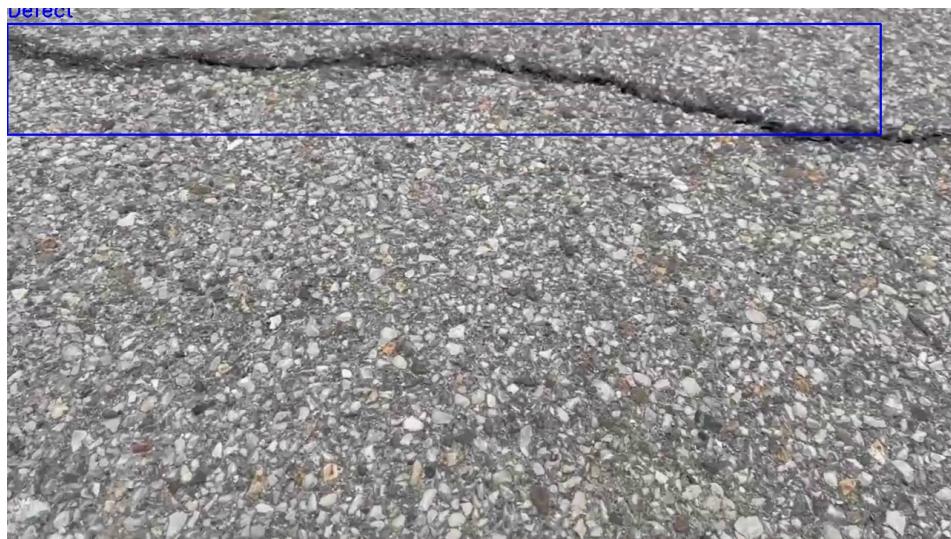
Defect Number: 4

Suspected Defects: transverse cracking: 56.49%

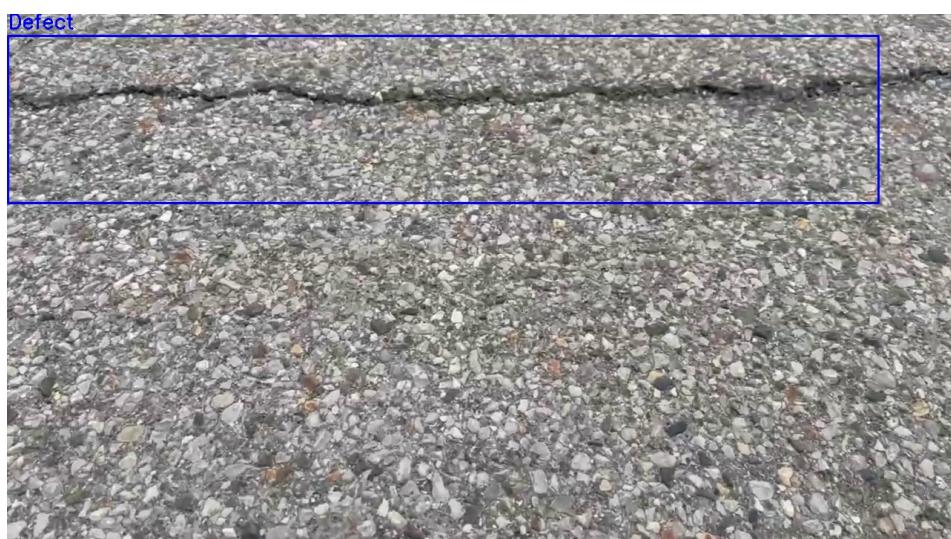
Defect Number: 5

Suspected Defects: transverse cracking: 60.48%

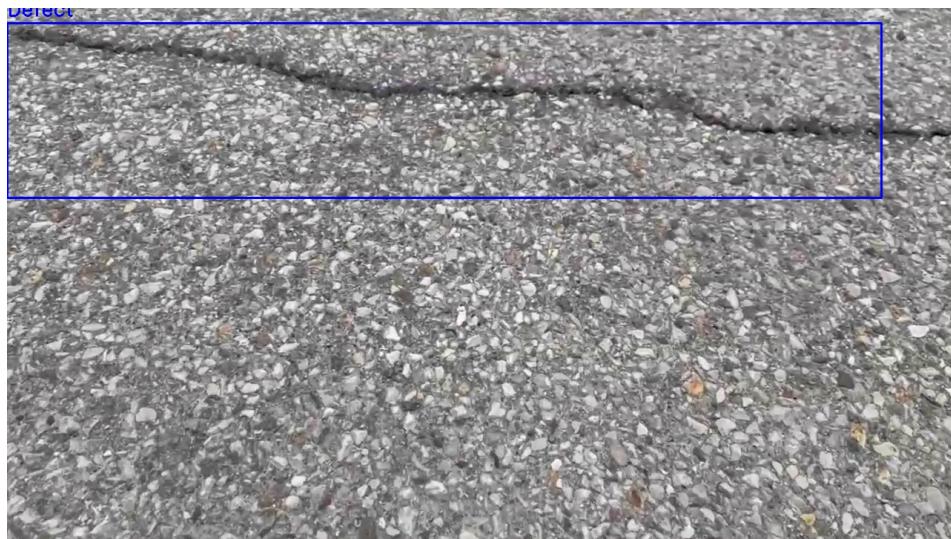
Defect Number: 6

Suspected Defects: transverse cracking: 75.42%

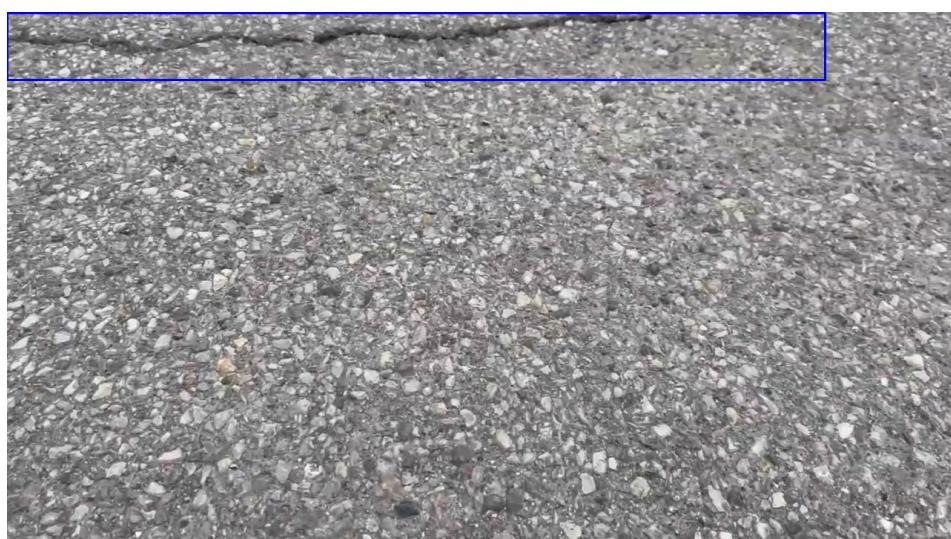
Defect Number: 7

Suspected Defects: transverse cracking: 55.53%

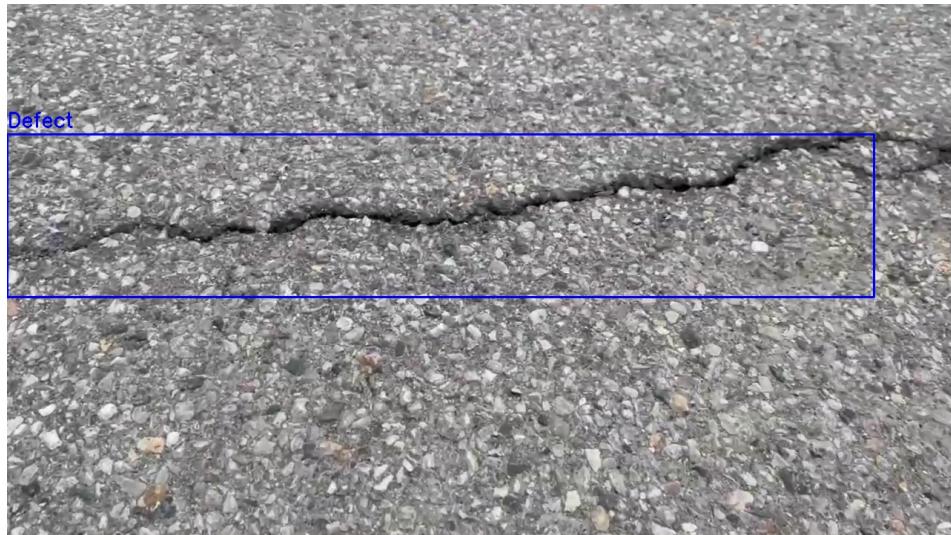
Defect Number: 8

Suspected Defects: transverse cracking: 60.88%

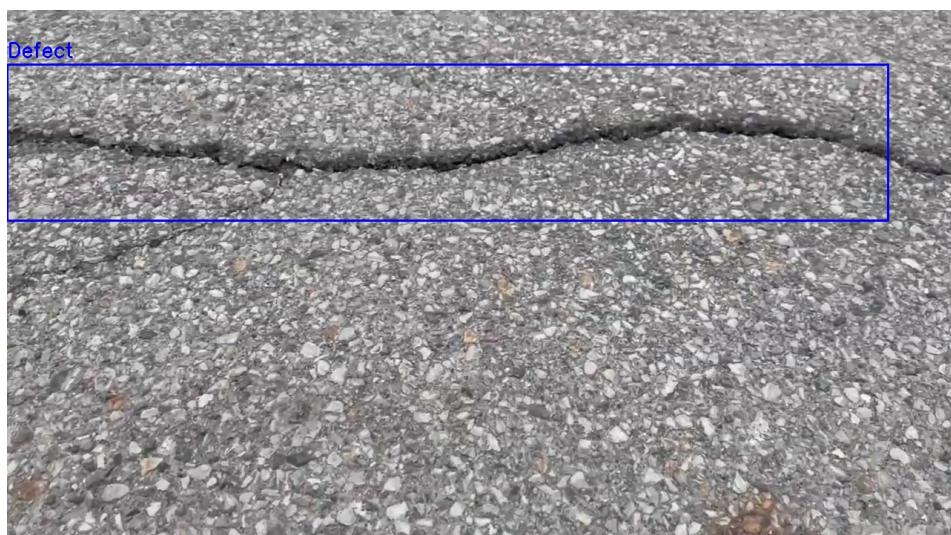
Defect Number: 9

Suspected Defects: transverse cracking: 53.63%

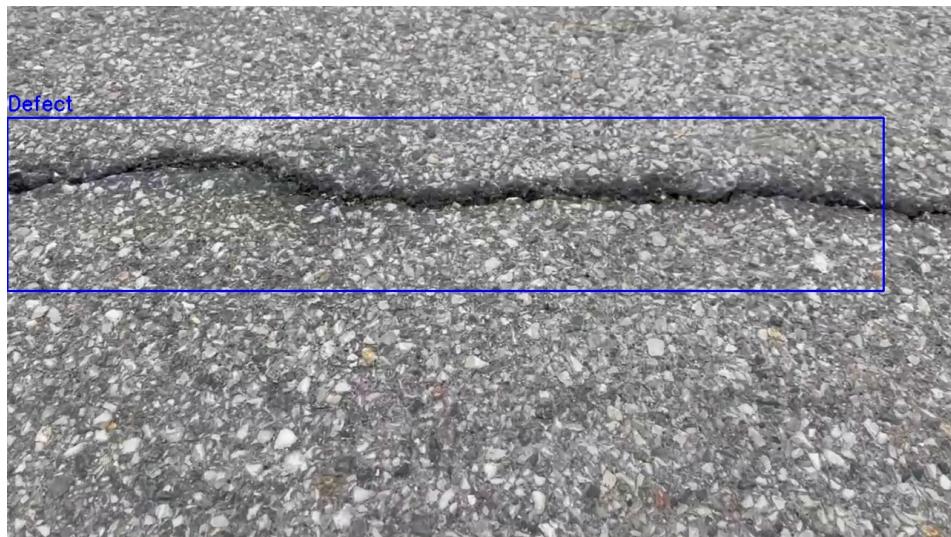
Defect Number: 10

Suspected Defects: transverse cracking: 62.38%

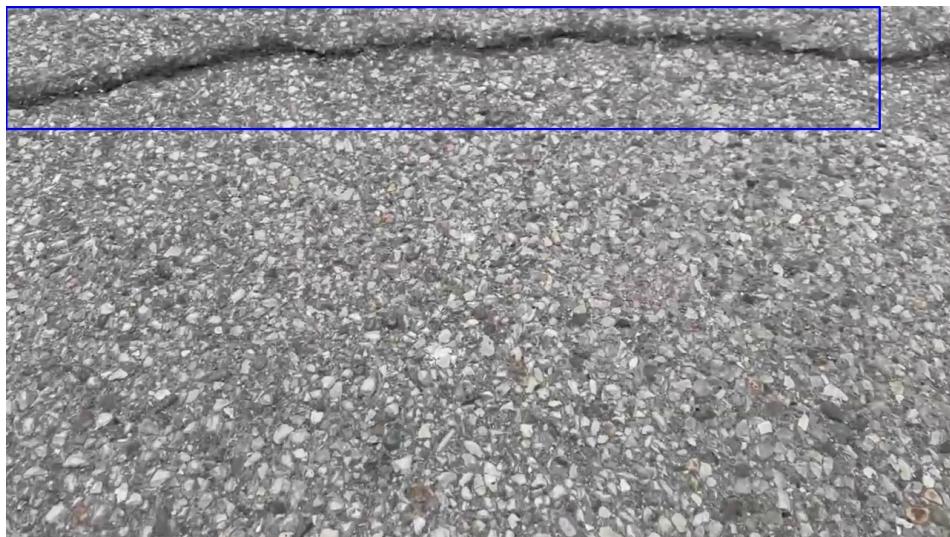
Defect Number: 12

Suspected Defects: transverse cracking: 74.97%

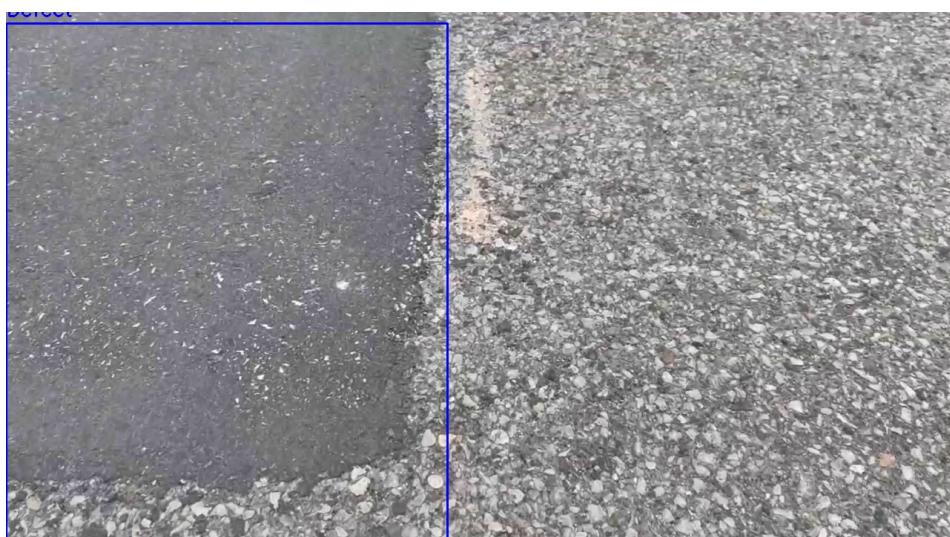
Defect Number: 13

Suspected Defects: alligator cracking: 48.38%

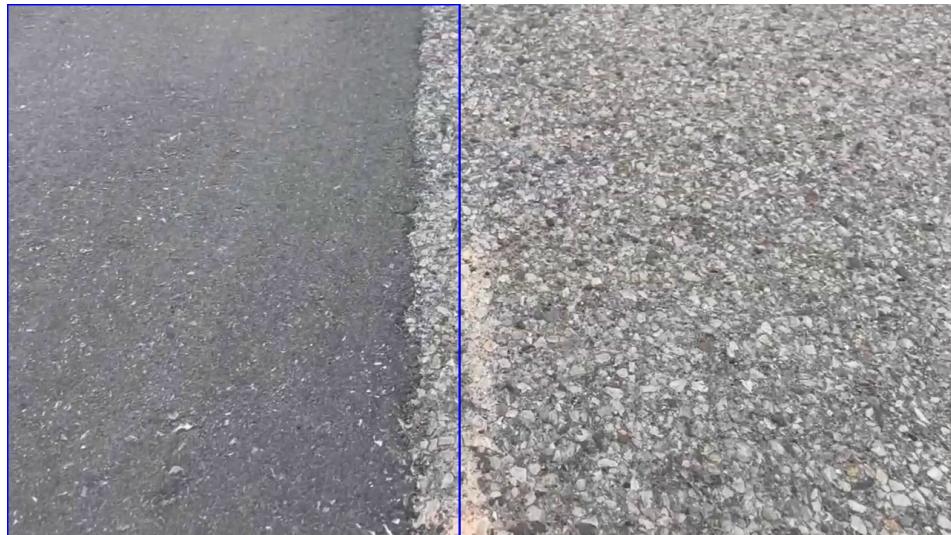
Defect Number: 14

Suspected Defects: alligator cracking: 63.03%

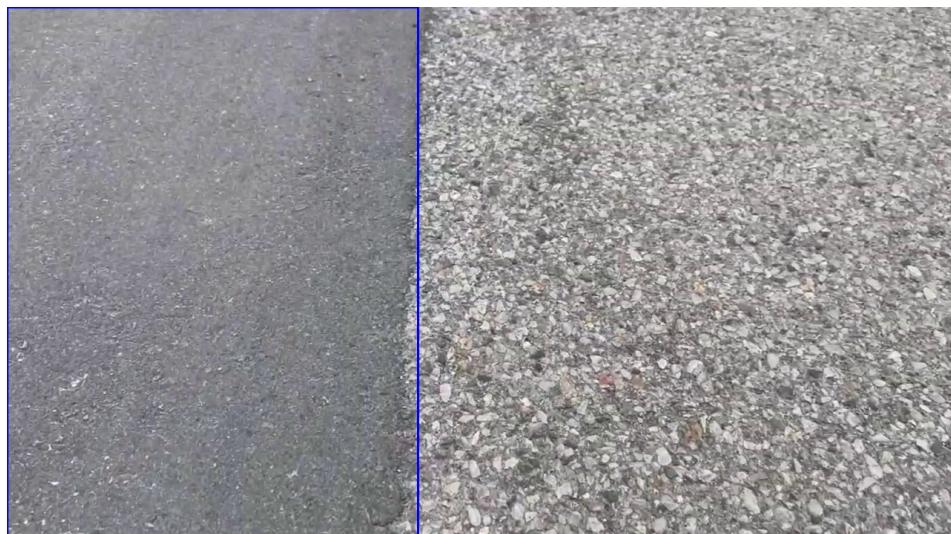
Defect Number: 15

Suspected Defects: patching: 50.80%

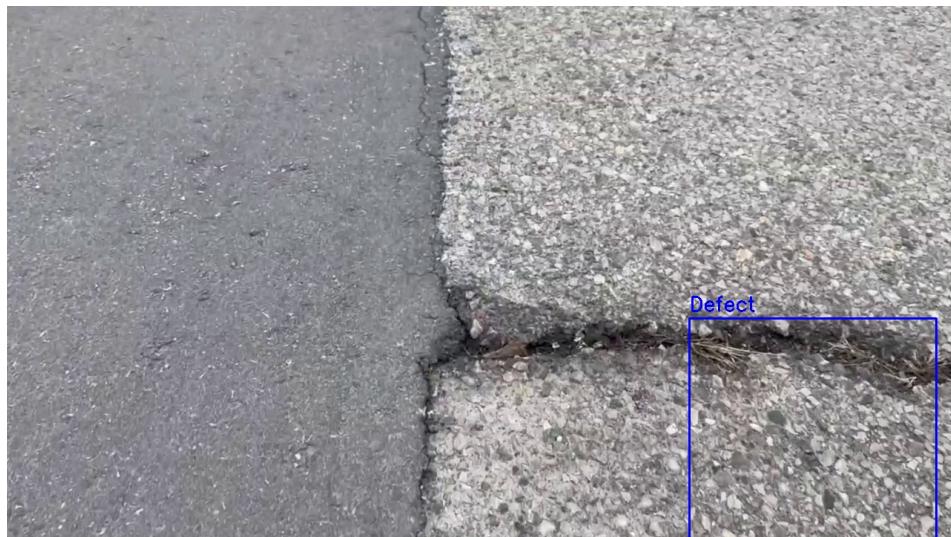
Defect Number: 16

Suspected Defects: alligator cracking: 48.04%

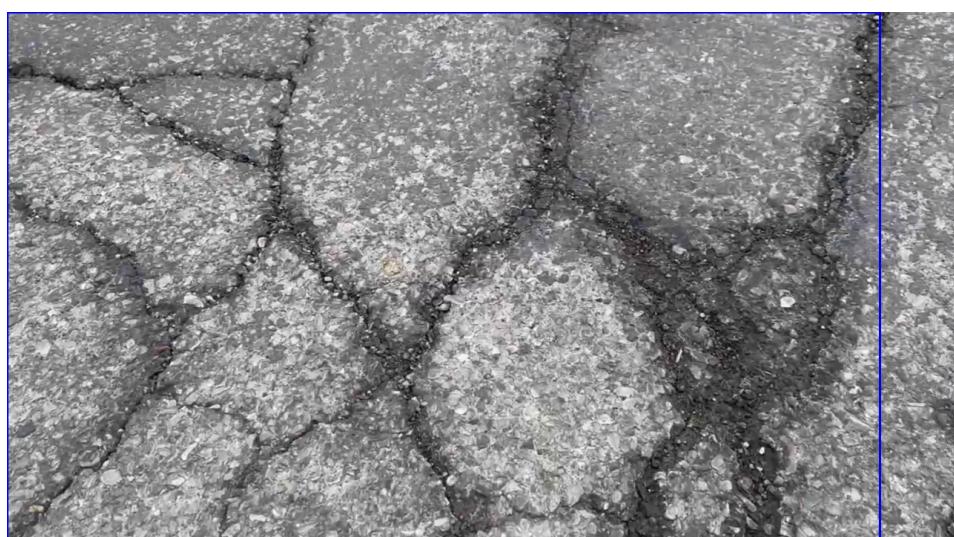
Defect Number: 21

Suspected Defects: alligator cracking: 79.06%

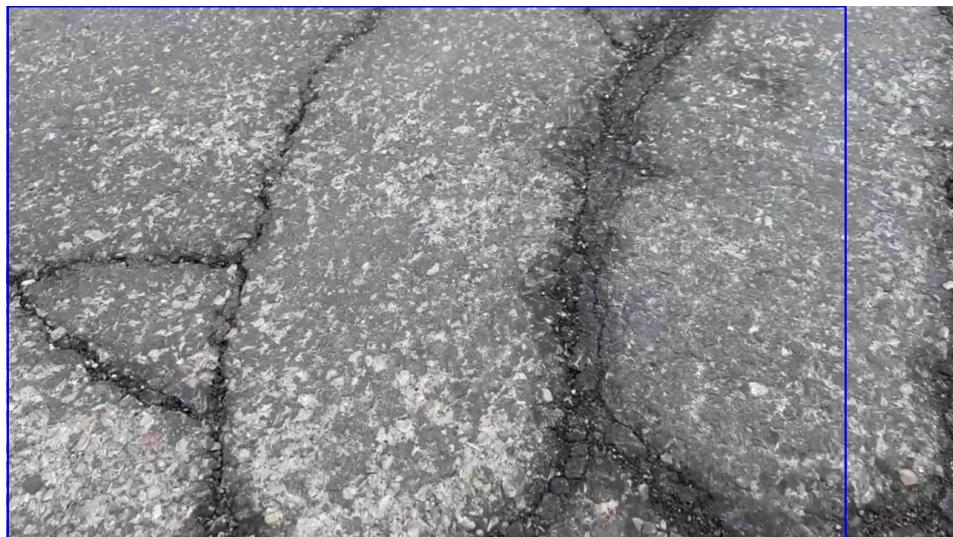
Defect Number: 22

Suspected Defects: alligator cracking: 75.34%

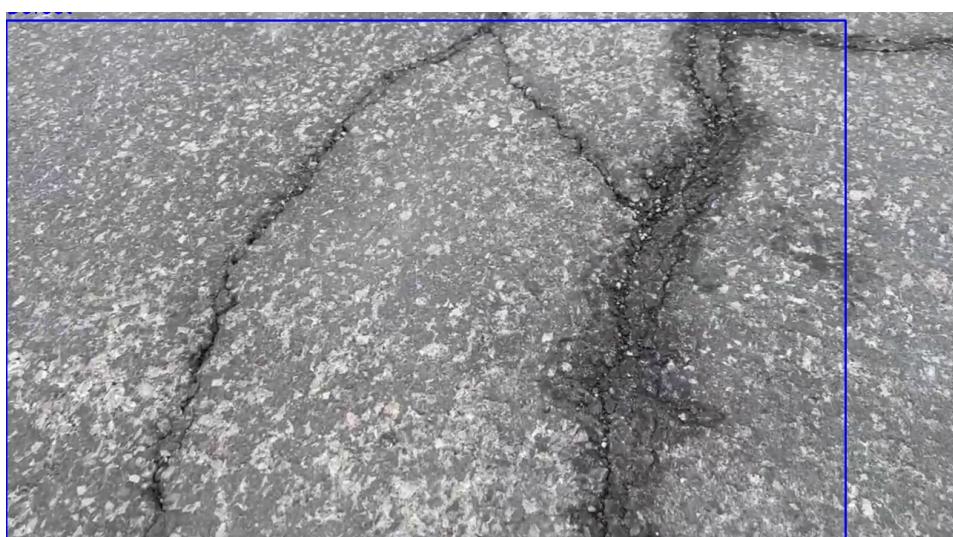
Defect Number: 23

Suspected Defects: alligator cracking: 70.62%

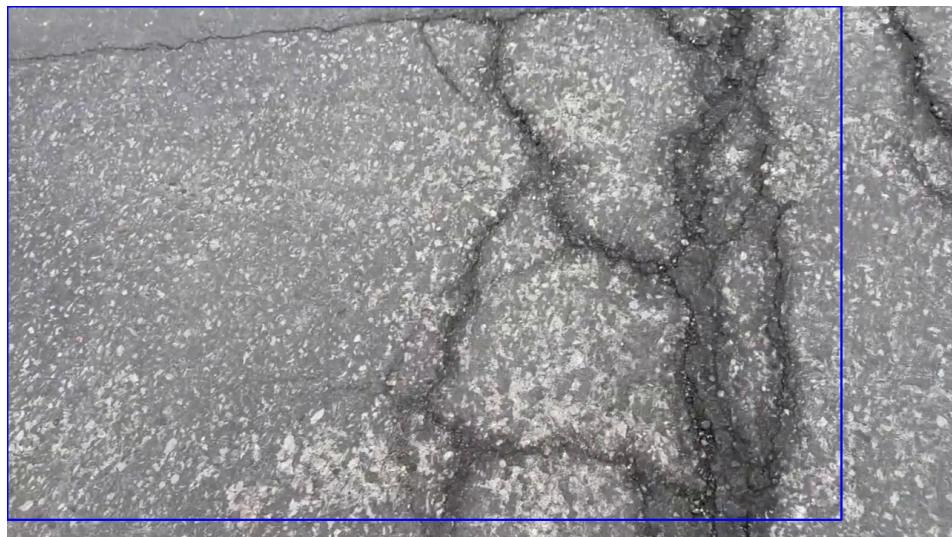
Defect Number: 24

Suspected Defects: alligator cracking: 80.76%
