Home Beam Analysis Elijah Roberts July 31st 2022

Finite Element Analysis (FEA)

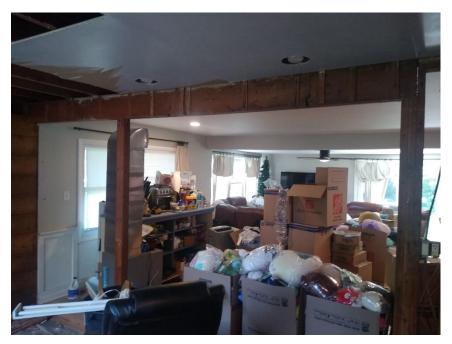
Figure (1): Photo of the homes support beam for reference.

The model beam loading conditions can be seen in Figure (6). Based on Figure (1) fixed supports were used at either end of the beam. Fixed supports assume zero deformation (movement) and zero rotation at that point. For the center support that is being relocated a pin support was used. Pin supports assume zero deformation but do allow for rotation around the given point. Lastly the loading of the beam is generated by a distributed line pressure along the length of the beam.
