U.S. Fire Administration/Technical Report Series

The World Trade Center Bombing: Report and Analysis

New York City, New York

USFA-TR-076/February 1993

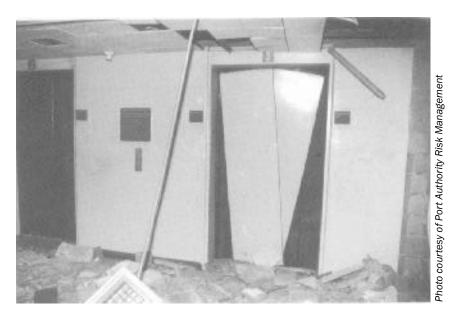
Damaged elevator doors and enclosures on the B-2 level presented a vertical channel for smoke spread into Tower 1.

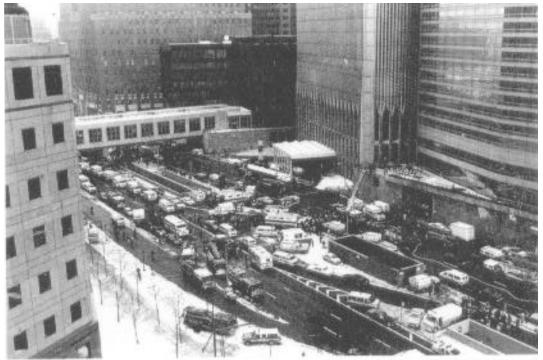
Above grade. The large quantities of smoke that had been generated prior to the fire's knockdown became a major operational factor. Due to the destroyed elevator shaft doors at the B-2 level, the hole in the Vista Hotel meeting room with the blown-out glass partition wall between the Vista Hotel and Tower 1, and doors being opened on all floors by people evacuating — and with the stack effect working — most floors and all stairways of Tower 1 and the Vista Hotel became charged with smoke. Tower 2 had a smoke condition but to a lesser degree. The smoke condition in Tower 1 was the worst of the three buildings above grade.

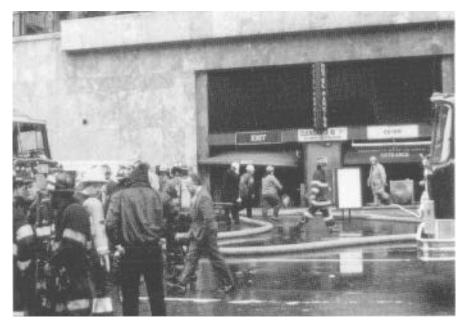
The scene on West Street within the first hour of the incident. The Vista Hotel is to the far right, and Tower 1 is next to it. The parking garage entrance is visible. Note also the tower ladder raised to the plaza level to remove occupants trapped at that level.

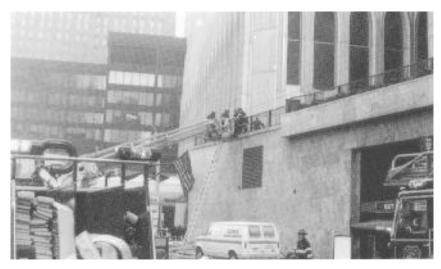
A view of the parking garage entrance on West Street, through which first fire companies launched the initial fire attack.

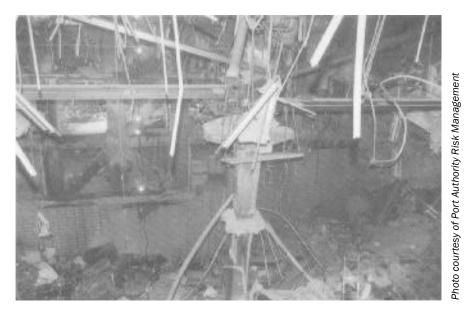
A view of the crater from the B-1 to B-5 levels. Noe the steel column. Horizontal supports were destroyed in some cases, but the columns did not give.

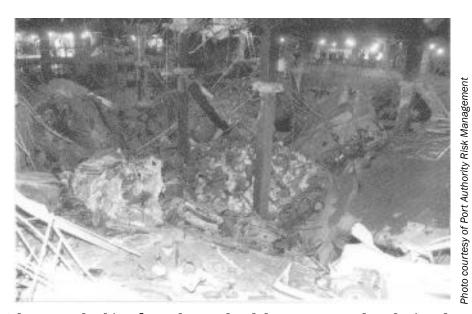
The crater, looking from the B-2 level down to B-5, taken during the investigation/restoration phase.

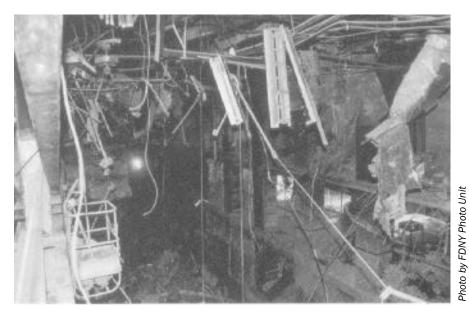
- An L-shaped crater, approximately 130 by 150 feet at its maximum points, was opened, collapsing reinforced concrete and debris onto levels below.
- At least nine steel columns were heavily damaged and left without lateral support.
- Many walls collapsed, including a concrete block wall adjacent to the blast area that collapsed onto and killed five WTC personnel.
- Doors/enclosure walls of Tower 1 elevator shafts were heavily damaged.

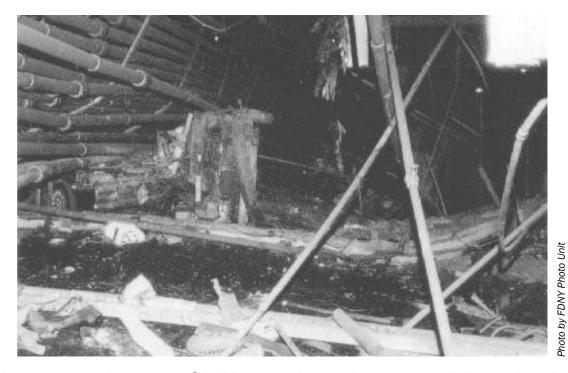
Building systems in the vicinity of the blast were destroyed. Here, twisted electrical conduit has landed on top of what was once a car.

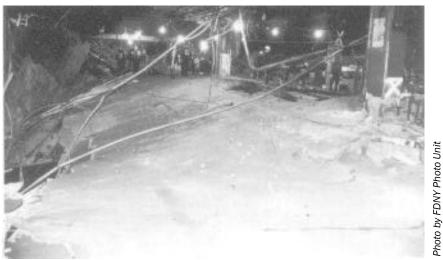
The sloping, hanging steel-reinforced concrete floor at the perimeter of the crater was a major hazard for units operating on the crater fire, particularly in the heavy smoke condition.

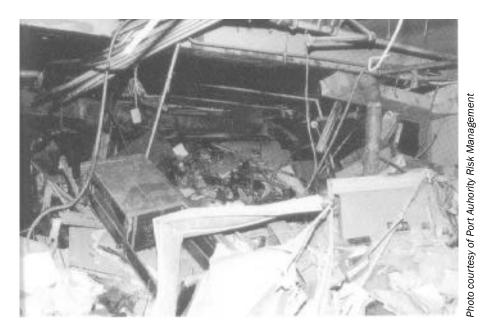
This destroyed office area on the B-2 level is typical of the debris piles faced by searching firefighters.

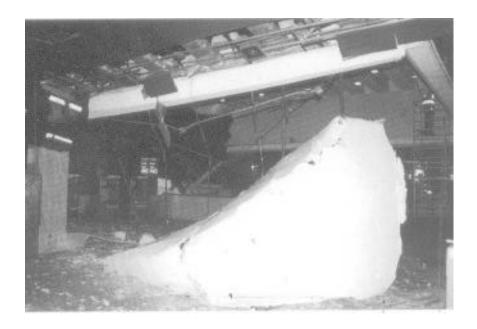
Damage/hazard assessment. Lights were brought into the below-grade areas. Damage from the blast was extensive. The B-2 level surrounding ground zero was completely destroyed. Piping and conduit were snapped like twigs. Masonry walls and steel-reinforced concrete flooring were blown apart. Cars were strewn about like toys. Steel columns were shocked but held.

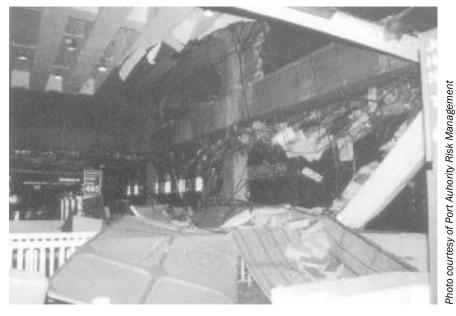
The explosion collapsed a portion of ceiling on the B-5 level onto a PATH train concourse.

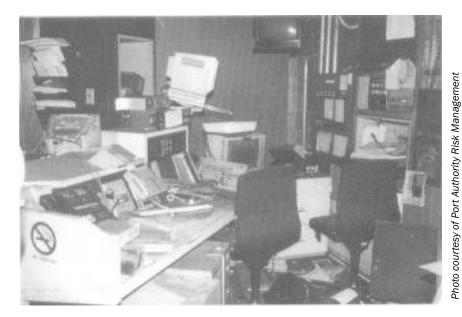
The Port Authority Command/Communications Center on the B-1 level, approximately 50 feet from the blast hole on that level, was damaged and communication with occupants in the towers was lost.

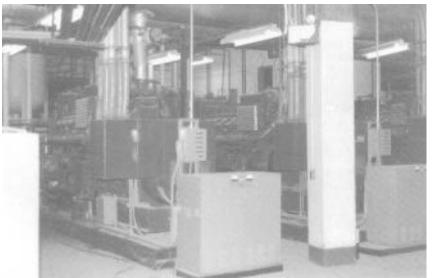
Emergency generators on the B-6 level. Cooling water lines for these unit were ruptured by the blast, shutting down all emergency power.
