Improving Nb₃Sn Cavity Performance Using Centrifugal Barrel Polishing

Despite having advantageous superconducting properties, Nb_3Sn SRF cavities still have practical challenges compared to Nb SRF cavities due to the brittle nature of Nb_3Sn . Performance degradation can occur when a Nb_3Sn experiences mechanical stresses such as during handling and tuning of the cavity. In this study, we present a potential treatment for cavities that have experienced stress induced performance degradation that involves a recoating procedure. The degraded cavity is coated with a small amount of Sn using a single step vapor-diffusion method. Using this procedure we are able to recover a significant portion of the lost performance of a Nb_3Sn SRF cavity.

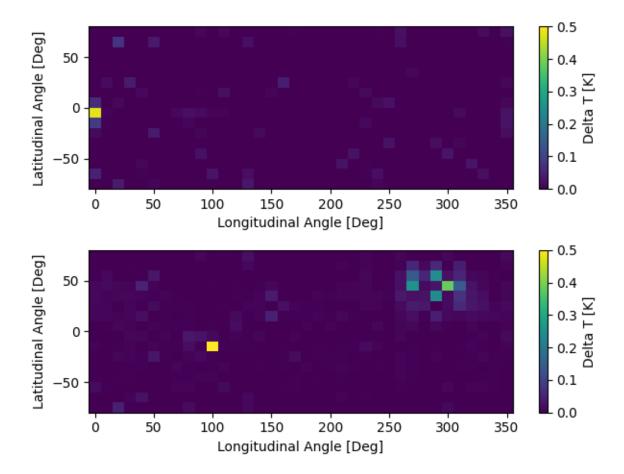
Temperature mapping was used to locate the quench source responsible for the performance degradation. A single hot spot on the equator of the cavity was discovered. Visual inspection of the cavity showed no visible defects near the quench location.

Temperature mapping of the cavity after the recoating shows that a similar small hotspot exists close to the equator, but the hot spot is activated at higher accelerating gradients. This indicates that the source of the degradation has been at least partially repaired by the recoating. In addition to the small hot spot near the equator, there is also a much larger hot spot closer to the iris which appears just before the cavity quench. This additional hotspot is accompanied by a large increase in x-ray production, which could indicate the heating is caused by field emission. It is possible that the cavity is limited by the multipacting, but higher accelerating gradients were not attainable even after 5 h of processing.

FIG. 2. Temperature maps of the cavity surface just before quench as measured before (top) and after (bottom) the recoating was applied.

In an attempt to heal the cracks causing the performance degradation, we apply a recoating procedure. During this recoating procedure, the cavity was heated to 1000 °C and exposed to Sn vapor for 1 h. Sn vapor was provided by 0.85 g of Sn heated to 1250 °C. The theory behind these parameters is that only a small amount of Sn is necessary to fill in any microscopic cracks in the film, and applying too much Sn would cause the film to become too thick or could negatively impact the surface roughness of the film. During the coating only a small portion of the Sn evaporated leaving behind a large amount of the initial Sn still in the crucible.
