# Healing Gradient Degradation in Nb<sub>3</sub>Sn SRF Cavities Using a Recoating Method

(Dated: May 28, 2024)

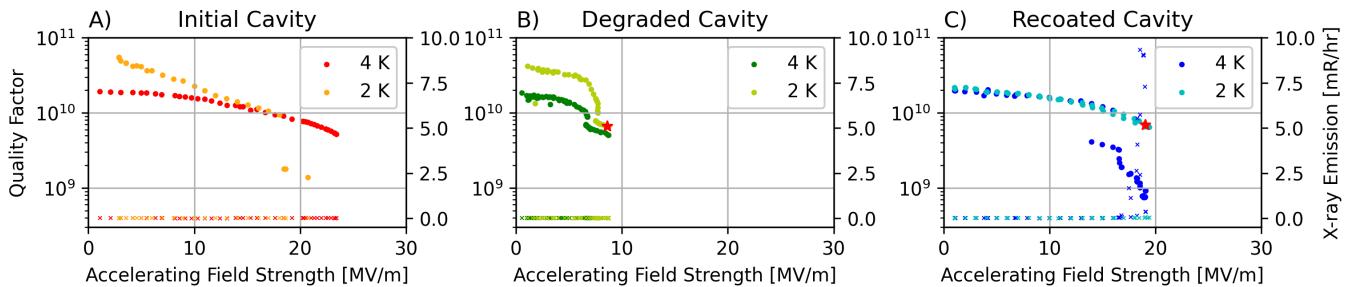
FIG. 1. The quality factor, indicated by dots, and X-ray emissions, indicated by x, versus the accelerating gradient of the cavity after the initial coating (A), after the degradation (B), and after the recoating (C). The quality factor and accelerating gradient of the T-maps in figure 2 are indicated by a red star.

After initially coating the cavity it achieves a peak accelerating field of 24 MV m<sup>-1</sup> and a maximum Q of  $2 \times 10^{10}$  at 4 K. The peak accelerating gradient after degradation is 8 MV m<sup>-1</sup> and a maximum Q of  $1 \times 10^{10}$  at 4 K. The cavity displays a decrease in the quality factor at around 6 MV m<sup>-1</sup> before a quench. A similar decrease in the quality factor is observed for other cavities affected by performance degradation[4, 5] and in Nb<sub>3</sub>Sn cavities treated with centrifugal barrel polishing[18]. Temperature mapping is displayed in figure 2 and is utilized to locate the quench source responsible for the performance degradation. A single hot spot on the equator of the cavity is present. Visual inspection of the cavity did not display visible defects near the quench location.

After the recoating procedure is applied the cavity's performance increases. The peak accelerating gradient increases to 19 MV m<sup>-1</sup> and the quality factor is  $1 \times 10^{10}$  at 4 K. Temperature mapping of the cavity after recoating demonstrates that the initial hot spot is healed with no detectable heating from that area. This indicates that the defect causing the performance degradation is repaired by recoating. At higher gradients another small hotspot appears in a new location close to the equator. Additionally, there is also a larger hot spot closer to the iris, which appears just before the cavity quench. This additional hotspot is accompanied by a large increase in x-ray emissions, figure 1, which may indicate that heating is caused by multipacting. Higher accelerating gradients are not attainable even after 5 h of processing. The cavity did not display any signs of multipacting during the 2 K measurement.

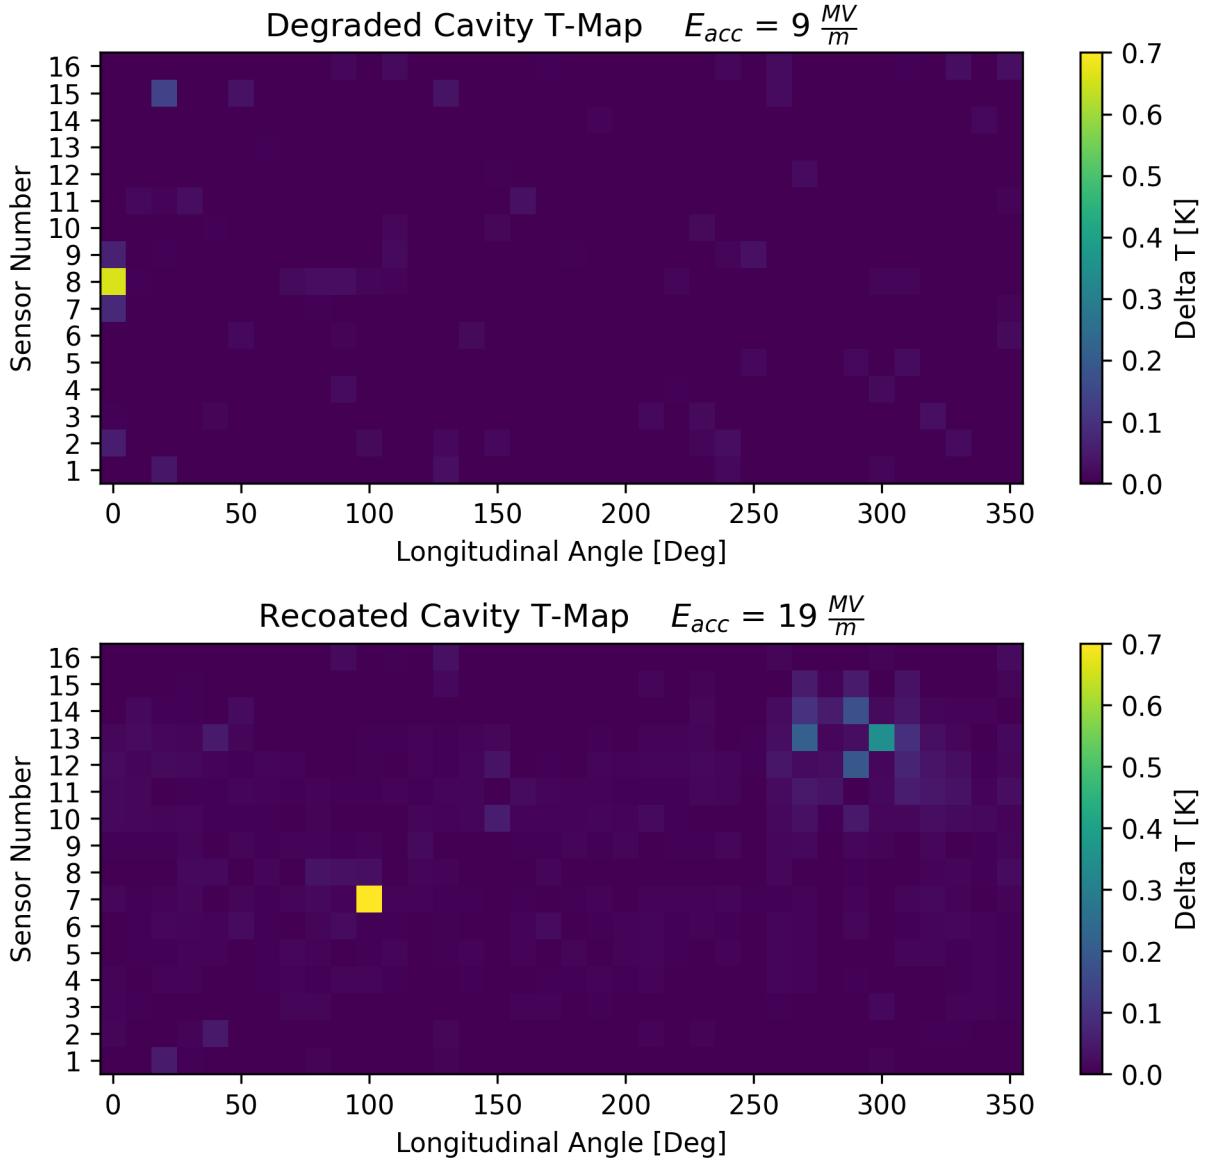
FIG. 2. Temperature maps of a cavity's surface prior to quench as measured before (top) and after (bottom) the recoating is applied. The temperature of the hot spot near the equator of the recoated cavity exceeds the maximum value of the color bar and achieves a maximum value at 3 K

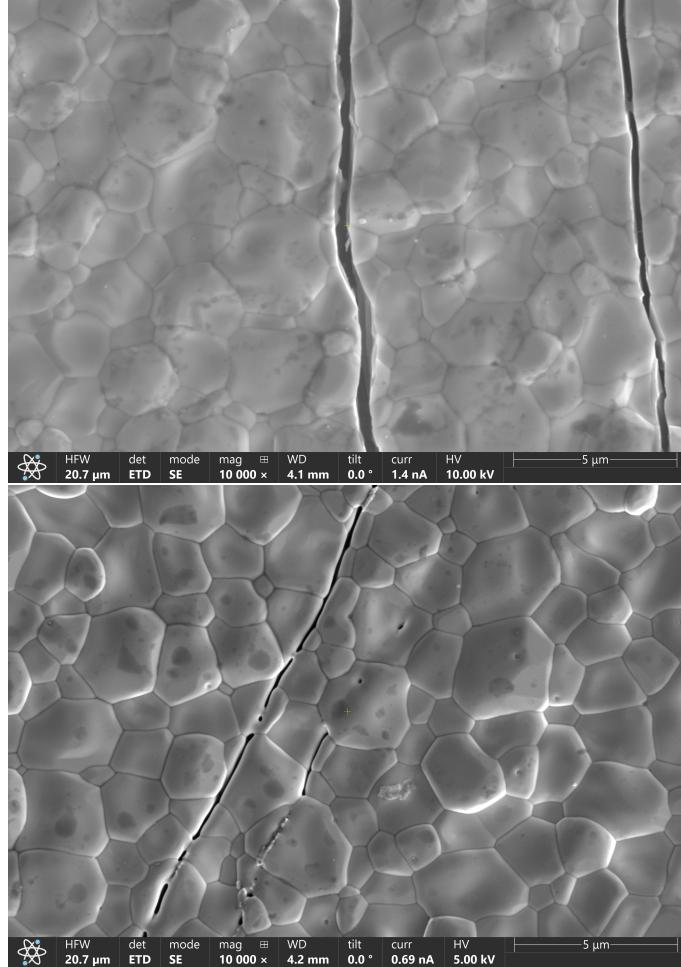
FIG. 3. Nb<sub>3</sub>Sn sample strained to 0.5% elongation before (top) and after (bottom) treatment with the recoating procedure. There is evidence of cracks filled in with newly created Nb<sub>3</sub>Sn.

Recoating a damaged Nb<sub>3</sub>Sn cavity can have a major impact on its performance. The mechanism for this change is heretofore unknown. We propose two possible mechanisms for the recoating process, which heals the Nb<sub>3</sub>Sn film. The first mechanism is by filling the cracks. When a cavity is exposed to Sn, a thin layer of liquid Sn coats the surface which thereby fills the cracks. Nb<sub>3</sub>Sn is then formed in the cracks by diffusion of Nb into the liquid Sn. The diffusion rate of Nb is relatively slow compared to the diffusion of Sn, however if the cracks are small, less than a few 100 nm, Nb may have sufficient time to diffuse into the crack. The second mechanism involves the diffusion of Sn into the Nb substrate through the crack. If the crack penetrates the Nb<sub>3</sub>Sn film, Sn can diffuse into the crack and react with the Nb substrate creating a region of new Nb<sub>3</sub>Sn. This new region acts as a bridge for electrical currents to flow through the film and prevents current from flowing through the Nb substrate, which has a higher resistivity than does Nb<sub>3</sub>Sn. This is an example of self healing [17].
