# Healing Gradient Degradation in Nb<sub>3</sub>Sn SRF Cavities Using a Recoating Method

(Dated: June 23, 2024)

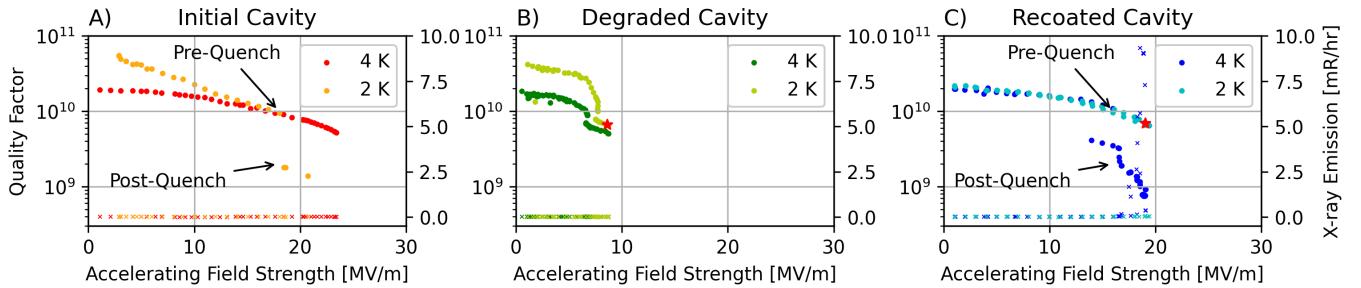
FIG. 1. The quality factor, indicated by dots, and X-ray emissions, indicated by x, versus the accelerating gradient of the cavity after the initial coating (A), after the degradation (B), and after the recoating (C). The quality factor and accelerating gradient of the T-maps in figure 2 are indicated by a red star.

After initially coating the cavity it achieves a peak accelerating field of 24 MV m<sup>-1</sup> and a maximum Q of  $2 \times 10^{10}$  at 4 K. The peak accelerating gradient after degradation is 8 MV m<sup>-1</sup> and a maximum Q of  $2 \times 10^{10}$  at 4 K. The cavity displays a decrease in the quality factor at around 6 MV m<sup>-1</sup> before a quench. A similar decrease in the quality factor is observed for other cavities affected by performance degradation[14, 15] and in Nb<sub>3</sub>Sn cavities treated with centrifugal barrel polishing[16]. Temperature mapping is displayed in figure 2 and is utilized to locate the quench source responsible for the performance degradation. A single hot spot on the equator of the cavity is present. Visual inspection of the cavity did not display visible defects near the quench location.

After the recoating procedure is applied the cavity's performance increases. The cavity experiences an initial quench at 16 MV m<sup>-1</sup> resulting in trapped flux which decreases the quality factor. The cavity is still able to reach a peak accelerating gradient of 19 MV m<sup>-1</sup>. At 2 K the cavity does not quench until reaching the maximum gradient of 19 MV m<sup>-1</sup>. The quality factor after recoating is  $2 \times 10^{10}$  at 4 K and the Q slope seen in the degraded cavity is not present. Temperature mapping of the cavity after recoating demonstrates that the initial hot spot is healed with no detectable heating from that area. This indicates that the defect causing the performance degradation is repaired by recoating. At higher gradients another small hotspot appears in a new location close to the equator, and there is also a larger hot spot closer to the iris, which appears just before the cavity quench. We also see a spike in the x-ray emissions from the cavity just before the final quench at 4 K. Although we are not certain what the cause of

Recoating a damaged Nb<sub>3</sub>Sn cavity can have a major impact on its performance. The recoating process was able to mostly recover both the maximum accelerating gradient and quality factor of the cavity. The degradation in quality factor seen at 2K at high fields seen in figure 1, C is caused by a quench at 16 MV m<sup>-1</sup> resulting in trapped flux. However, the cavity was able to reach a higher gradient of 19 MV m<sup>-1</sup> after the initial quench. This is close to the

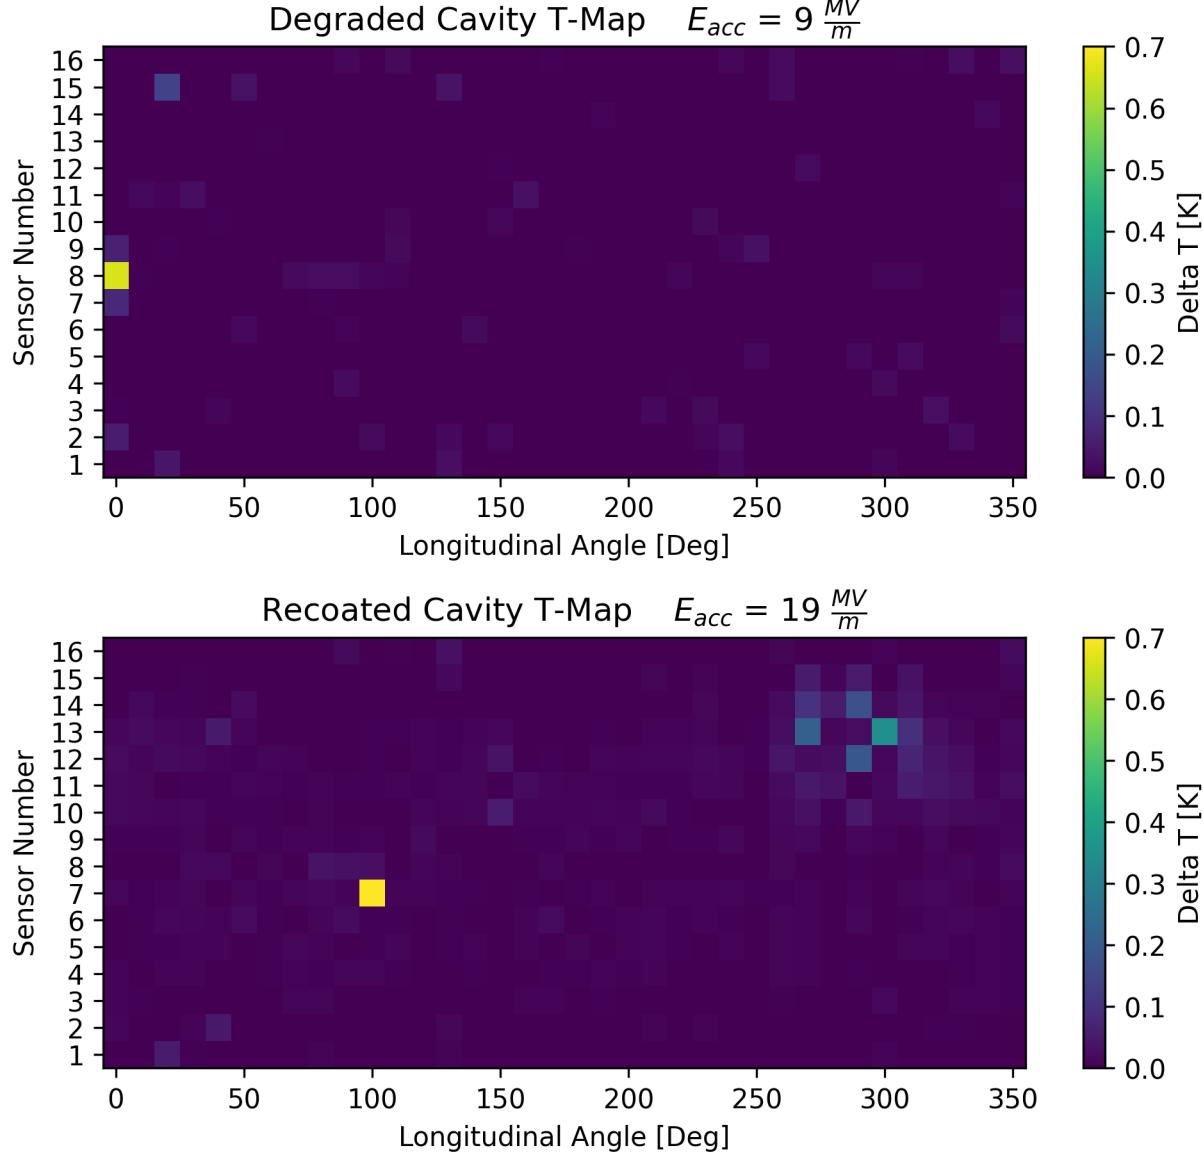
FIG. 2. Temperature maps of a cavity's surface prior to quench as measured before (top) and after (bottom) the recoating is applied. The temperature maps are measured at 2 K. The sensor number corresponds to different regions of the cavity. Sensor 1 and 16 are near the top and bottom iris while sensor 8 is on the equator. The quality factor and accelerating gradient of the cavity during the measurement is shown by the red star in figure 1. The temperature of the hot spot near the equator of the recoated cavity exceeds the maximum value of the color bar and achieves a maximum value at 3 K

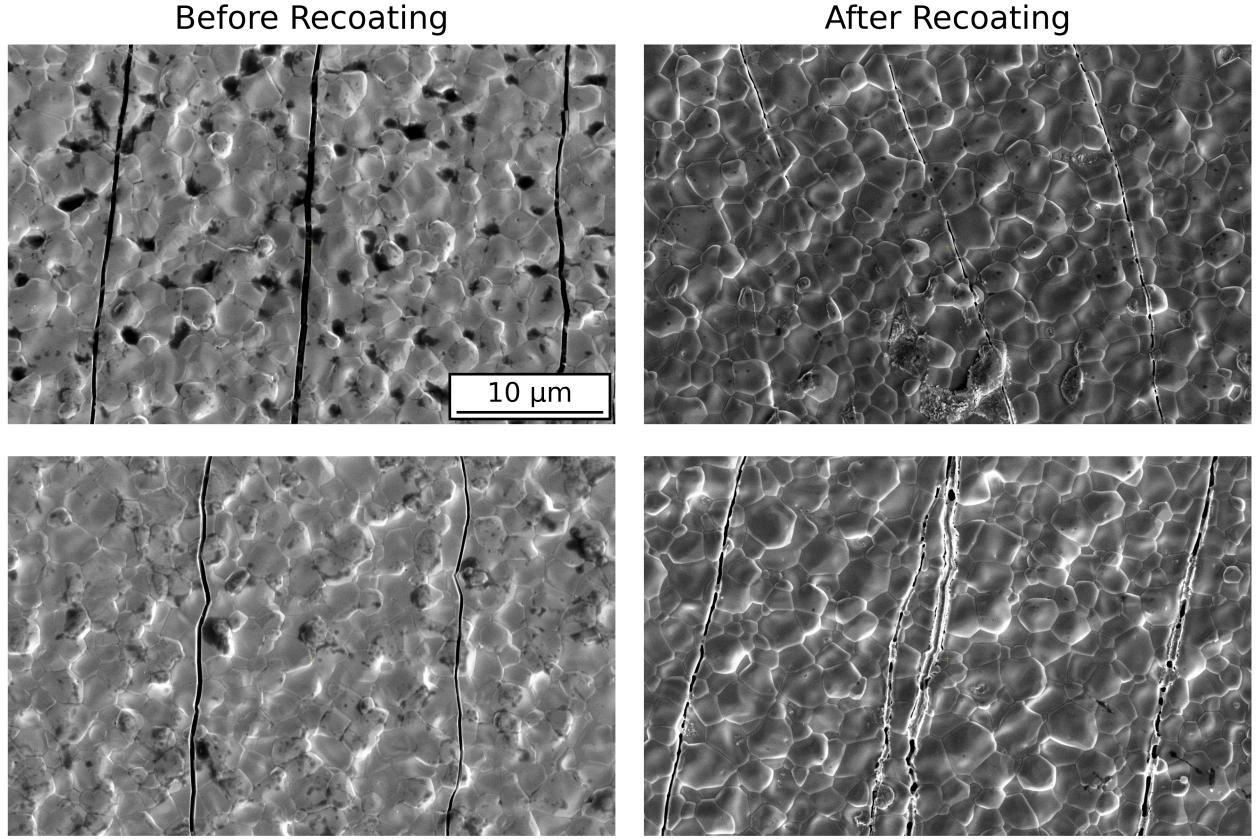
FIG. 3. This figure shows micrographs of elongated Nb<sub>3</sub>Sn coated wires. The left side shows the samples before treatment with recoating and the right side shows the samples after recoating. After the recoating treatment the cracks appear to be partially filled with new Nb<sub>3</sub>Sn.

The elongation of the wires causes intragranular cracks to form perpendicular to the direction of applied stress as shown in figure 3. A cross section of the sample, as seen in figure 4, show that the cracks penetrate all the way through the Nb<sub>3</sub>Sn film and stop at the Nb substrate giving the crack a rectangular profile with sharp 90° edges. These cracks can be considered an extreme example of the cracks we expect to see in Nb<sub>3</sub>Sn cavities since the wires are heavily deformed in the plastic regime. In contrast, cracks formed in Nb<sub>3</sub>Sn cavities are formed during elastic deformation of the niobium substrate or only slight plastic deformation which does not significantly impact the geometry of the cavity. Therefore, we expect cracks in degraded cavities to be smaller than what is seen in this study.

After the recoating, the cracks appear to be partially healed. Figure 3 shows some of the cracks being partially filled in with new material creating a discontinuous crack. Additionally, the sharp edges of the untreated cracks have been smoothed out due to deposition of new material. The cross section of the sample in figure 4 shows that new Nb<sub>3</sub>Sn is created both within the crack and at the exposed Nb substrate at the base of the crack. Since the cracks produced by elongating the wires are larger than what we expect in Nb<sub>3</sub>Sn cavities, it is likely that the cracks formed in cavities can be completely healed using this recoating recipe. It may also be possible to increase the recoating duration or temperature to allow larger cracks to heal completely as well.

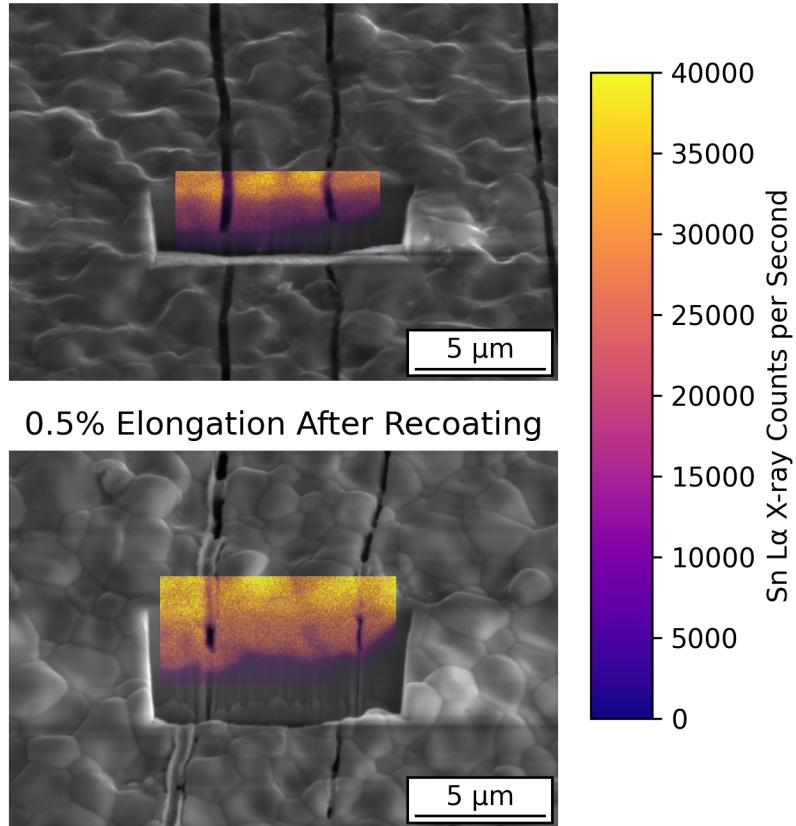
0.5% Elongation Before Recoating

FIG. 4. The cross section of the film cracks is imaged using FIB/SEM before and after recoating. The Sn content of the cracks is measured qualitatively using Energy dispersive X-ray Spectroscopy (EDS). We find that there is new Nb<sub>3</sub>Sn material both in the crack and in the substrate at the base of the crack. There is no evidence of Sn rich phases in the crack.

The healing mechanism of the recoating is heretofore unknown. From our observations it appears that the healing occurs via two different processes, the creation of new Nb<sub>3</sub>Sn within the crack and the creation of Nb<sub>3</sub>Sn at the exposed Nb substrate at the base of the crack. This phenomenon has been studied in other thin film system and is known as self healing [18]. Here we propose two mechanisms to explain the self healing observed in our experiments.
