# Healing Gradient Degradation in Nb<sub>3</sub>Sn SRF Cavities Using a Recoating Method

Despite having advantageous superconducting properties, Nb<sub>3</sub>Sn superconducting radiofrequency (SRF) cavities still have practical challenges compared to Nb SRF cavities due to the brittle nature of Nb<sub>3</sub>Sn. Performance degradation can occur when a Nb<sub>3</sub>Sn SRF cavity experiences mechanical stresses such as during handling and tuning of the cavity. In this study, we present a potential treatment for SRF cavities that have experienced stress induced performance degradation that involves a recoating procedure. The degraded cavity is coated with a small amount of Sn using a single step vapor-diffusion methodology. Using this approach we can recover a significant portion of the lost performance of a Nb<sub>3</sub>Sn SRF cavity.

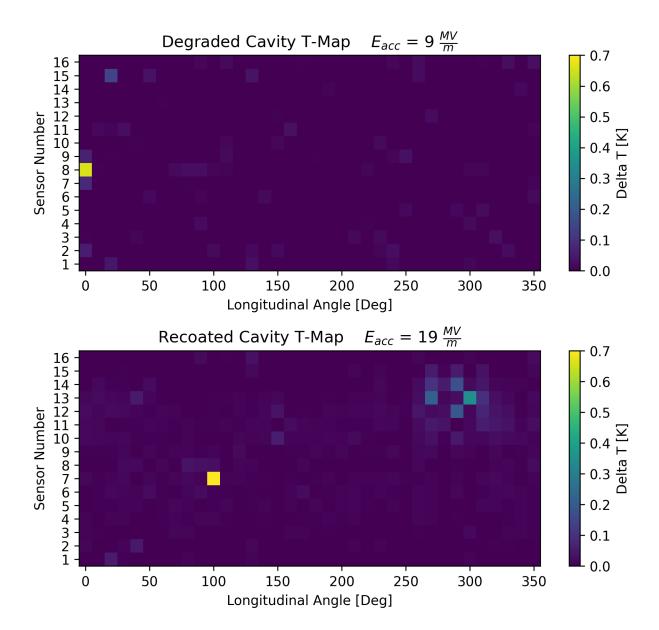
After initially coating the cavity it achieves a peak accelerating field of  $24\,\mathrm{MV\,m^{-1}}$  and a maximum Q of  $2\times10^{10}$  at  $4\,\mathrm{K}$ . The peak accelerating gradient after degradation is  $8\,\mathrm{MV\,m^{-1}}$  and a maximum Q of  $1\times10^{10}$  at  $4\,\mathrm{K}$ . The cavity displays a decrease in the quality factor at around  $6\,\mathrm{MV\,m^{-1}}$  before a quench. A similar decrease in the quality factor is observed for other cavities affected by performance degradation[4, 5] and in Nb<sub>3</sub>Sn cavities treated with centrifugal barrel polishing[18]. Temperature mapping is displayed in figure 2 and is utilized to locate the quench source responsible for the performance degradation. A single hot spot on the equator of the cavity is present. Visual inspection of the cavity did not display visible defects near the quench location.

After the recoating procedure is applied the cavity's performance increases. The peak accelerating gradient increases to  $19\,\mathrm{MV}\,\mathrm{m}^{-1}$  and the quality factor is  $1\times10^{10}$  at 4 K. Temperature mapping of the cavity after recoating demonstrates that the initial hot spot is healed with no detectable heating from that area. This indicates that the defect causing the performance degradation is repaired by recoating. At higher gradients another small hotspot appears in a new location close to the equator. Additionally, there is also a larger hot spot closer to the iris, which appears just before the cavity quench. This additional hotspot is accompanied by a large increase in x-ray emissions, figure 1, which may indicate that heating is caused by multipacting. Higher accelerating gradients are not attainable even after 5 h of processing. The cavity did not display any signs of multipacting during the 2 K measurement.

FIG. 2. Temperature maps of a cavity's surface prior to quench as measured before (top) and after (bottom) the recoating is applied. The temperature of the hot spot near the equator of the recoated cavity exceeds the maximum value of the color bar and achieves a maximum value at 3 K

Using a low temperature (1000 °C), short duration (1 h) Sn recoating process, we are able to heal a degraded Nb<sub>3</sub>Sn cavity that suffered damage during transportation. The recoating process improved the maximum gradient of the cavity from  $8 \,\mathrm{MV} \,\mathrm{m}^{-1}$  to  $19 \,\mathrm{MV} \,\mathrm{m}^{-1}$ , which is close to the initial performance of the cavity of  $24 \,\mathrm{MV} \,\mathrm{m}^{-1}$ . Temperature mapping measurements of the cavity demonstrate that a single hot spot on the equator of the cavity was responsible for the performance degradation. After the recoating process this defect becomes healed leading to

less heating and a higher maximum electric field gradient. Ultimately, the performance is limited by a second hot spot.

To heal the cracks causing the performance degradation, we apply a recoating procedure. During this recoating procedure, the cavity was heated to 1000 °C and exposed to Sn vapor for 1 h. Sn vapor was provided by 0.85 g of Sn heated to 1250 °C. The reasoning behind these parameters is that only a small amount of Sn is necessary to fill the microscopic cracks in the film. Applying too much Sn causes the film to become too thick and negatively impacts the surface roughness of the film. During the coating process only a small fraction of the Sn evaporated leaving behind a large amount of the initial Sn still in the crucible.
