Healing Gradient Degradation in Nb₃Sn SRF Cavities Using a Recoating Method

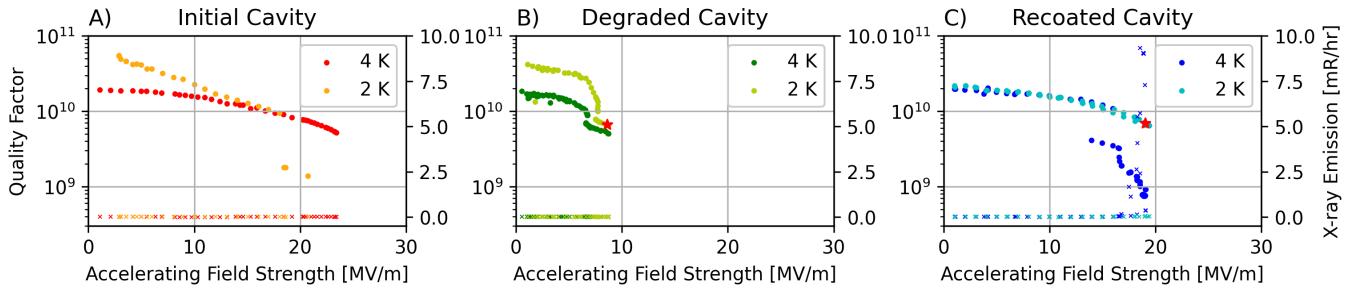
FIG. 1. The quality factor, indicated by dots, and X-ray emissions, indicated by x, versus the accelerating gradient of the cavity after the initial coating (A), after the degradation (B), and after the recoating (C). The quality factor and accelerating gradient of the T-maps in figure 2 are indicated by a red star.

After initially coating the cavity it achieves a peak accelerating field of 24 MV m⁻¹ and a maximum Q of 2×10^{10} at 4 K. The peak accelerating gradient after degradation is 8 MV m⁻¹ and a maximum Q of 2×10^{10} at 4 K. The cavity displays a decrease in the quality factor at around 6 MV m⁻¹ before a quench. A similar decrease in the quality factor is observed for other cavities affected by performance degradation[4, 5] and in Nb₃Sn cavities treated with centrifugal barrel polishing[18]. Temperature mapping is displayed in figure 2 and is utilized to locate the quench source responsible for the performance degradation. A single hot spot on the equator of the cavity is present. Visual inspection of the cavity did not display visible defects near the quench location.

After the recoating procedure is applied the cavity's performance increases. The cavity experiences an initial quench at 16 MV m⁻¹ resulting in trapped flux which decreases the quality factor. The cavity is still able to reach a peak accelerating gradient of 19 MV m⁻¹. At 2 K the cavity does not quench until reaching the maximum gradient of 19 MV m⁻¹. The quality factor after recoating is 2×10^{10} at 4 K and the Q slope seen in the degraded cavity is not present. Temperature mapping of the cavity after recoating demonstrates that the initial hot spot is healed with no detectable heating from that area. This indicates that the defect causing the performance degradation is repaired by recoating. At higher gradients another small hotspot appears in a new location close to the equator. Additionally, there is also a larger hot spot closer to the iris, which appears just before the cavity quench. This additional hotspot is accompanied by a large increase in x-ray emissions, figure 1, which may indicate that heating is

factor seen at 2K at high fields seen in figure 1, C does not seem to be inherently caused by the recoating process but instead caused by multipacting induced quench which this cavity has been reported to experience even before the recoating.

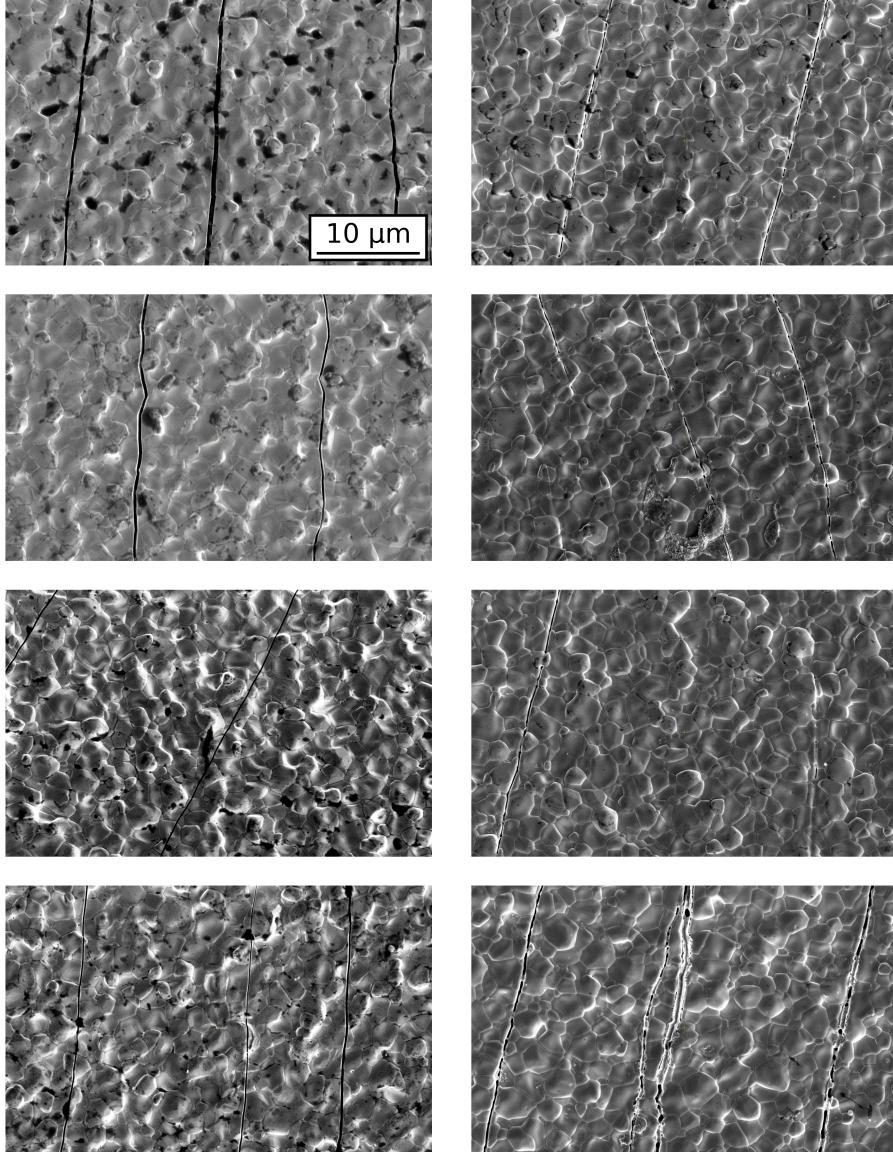
FIG. 3. This figure shows micrographs of Nb₃Sn coated wires elongated to, from top to bottom, 0.1%, 0.2%, 0.3%, and 0.5% elongation. The left side shows the samples before treatment with recoating and the right side shows the samples after recoating. After the recoating treatment the cracks appear to be partially filled with new Nb₃Sn.

The elongation of the wires causes intragranular cracks to form perpendicular to the direction of applied stress as shown in figure 3. A cross section of the sample, as seen in figure 4, show that the cracks penetrate all the way through the Nb₃Sn film and stop at the Nb substrate giving the crack a rectangular profile with sharp 90° edges. After the recoating, the cracks appear to be partially healed. Figure 3 shows some of the cracks being partially filled in with new material creating a discontinuous crack. Additionally, the sharp edges of the untreated cracks have been smoothed out due to deposition of new material. The cross section of the sample in figure 4 shows that new Nb₃Sn is created both within the crack and at the exposed Nb substrate at the base of the crack.

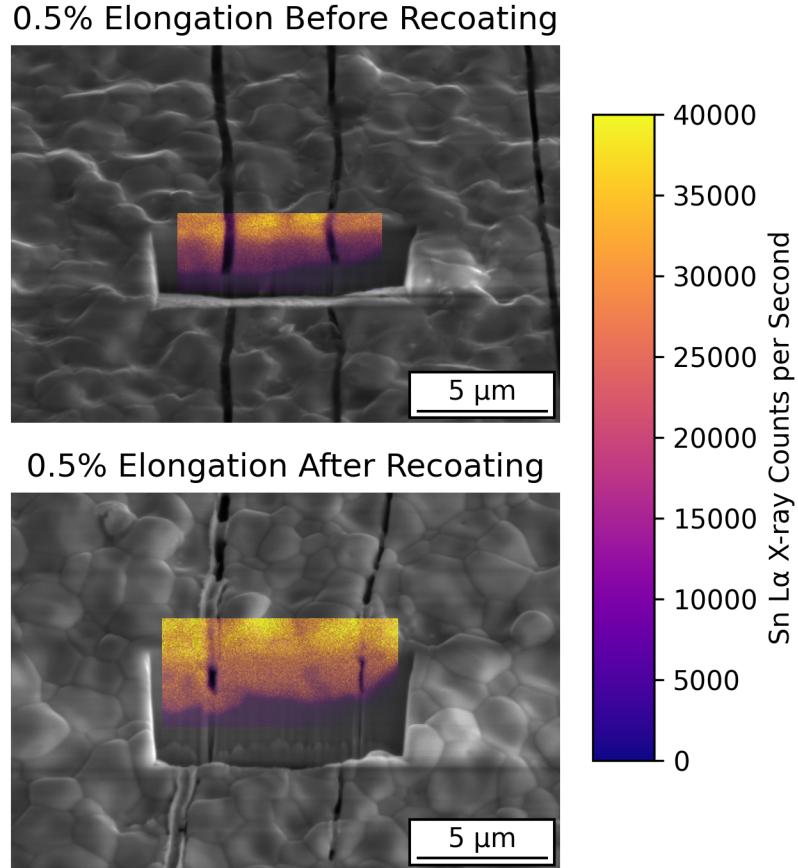
FIG. 4. The cross section of the film cracks is imaged using FIB/SEM before and after recoating. The Sn content of the cracks is measured qualitatively using Energy dispersive X-ray Spectroscopy (EDS). We find that there is new Nb₃Sn material both in the crack and in the substrate at the base of the crack. There is no evidence of Sn rich phases in the crack.
