Healing Gradient Degradation in Nb₃Sn SRF Cavities Using a Recoating Method

Despite having advantageous superconducting properties, Nb₃Sn SRF cavities still have practical challenges compared to Nb SRF cavities due to the brittle nature of Nb₃Sn. Performance degradation can occur when a Nb₃Sn experiences mechanical stresses such as during handling and tuning of the cavity. In this study, we present a potential treatment for cavities that have experienced stress induced performance degradation that involves a recoating procedure. The degraded cavity is coated with a small amount of Sn using a single step vapor-diffusion method. Using this procedure we are able to recover a significant portion of the lost performance of a Nb₃Sn SRF cavity.

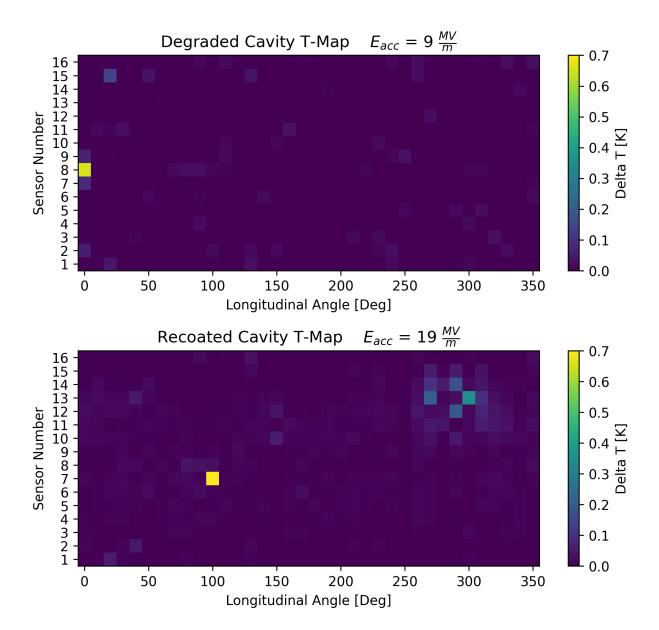
After the initial coating the cavity reached a peak accelerating field of $24\,\mathrm{MV\,m^{-1}}$ and maximum Q of 2×10^{10} at $4\,\mathrm{K}$. The peak accelerating gradient after the degradation was $8\,\mathrm{MV\,m^{-1}}$ and maximum Q of 1×10^{10} at $4\,\mathrm{K}$. The cavity shows a decrease in quality factor around $6\,\mathrm{MV\,m^{-1}}$ before quench. A similar drop in quality factor was seen in other cavities affected by performance degradation[4, 5] and in Nb₃Sn cavities treated with centrifugal barrel polishing[18]. Temperature mapping as shown in figure 2 was used to locate the quench source responsible for the performance degradation. A single hot spot on the equator of the cavity was discovered. Visual inspection of the cavity showed no visible defects near the quench location.

After the recoating was applied the cavity performance increased. The peak accelerating gradient increased to $19\,\mathrm{MV}\,\mathrm{m}^{-1}$ and the quality factor was 1×10^{10} at $4\,\mathrm{K}$. Temperature mapping of the cavity after the recoating shows that the initial hot spot has been healed with no detectable heating from that area. This indicates that the defect causing the performance degradation has been repaired by the recoating. At higher gradients another small hotspot appears in a new location close to the equator. Additionally, there is also a much larger hot spot closer to the iris which appears just before the cavity quench. This additional hotspot is accompanied by a large increase in x-ray emissions as shown in figure 1, which could indicate the heating is caused by multipacting. However, higher accelerating gradients were not attainable even after 5 h of processing. The cavity also did not show any signs of multipacting during the $2\,\mathrm{K}$ measurement.

FIG. 2. Temperature maps of the cavity surface just before quench as measured before (top) and after (bottom) the recoating was applied. The temperature of the hot spot near the equator of the recoated cavity exceeds the maximum value of the color bar and reached a maximum value of $3\,\mathrm{K}$

In an attempt to heal the cracks causing the performance degradation, we apply a recoating procedure. During this recoating procedure, the cavity was heated to 1000 °C and exposed to Sn vapor for 1 h. Sn vapor was provided by 0.85 g of Sn heated to 1250 °C. The theory behind these parameters is that only a small amount of Sn is necessary to fill in any microscopic cracks in the film, and applying too much Sn would cause the film to become too thick or could negatively impact the surface roughness of the film. During the coating only a small portion of the Sn evaporated leaving behind a large amount of the initial Sn still in the crucible.
