Healing Gradient Degradation in Nb₃Sn SRF Cavities Using a Recoating Method

Despite having advantageous superconducting properties, Nb₃Sn SRF cavities still have practical challenges compared to Nb SRF cavities due to the brittle nature of Nb₃Sn. Performance degradation can occur when a Nb₃Sn experiences mechanical stresses such as during handling and tuning of the cavity. In this study, we present a potential treatment for cavities that have experienced stress induced performance degradation that involves a recoating procedure. The degraded cavity is coated with a small amount of Sn using a single step vapor-diffusion method. Using this procedure we are able to recover a significant portion of the lost performance of a Nb₃Sn SRF cavity.

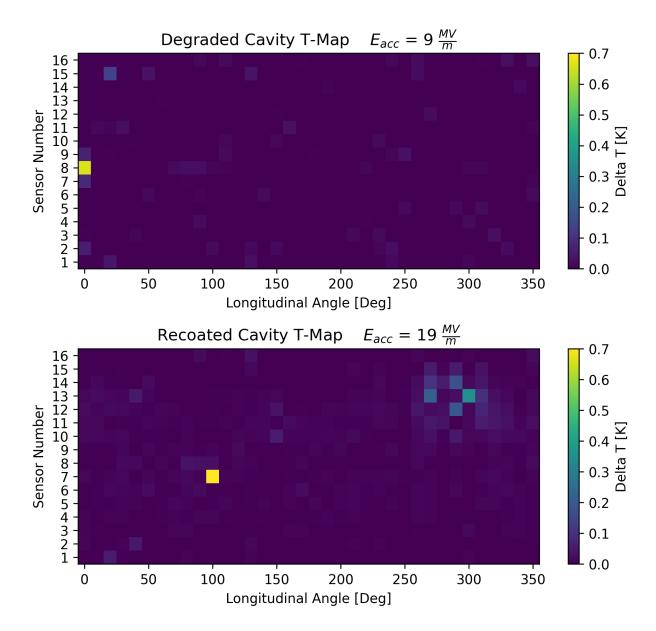
After the initial coating the cavity reached a peak accelerating field of $24\,\mathrm{MV\,m^{-1}}$ and maximum Q of 2×10^{10} at $4\,\mathrm{K}$. After the cavity was damaged the performance was degraded, the cavity only reached $8\,\mathrm{MV\,m^{-1}}$. The cavity shows a decrease in quality factor around $6\,\mathrm{MV\,m^{-1}}$ before quench. Temperature mapping as shown in figure 2 was used to locate the quench source responsible for the performance degradation. A single hot spot on the equator of the cavity was discovered. Visual inspection of the cavity showed no visible defects near the quench location.

After the recoating was applied the cavity performance increased. The peak accelerating gradient increased to $19\,\mathrm{MV}\,\mathrm{m}^{-1}$ and the quality factor was 1×10^{10} at $4\,\mathrm{K}$. Temperature mapping of the cavity after the recoating shows that a similar small hotspot exists close to the equator, but the hot spot is activated at higher accelerating gradients. This indicates that the source of the degradation has been at least partially repaired by the recoating. In addition to the small hot spot near the equator, there is also a much larger hot spot closer to the iris which appears just before the cavity quench. This additional hotspot is accompanied by a large increase in x-ray emissions, which could indicate the heating is caused by multipacting, but higher accelerating gradients were not attainable even after 5 h of processing. The cavity also did not show any signs of multipacting during the $2\,\mathrm{K}$ measurement.

FIG. 2. Temperature maps of the cavity surface just before quench as measured before (top) and after (bottom) the recoating was applied. The hot spot near the equator of the recoated cavity is plotted off-scale and reached a maximum value of $3\,\mathrm{K}$

In an attempt to heal the cracks causing the performance degradation, we apply a recoating procedure. During this recoating procedure, the cavity was heated to 1000 °C and exposed to Sn vapor for 1 h. Sn vapor was provided by 0.85 g of Sn heated to 1250 °C. The theory behind these parameters is that only a small amount of Sn is necessary to fill in any microscopic cracks in the film, and applying too much Sn would cause the film to become too thick or could negatively impact the surface roughness of the film. During the coating only a small portion of the Sn evaporated leaving behind a large amount of the initial Sn still in the crucible.
