Healing Gradient Degradation in Nb₃Sn SRF Cavities Using a Recoating Method

Despite having advantageous superconducting properties, Nb₃Sn SRF cavities still have practical challenges compared to Nb SRF cavities due to the brittle nature of Nb₃Sn. Performance degradation can occur when a Nb₃Sn experiences mechanical stresses such as during handling and tuning of the cavity. In this study, we present a potential treatment for cavities that have experienced stress induced performance degradation that involves a recoating procedure. The degraded cavity is coated with a small amount of Sn using a single step vapor-diffusion method. Using this procedure we are able to recover a significant portion of the lost performance of a Nb₃Sn SRF cavity.

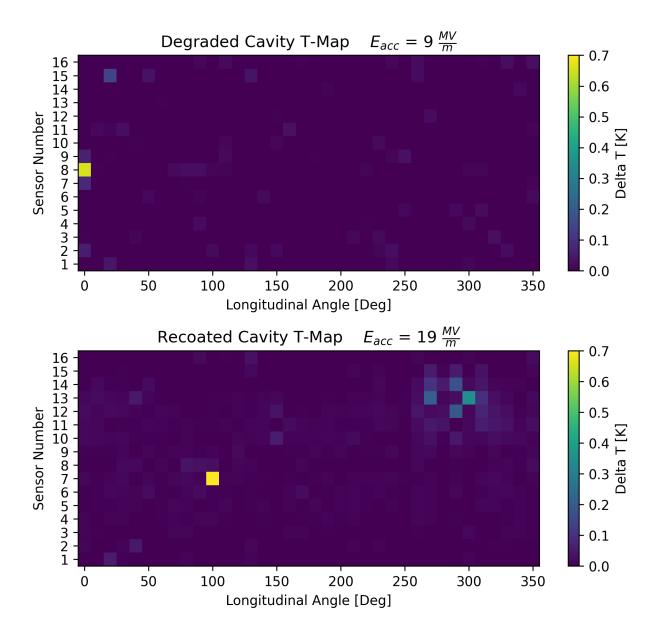
After the initial coating the cavity reached a peak accelerating field of $24\,\mathrm{MV\,m^{-1}}$ and maximum Q of 2×10^{10} at $4\,\mathrm{K}$. The peak accelerating gradient after the degradation was $8\,\mathrm{MV\,m^{-1}}$ and maximum Q of 1×10^{10} at $4\,\mathrm{K}$. The cavity shows a decrease in quality factor around $6\,\mathrm{MV\,m^{-1}}$ before quench. A similar drop in quality factor was seen in other cavities affected by performance degradation[4, 5] and in Nb₃Sn cavities treated with centrifugal barrel polishing[18]. Temperature mapping as shown in figure 2 was used to locate the quench source responsible for the performance degradation. A single hot spot on the equator of the cavity was discovered. Visual inspection of the cavity showed no visible defects near the quench location.

After the recoating was applied the cavity performance increased. The peak accelerating gradient increased to $19\,\mathrm{MV}\,\mathrm{m}^{-1}$ and the quality factor was 1×10^{10} at $4\,\mathrm{K}$. Temperature mapping of the cavity after the recoating shows that the initial hot spot has been healed with no detectable heating from that area. This indicates that the defect causing the performance degradation has been repaired by the recoating. At higher gradients another small hotspot appears in a new location close to the equator. Additionally, there is also a much larger hot spot closer to the iris which appears just before the cavity quench. This additional hotspot is accompanied by a large increase in x-ray emissions as shown in figure 1, which could indicate the heating is caused by multipacting. However, higher accelerating gradients were not attainable even after 5 h of processing. The cavity also did not show any signs of multipacting during the $2\,\mathrm{K}$ measurement.

FIG. 2. Temperature maps of the cavity surface just before quench as measured before (top) and after (bottom) the recoating was applied. The hot spot near the equator of the recoated cavity is plotted off-scale and reached a maximum value of $3\,\mathrm{K}$

In an attempt to heal the cracks causing the performance degradation, we apply a recoating procedure. During this recoating procedure, the cavity was heated to 1000 °C and exposed to Sn vapor for 1 h. Sn vapor was provided by 0.85 g of Sn heated to 1250 °C. The theory behind these parameters is that only a small amount of Sn is necessary to fill in any microscopic cracks in the film, and applying too much Sn would cause the film to become too thick or could negatively impact the surface roughness of the film. During the coating only a small portion of the Sn evaporated leaving behind a large amount of the initial Sn still in the crucible.
