Kerman Space Systems

125 cm fairings and payload bays

Test report: test#4

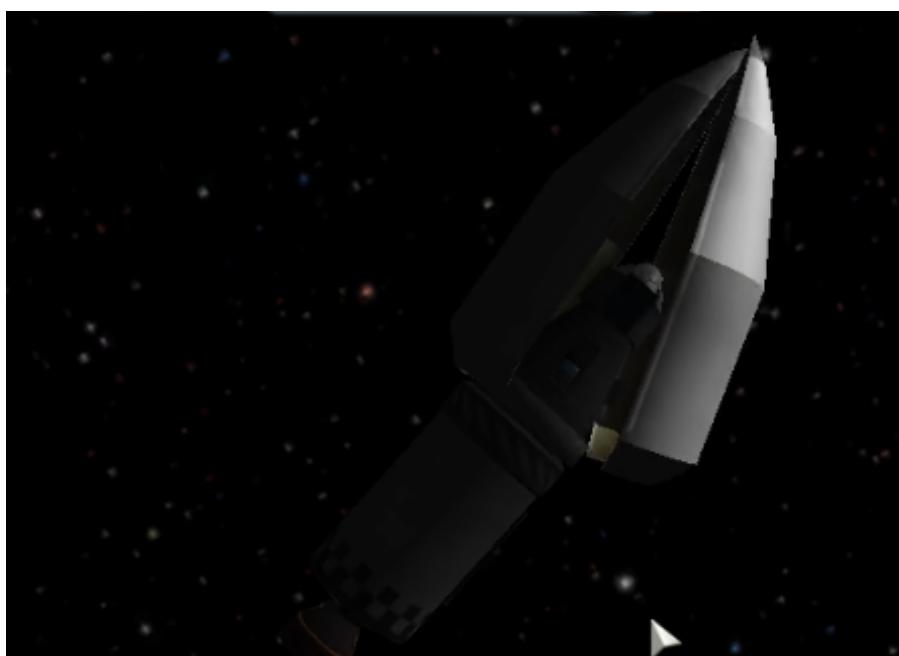
Two part B fairings failed to detach when deployed if the launch vehicle is in service module configuration.

Fairing gets stuck on heat shield or other capsule parts. Fairing ejection mechanism on 2 section B type fairings tend to propel the fairing sections forward. With a payload bay present, nothing obstructs this forward movement. The fairing pieces then strike the lower bay decoupler, which propel the section outwards.

When a capsule is directly connected to the rocket stage, this forward movement is impeded. The fairing sections either get stuck between the heat shield and fairing base, or impacts solar panels, RCS pods or other external features. The forward movement is impeded because the capsule has a full 125 cm diameter at its rear. The fairing either destroys the outer features, or gets stuck in them, preventing separation.

This problem is exacerbated on type B fairings, as the outward taper at the bottom of the fairing is steeper than on types A and C (which use an identical fairing base).

Illustration 1: Type B1/2 fairing locked onto heat shield shroud

Several parameters were modified to test the effects on the deployment dynamics. Increasing the ejection force caused the outward force to increase somewhat, altering the proportion of lateral to forward motion and improving clearance. Although this corrected the issue when the capsule's heat shield was connected using a shroud, the increase in ejection force to 150% did not correct the issue when the capsule was directly connected to the fairing base.

The definitive solution involved a change in the number of sections from 2 to 4. A two section fairing creates a 180 degree half ring in its base on deployment, which snags the capsule's heat shield and external features. A four section fairing creates four 90 degree sections, which tend to move outwards easily and are not as capable of snagging the capsule's external features. The smaller sections also increase the range of directions where the fairing parts can move without locking onto the heat shield, improving the chances of successful separation.
