| | <b>DOCUMENT TITLE:</b><br>CAPA Report Form | <b>Revision:</b> A |

**CAPA #:001-2025**

**SECTION I: INITIATION OF CAPA PROPOSAL**

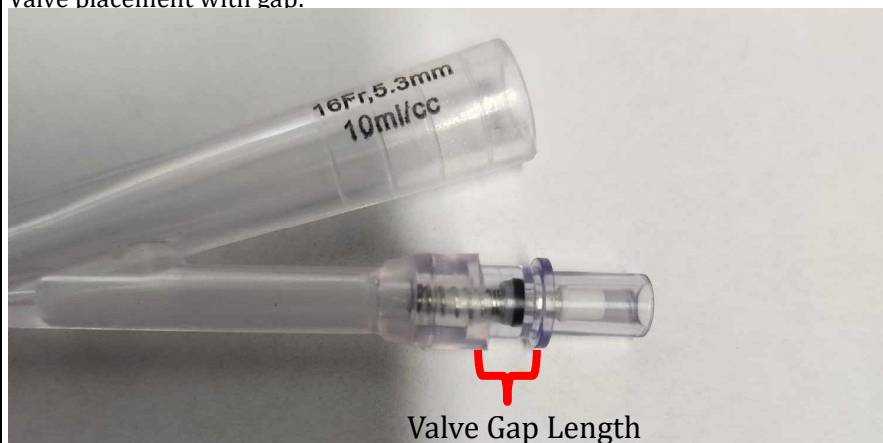
Valve placement with gap:

On 5 occasions over a period of 3 years, it was reported to Silq that the port allowing connection of the saline syringe to the catheter became unseated from the catheter when the syringe was being connected. The check valve on the catheter is not always seated completely flush against the catheter tubing. The gap between the check valve and tubing varies from sample to sample. See image below of a catheter sample with a gap between the valve and the tubing.

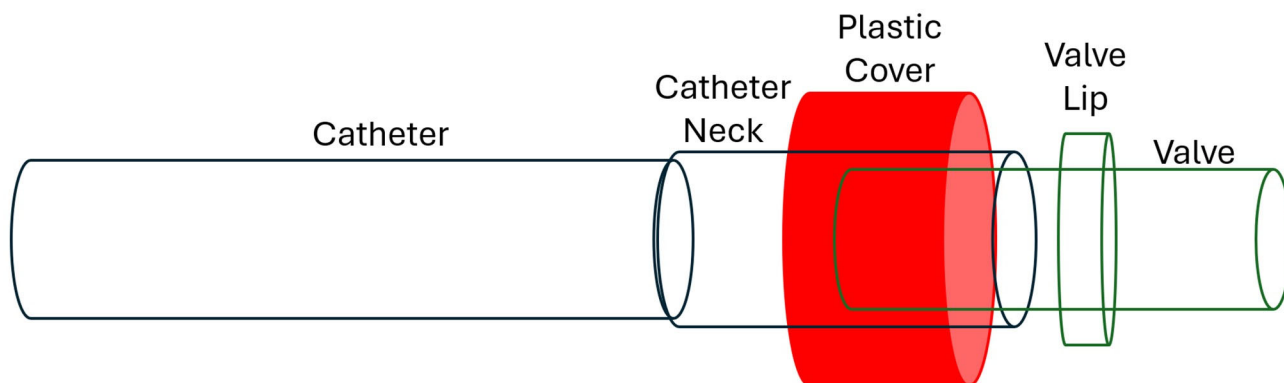
Silq researchers continued to evaluate the 100 randomly sampled catheters and established criteria that could potentially be used for a non-destructive evaluation of the existing inventory to identify any units where this issue may occur. The proposed rejection criteria were as follows:

- 1) The check valve is not securely and properly seated to the catheter neck connector.
- 2) The maximum length from the plastic cover to the end of the valve should be less than 26mm.

| OWNER | # | CORRECTIVE / PREVENTIVE ACTION: | RESPONSIBILITY: | ESTIMATED DATE ACTION WILL BE IMPLEMENTED: |
|---|---|---|---|---|
| | 1 | 100% visual/dimensional inspection of the SLQ-211610SPT finished goods | Ethan Rao | 18 Nov 2025 |
| | 2 | Revision of device drawings to reflect updated specifications for conformance | Ethan Rao | 18 Jan 2026 |
