Damage Detection and Damage Localization in Bridges with Low-Density Instrumentations Using the Wave-Method: Application to a Shake-Table Tested Bridge

Mehran Rahmani, Xintong Ji, and Sovann Reach Kiet. "Damage Detection and Damage Localization in Bridges with Low-Density Instrumentations Using the Wave-Method: Application to a Shake-Table Tested Bridge" *Mineta Transportation Institute Publications* (2022). <https://doi.org/10.31979/mti.2022.2033>

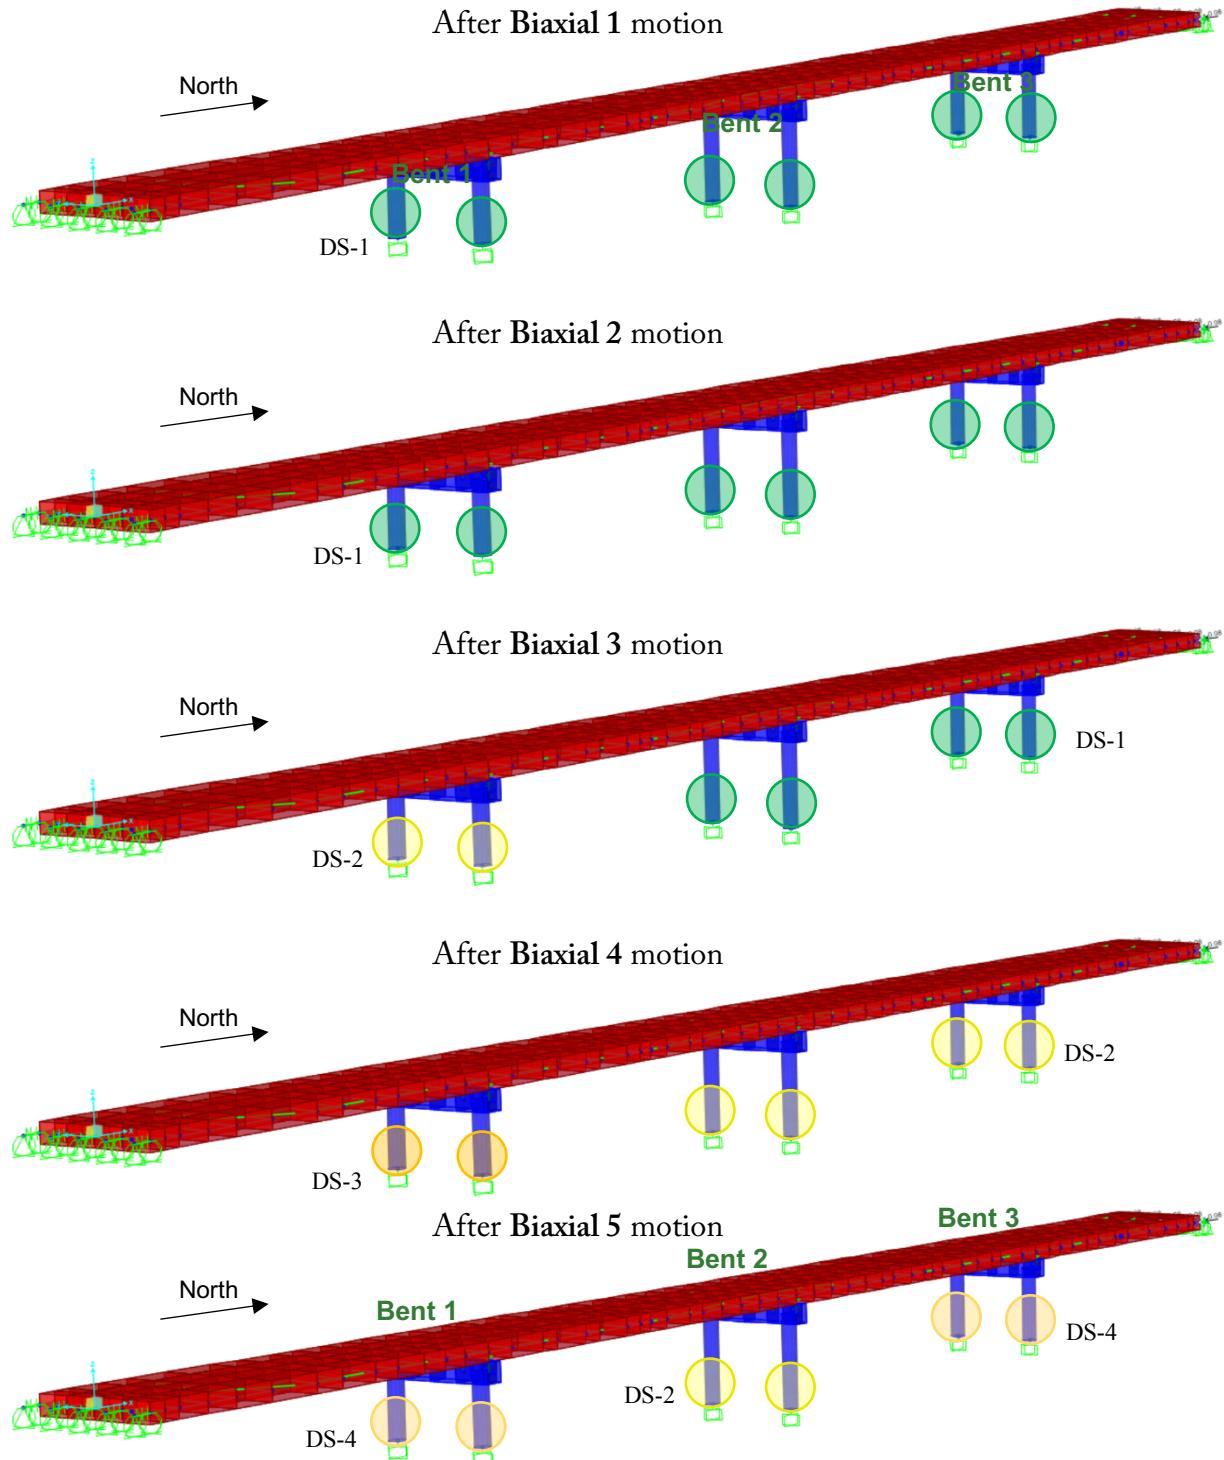
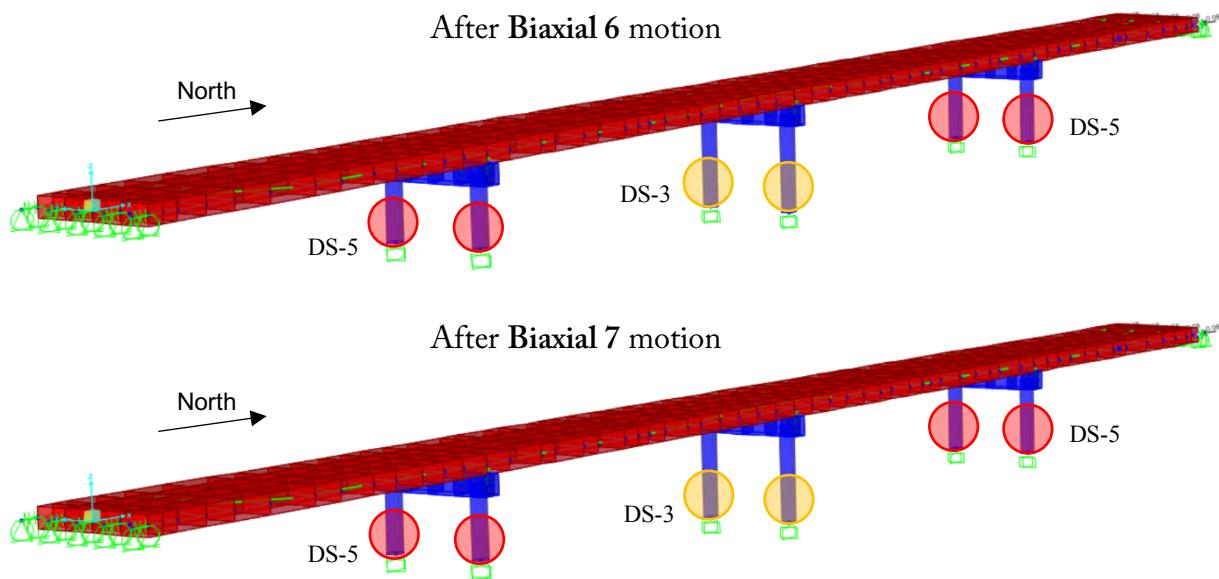
- DS-1: Minor flexural cracks
- DS-2: First spalling and shear cracks
- DS-3: Extensive cracks and spalling
- DS-4: Visible lateral and longitudinal bars
- DS-5: Imminent failure

Figure 4.30. Damage States Observed at the Three Bents of the Bridge After Each Biaxial Motions According to On-Site Damage Inspection Report by Nelson et al. (2007). The 3D Rendering ss Schematic

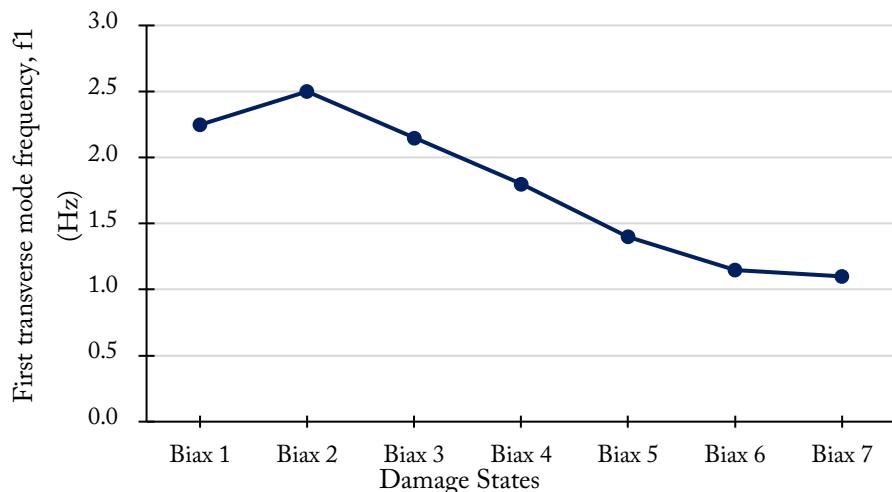
motion. This is consistent with observed increase in $f_{l, app}$ as shown in Figure 4.32. The source of this slight increase in stiffness is unknown, but the change is consistently captured by both parameters. Here, we consider this increase as no additional damage to the bents.

10. Figure 4.33 also shows reducing trends in the first apparent transverse mode of vibration of the bridge ($f_{t,app}$). The trends reveal significant reduction in the modal frequencies after the fourth shaking (biaxial 4). This is consistent with the detected reduction in c_s at both bents 1 and 3. The overall degrees of reductions in frequencies and c_s are comparable. However, the wave method is superior in its ability to localize the damage at bents 1 and 3.

Figure 4.32. First Transverse Mode Frequency f_1 from Actual Tested Bridge

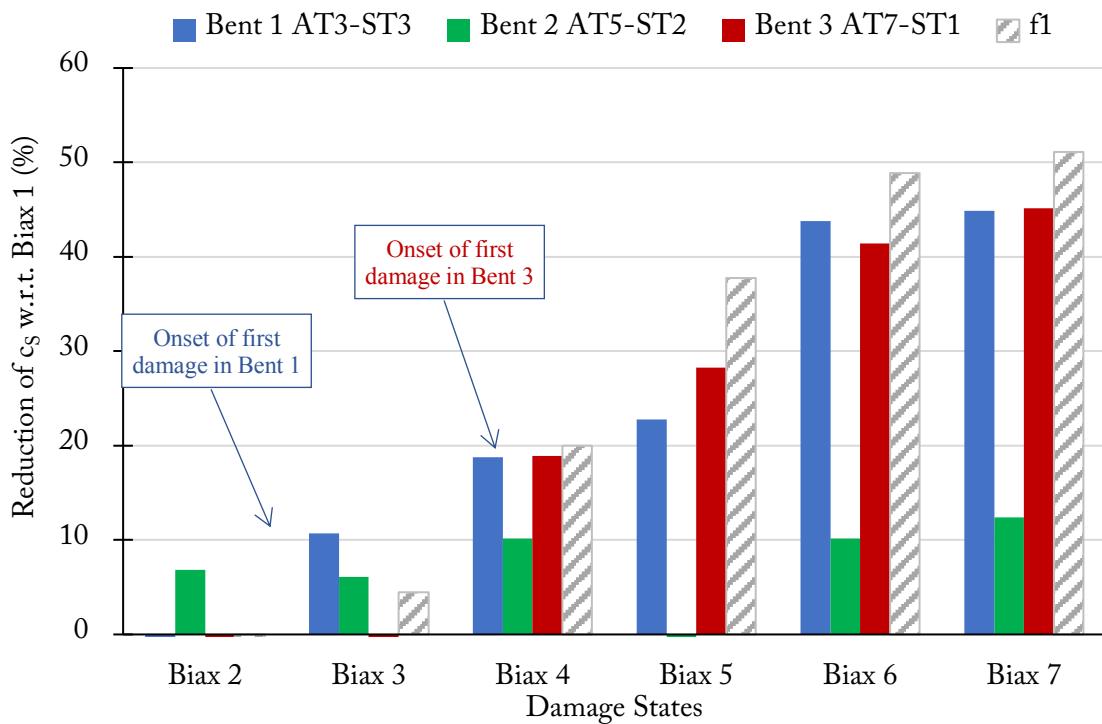
Note: First Transverse Mode's Apparent Frequency is Shown for Comparison

Figure 4.33. Reduction of c_s Three Bents of Actual Bridge

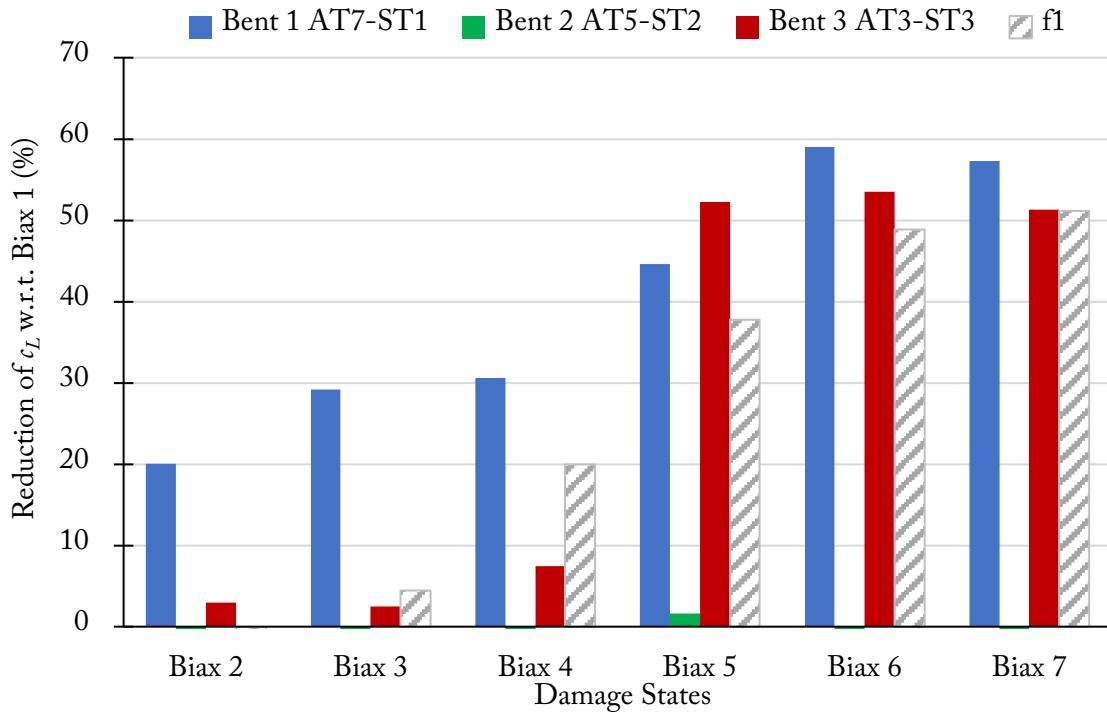
11. As discussed in the results section of this study, due to the predominantly shear-like movement of the deck and the large gravity loads on the piers, the longitudinal (i.e., compression) wave velocity in the piers, c_L , has relatively large and volatile values and is not a reliable damage-sensitive parameter for this type of bridge structure. Figure 4.34 shows the percent reduction in the c_L . The changes are somewhat inconsistent with the actual damage in bents 1 and 3 during smaller motions. For example, the c_L reductions overestimated damage in bent 1 during biaxials 1 through 3, while it underestimated damage in bent 3 during the biaxial 4 motion. Nevertheless, the overall reduction in c_L remains consistent with overall damage in the piers and reductions in the modal frequency. Figure 4.34 shows that even c_L could show the location of the most severe damages at bents 1 and 3 during larger biaxial motions.

Note: The change is volatile and not considered as a reliable damage indicator for smaller shakings.

Figure 4.34. Reduction of c_L for Three Bents of Actual Bridge. The Change is Volatile and Not Considered a Reliable Damage Indicator for Smaller Shakings

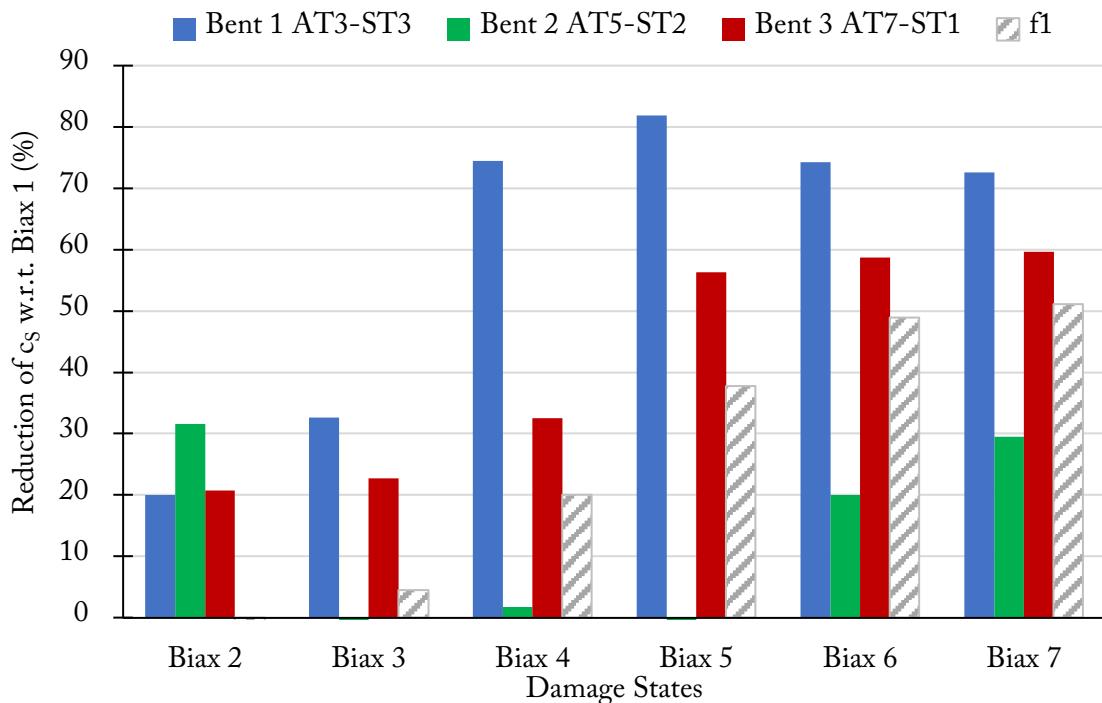
2. Results for bents 1 and 3 are consistent with the hinge formation sequence in the FEM. Bent 1 was damaged first, followed by bent 3 from biaxials 3 to 7. At biaxial 4, the reduction in c_S for bent 1 is very large relative to bent 3. Investigating the hinge hysteresis results shows a reasonable correlation between the nonlinearity in the columns and the observed reduction in c_S .

Figure 4.35. Reduction of c_s for Three Bents for FEM Response

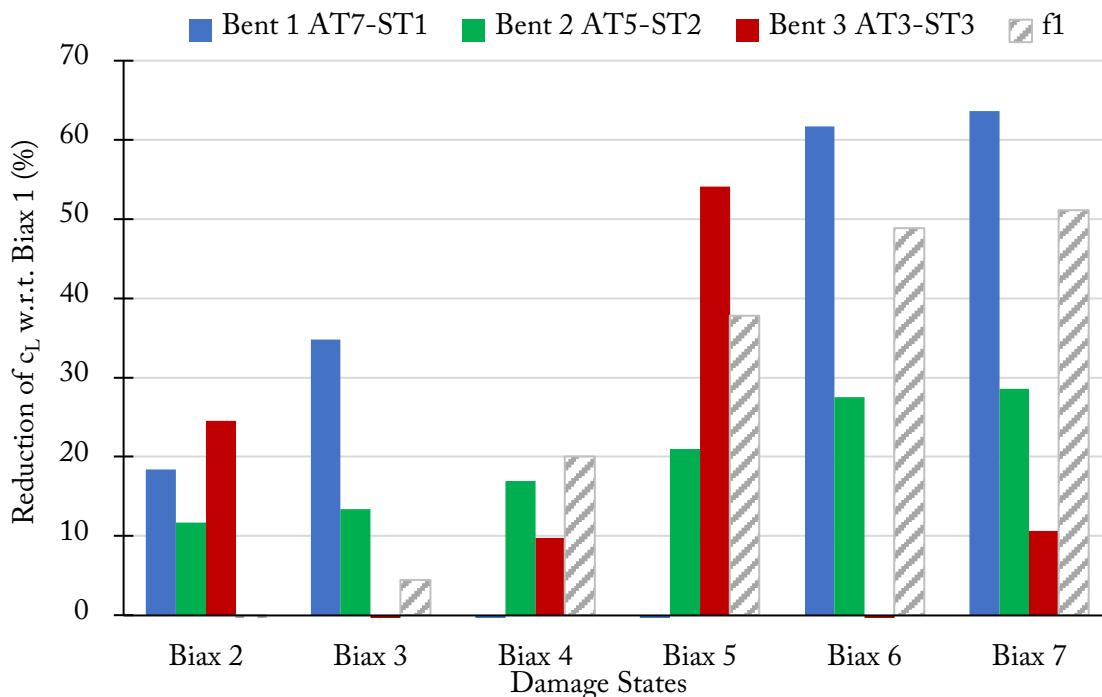
Figure 4.36 Reduction of c_L for Three Bents for FEM Response
