I. Introduction and Instrument Status:

International Ozone Services Inc. (IOS) with the help of AFC Ingenieros, S.A. completed the ozone and UV calibration and service of four INM Brewer instruments at Izaña. Traveling standard instrument #017 along with #185 and #157 were used here as the main calibration references.

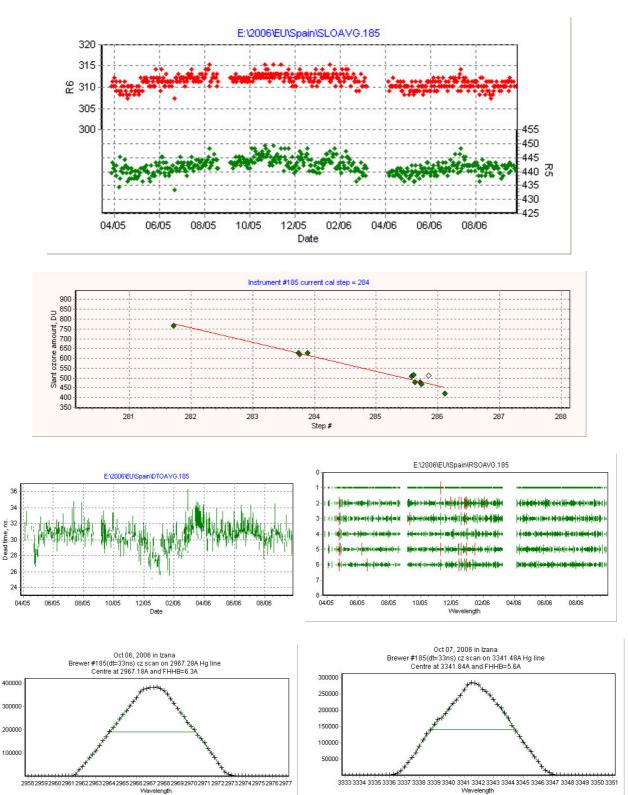
Below are graphs of SL, SC, DT, RS, and CZ test results from the MKIII Brewer #185:

All show quite good stability or are normal except for bump on left side of CZ 3341 scan as it had last year as well. The instrument was taken to a campaign in Finland in March, 2006.
