I. Introduction and Instrument Status:

International Ozone Services Inc. (IOS) with the help of AFC Ingenieros, S.A. completed the ozone and UV calibration and service of four INM Brewer instruments at Izaña. There is now a triad of MKIII instruments here - #157, #183 and #185, a new instrument. #185 was used here as the main calibration reference along with #017 from Canada. Both had just been at the El Arenosillo RBCC-E campaign.

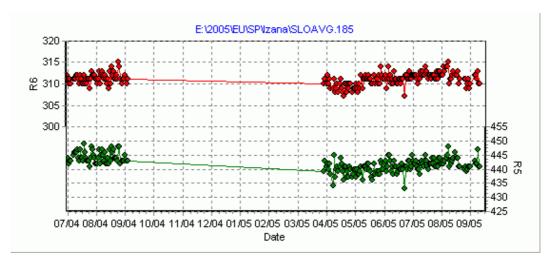
Below are graphs of SL, SC, DT, RS, and CZ test results from the new MKIII Brewer #185:

All show quite good stability or are normal except for bump on left side of CZ 3341 scan which was unusual and showed up on #183 as well.
