Electronics Refurbishment Portfolio

Evan Frackelton Mechatronics Engineer

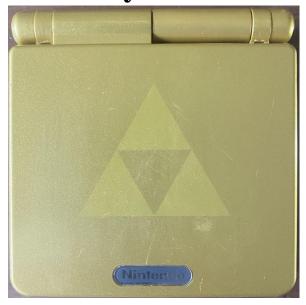
Figure 1.1: Outside Case

- Console turns on but shuts off randomly
- Expanded Lithium Ion Battery
- Dirty motherboard board and components
- Corroded Ports

This repair was fairly easy and was listed for sale on eBay the same day I received it. The biggest issue affecting the performance was the dust on the motherboard.

The motherboard was dusty so <u>IPA [1]</u> was used to clean it as well as the ports and components. The power switch was dirty which was causing the console to randomly shut off. Taking out the switch, cleaning it, and resoldering it fixed that issue. The battery was also replaced because the original was slightly bloated. The ports are corroded but it does not seem to be affecting the continuity. The case was also fully cleaned with IPA as well as the inside of the case below the motherboard, including the buttons and speaker.

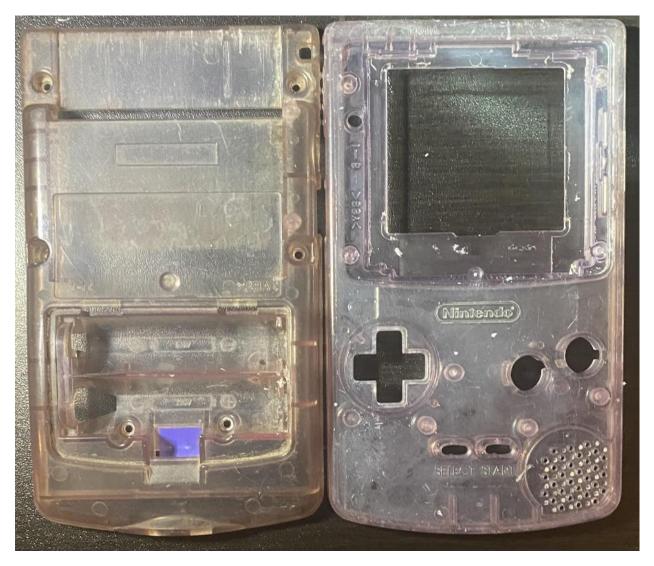
Figure 2.2: Yellow reversed case comparison

When polymer chains degrade from UV radiation, stabilizing agents in the plastic form free radicals. Hydrogen peroxide (H_2O_2) binds to the free radicals and reverse the yellowing in the plastic. By submerging the plastic casing in hydrogen peroxide and putting UV light under it, the bonding begins and over the next few hours the yellowing is removed. Figure 2.2 shows a clear difference between the yellowed and non-yellowed plastic. For clarification, the front panel on the right is the one that was what the restoration community calls, "Retrobrighted [3]" or "deyellowed".

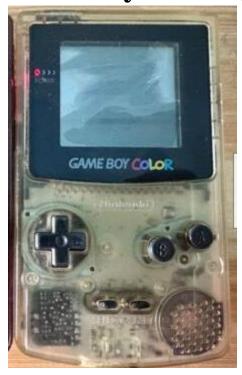
Figure 3.1: Gameboy Color as purchased

- LCD Polarizer is burned and falling off
- Does not read games
- Generally dusty and yellowed plastic
- Corroded battery terminals

Similar to the previous Gameboy Color here, I took it apart and cleaned the motherboard and casing using IPA [1]. The console already powered on with the corroded terminals but they were cleaned as well to make sure that it does not become a future issue. To fix the issue with reading games the pins were cleaned and continuity of the pins was checked. It appeared that each pin was functioning so there was no problem with the cartridge input port. (Need polarizing film to confirm game being read. The speaker was working on initial start up but has issues after cleaning motherboard. (Check issue).
