Technical Service Information

SATURN GRINDING NOISE IN REVERSE (MANUAL VALVE)

94-21 Page 1 of 2

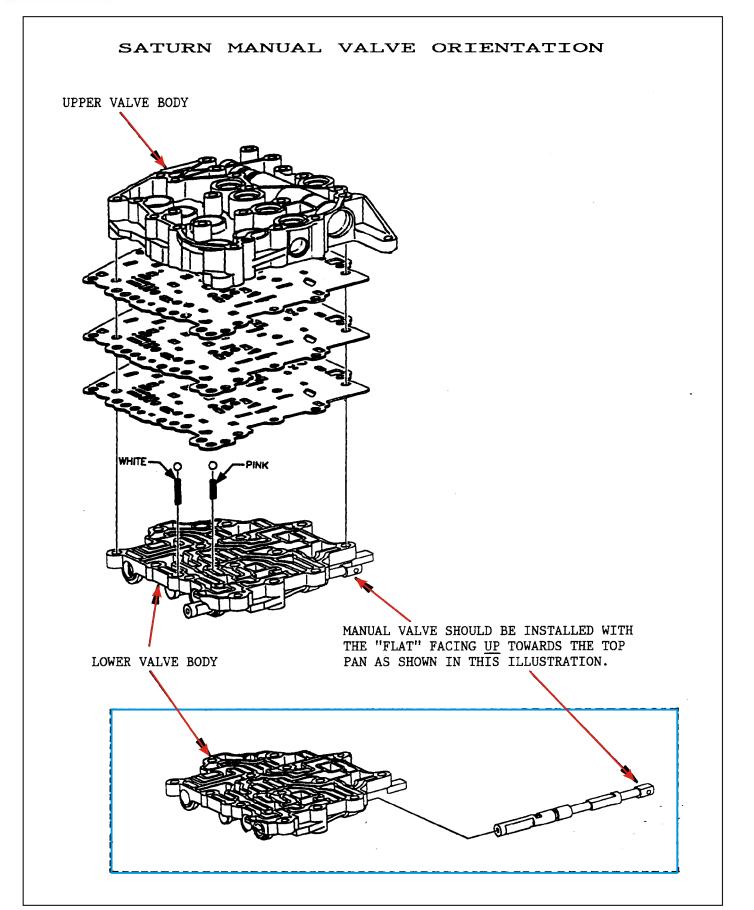
COMPLAINT: After overhaul, you have a bad grinding noise when the selector lever is placed in reverse,

and the vehicle feels as if it wants to move forward.

CAUSE: The cause may be, the manual valve installed improperly with the "Flat" oriented so that it is

facing down towards the case.

CORRECTION: The cause may be, the manual valve installed improperly with the "Flat" oriented so that it is

facing down towards the case.
