## **Technical Service Information**

## THM 4L60 (700-R4) NO WOT 3-4 UPSHIFT (POLICE ONLY)

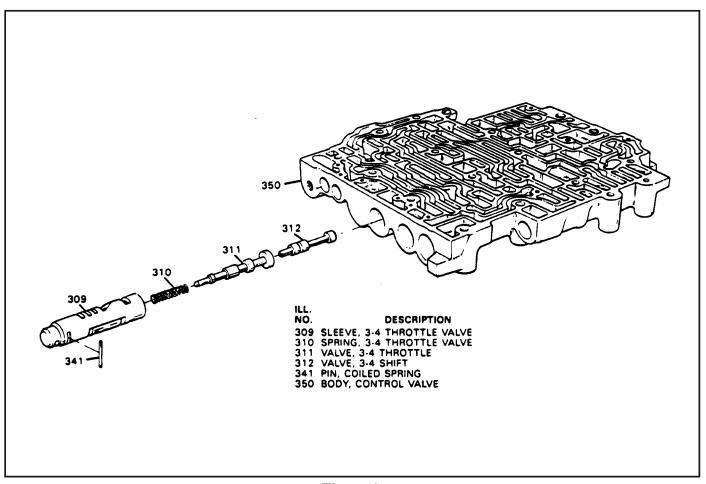
**COMPLAINT:** 5.7L "B" Car (Police Only) may exhibit a loss of wide open throttle upshift after vehicle is

hot.

**CAUSE:** The cause may be the wrong calibration.

**CORRECTION:** There is now available from OEM a new 3-4 throttle valve and sleeve assembly, in service

package part number 8671953, to address this condition. Refer to Figure 1 for proper

assembly procedure.
