Technical Service Information

ZF4HP22 NO REVERSE

(F CLUTCH CYLINDER FAILURE)

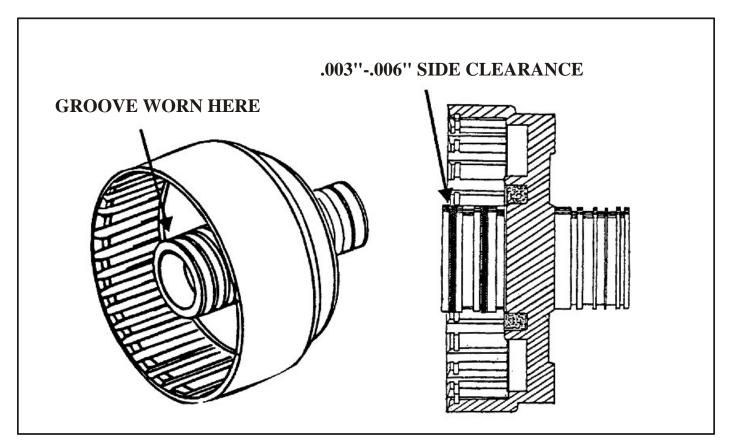
will be necessary. Severe ring groove wear on the (F) clutch cylinder where the (E) clutch rides or even ring grooves missing because of wear is possible (SEE FIGURE 1).

with a new ring installed on the drum, side clearance should be .003-.006 in.

CORRECTION: A new F clutch cylinder must be installed if any wear or damage is found. New sealing

rings must also be installed. Steel rings mast be used for the E clutch sealing grooves.

The part number for the F clutch cylinder is 24-23-1217-088.
