Technical Service Information

FORD AOD

HARSH 4-3 DOWNSHIFT

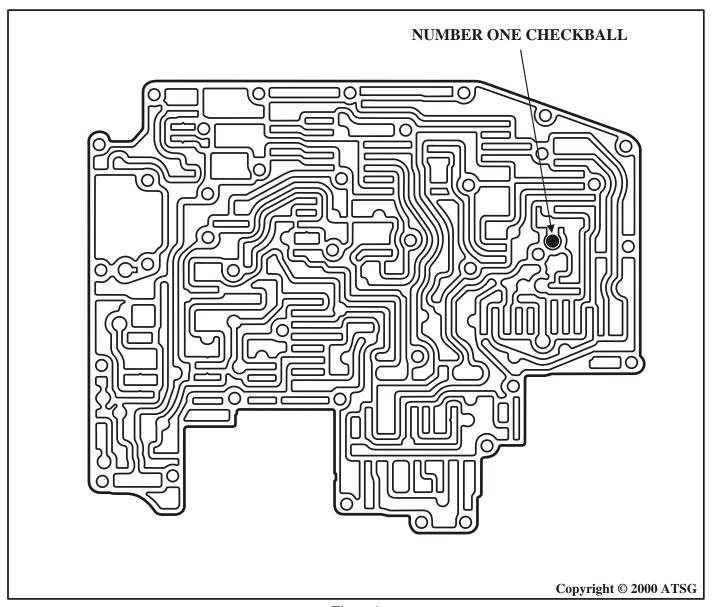
Figure1

COMPLAINT: Ford vehicles equipped with the AOD Transmission may exhibit a harsh 4-3 downshift,

either on coast-down, or during throttle kickdown.

CAUSE: The cause may be a missing Number One Checkball in the Valve Body.

CORRECTION: Make sure that the orange colored .310" Checkball is installed in the location, as shown in Figure 1.
