Technical Service Information

THM 440-T4 SLIPPING OR NO 1-2 SHIFT (VESPEL RINGS)

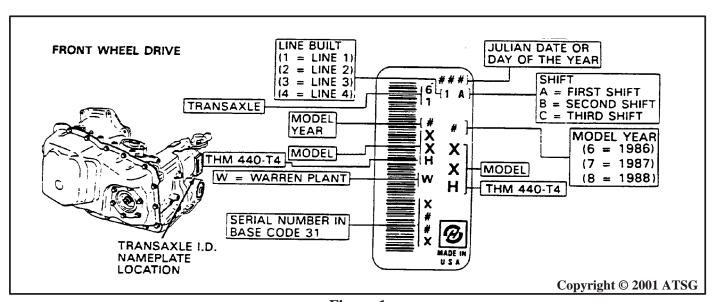
Figure 1

DATE OF PRODUCTION CHANGE: (Figure 1)

Start of production for all 1987 THM 440-T4 transaxle models.

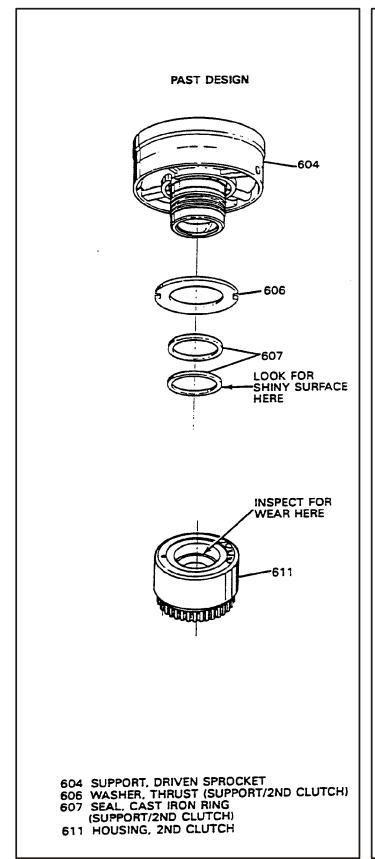
A soft, slipping or no 1-2 shift condition may result if the two cast iron seals between the driven sprocket support and 2nd clutch housing bind to the driven sprocket support and wear into the 2nd clutch housing.

Inspect the cast iron oil seal rings (607) for wear (indicated by a shiny surface on the O.D.) and the 2nd clutch housing (611) for wear (grooves caused by the seal rings). The driven sprocket support may not appear affected, but must be replaced if these wear conditions are present.

SERVICE ACTION: (Figure 2)

For all 1984 through 1986 model year THM 440-T4 transaxles, it is recommended that the new Vespel (TM) oil seal rings, 4-lobe ring seals and driven sprocket support be installed with other parts that indicate wear (such as the 2nd clutch housing).

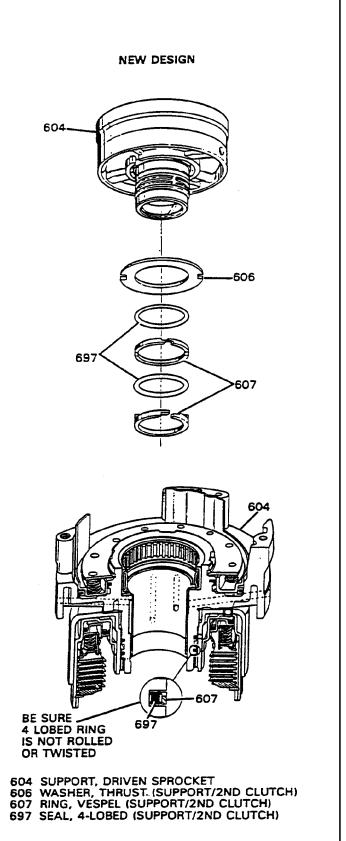
Due to changes in the driven sprocket support for 1987, the new Vespel (TM) oil seal rings and 4-lobe ring seals are not interchangeable with the cast iron oil seal rings on models built prior to 1987 Start Of Production (SOP). Changes made to the driven sprocket support include deeper seal ring grooves and 'cutouts" to accommodate the ring tangs which prevent the Vespel (TM) oil seal rings from rotating (refer to Figure 3).

SERVICE NOTES; (Figure 3, Item 697)

IMPORTANT: When installing a 4-lobe ring seal, make sure that it is not rolled or twisted. Lubricate the vespel rings with transaxle fluid or petroleum jelly for easier installation into the 2nd clutch housing.
