Technical Service Information

THM 4L60-E INTERMITTENT PRESSURE RISE ON 1996 MODELS ONLY

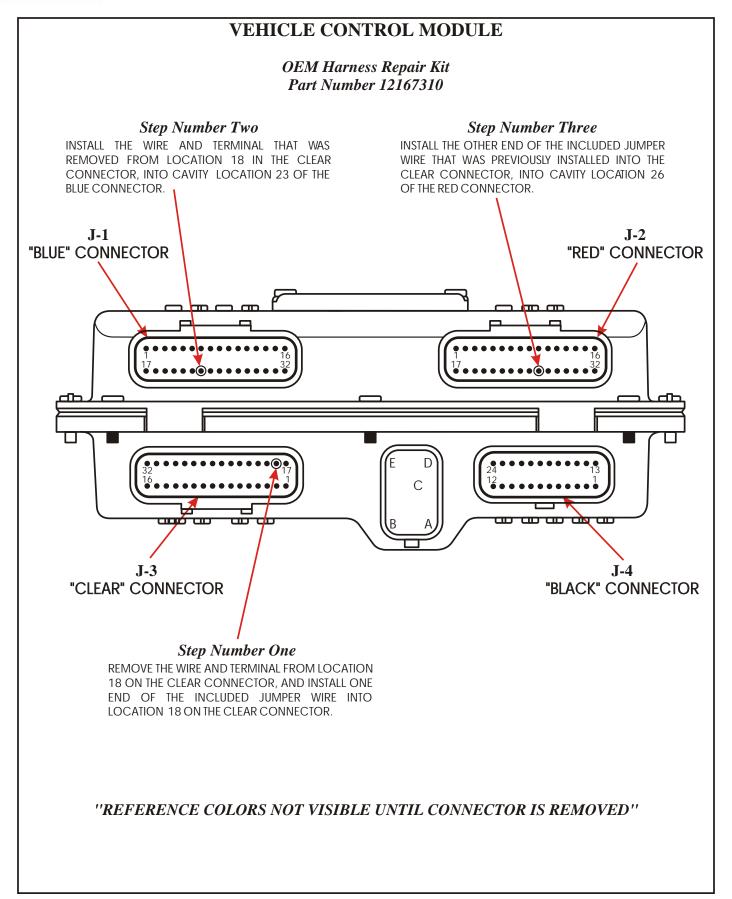
Beginning at the start of production for all 1996 model vehicles equipped with the THM 4L60-E transmission, there was a VCM (Vehicle Control Module) installed on the vehicles with an internal ground wire that connects the two printed circuit boards together. Some vehicles with the VCM will display very erratic and unstable line pressure rise in the transmission, and in some instances, premature failure of the transmission.

Bad ground connection from one printed circuit board to the other.

CORRECTION: There is now available from OEM parts sources, a new service repair kit with an instruction sheet, to repair 1996 vehicles with this condition, and is available under OEM part number 12167310.

Remove the wire and terminal from location 18 in the "Clear" connector, and install one end of the jumper wire that is included in the service kit into location 18 in the "Clear" connector, and reinstall the clear connector, as shown in Figure 1.

Install the wire and terminal that was removed from cavity location 18 in the clear connector, into empty cavity location 23 of the "Blue" connector, as shown in Figure 1.

Install the other end of the included jumper wire that was previously installed in cavity 18 of the clear connector, into empty cavity location 26 of the "Red" connector, as shown in Figure 1.
