Technical Service Information

FORD A4LD NO ENGAGEMENT IN REVERSE

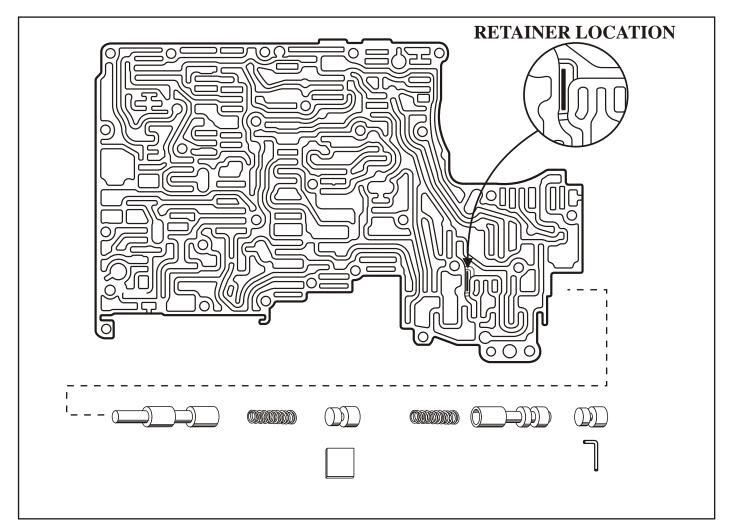
Figure 1

COMPLAINT: No engagement in reverse on late model vehicles with reverse engagement control valve.

CAUSE: The cause may be, the Number 2 retainer missing or off location.

CORRECTION: Position the Number 2 retainer in the valve body in the location shown in Figure 1.
