GENERAL MOTORS 4L80E NEUTRALS DURING OR AFTER THE UP SHIFT TO 4TH GEAR

09-02 Page 1 of 4

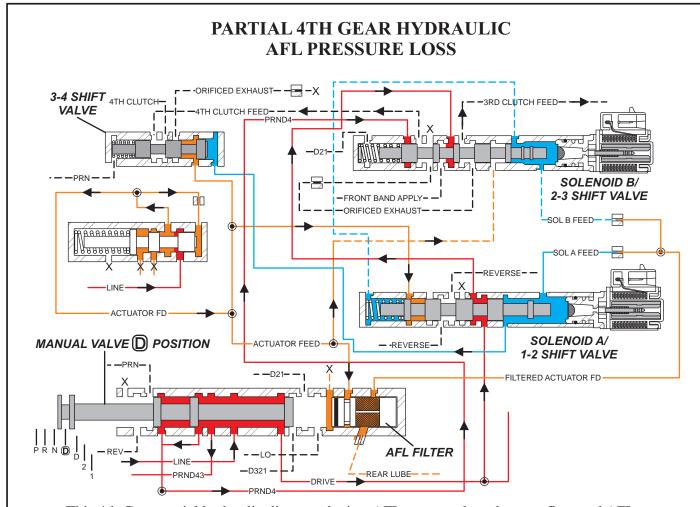
Figure 1

This 4th Gear partial hydraulic diagram depicts AFL pressure loss due to a flattened AFL Filter O-ring and a worn AFL Valve bore. Note the loss of Actuator Feed pressure to the 2-3 Shift Valve and also Sol. B Feed. The 2-3 Shift Valve is affected before the 1-2 Shift Valve because the 2-3 Shift Valve Spring is heavier. This loss of AFL pressure moves the 2-3 Shift Valve into the 1st gear position, and 1st gear is obtained regardless of the position of the 3-4 Shift Valve.

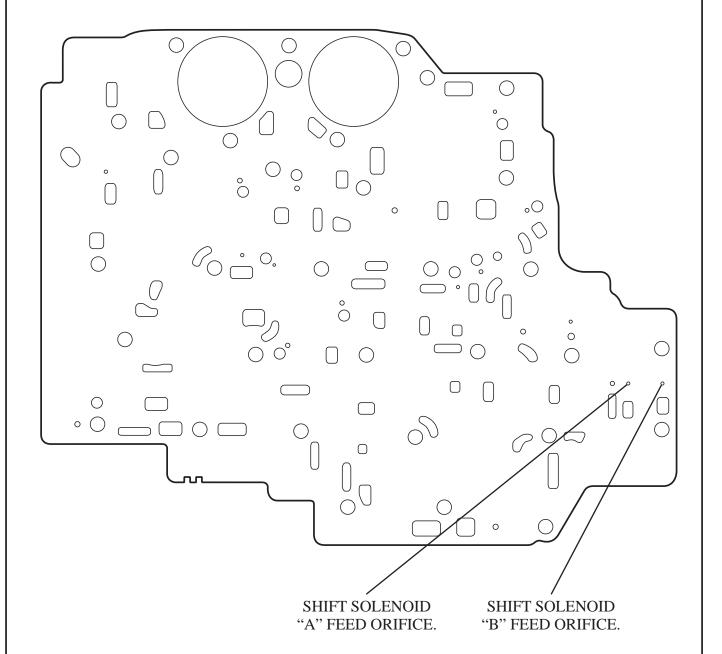
4L80E SPACER PLATE SOLENOID FEED ORIFICE LOCATIONS

If the AFL valve and the Filter are in good condition, then it may be necessary to replace Shift Solenoid B. In addition, the solenoid feed hole in the separator plate may be enlarged slightly to overcome this condition. Using a .035" drill bit, carefully enlarge solenoid feed hole. *DO NOT ENLARGE SOLENOID FEED HOLE MORE THAN .035*". Refer to Figure 4 for Shift Solenoid B feed hole location in the separator plate.

DO NOT ENLARGE EITHER FEED ORIFICE DIAMETER GREATER THAN .035"
