# **Technical Service Information**

# 2001-03 "C/K" TRUCK WITH 4L60E TRANSMISSION SLIPPING 1-2 SHIFT OR SHUDDER

AUTOMATIC TRANSMISSION SERVICE GROUP

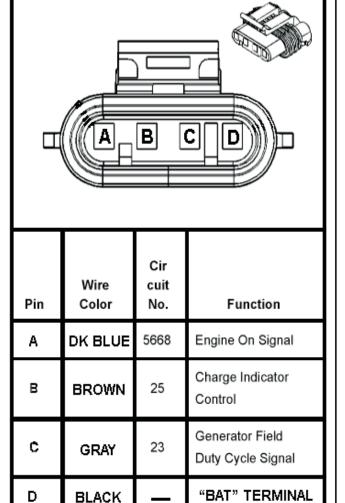
### **AFTER REWIRING**

**COMPLAINT:** Trucks built before August 5, 2003 may have a complaint of slipping, shudder or a

**CAUSE:** A 12 Hz electrical feedback from the charging circuit may be affecting the proper

operation of the transmissions pressure control solenoid. This causes a fluctuation of line pressure which causes the above complaints when line pressure dips below normal.

The alternator will require the installation of an external "Sense Lead" which is accomplished by adding a wire from the alternator four wire connector to the alternator output "BAT" terminal. The procedure is as follows as seen in figure 1:
