1996 & LATER DODGE/CHRYSLER VEHICLES WITH 41TE/42LE TRANSAXLES PRND3L LIGHTS MALFUNCTION

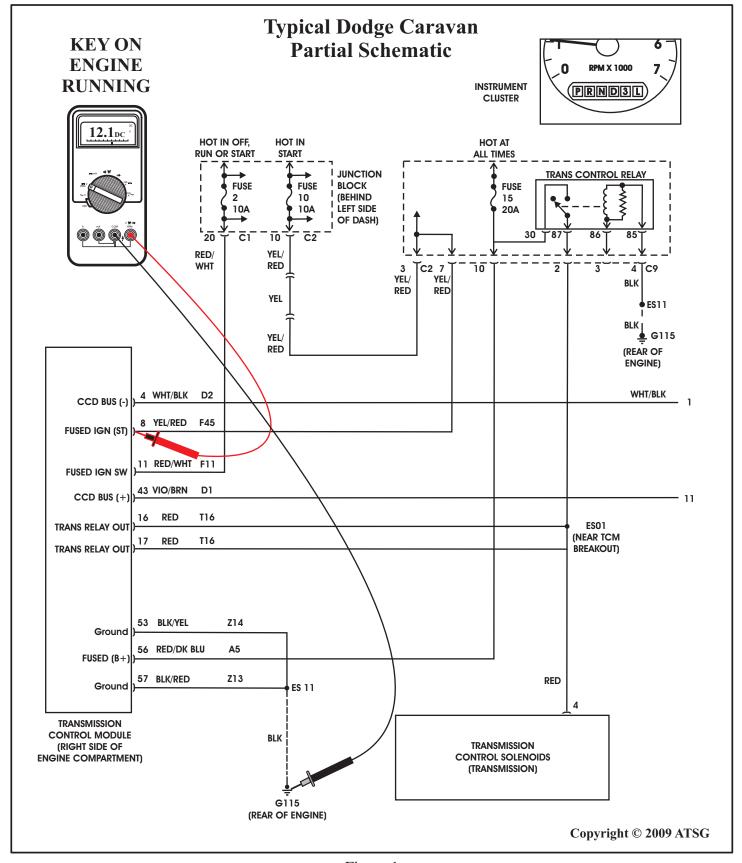
Figure 1

Malfunctioning ignition switch causing a continuous 12 volts present on pin 8 of the TCM while the engine is running (shown in figure 1). Battery voltage on pin 8 should only be present with the ignition switch in the crank position. Voltage should drop to zero when ignition key is released back to the run position (figure 2). Some models vehicle start when the key is turned to the "On" position, such as the 2000 Dodge Intrepid with the type of starting circuit as seen in figure 3.

CORRECTION: Replace ignition switch or fix possible short to power.
