Technical Service Information

FORD CD4E

NO FORWARD ENGAGEMENT AND/OR NO 3RD GEAR

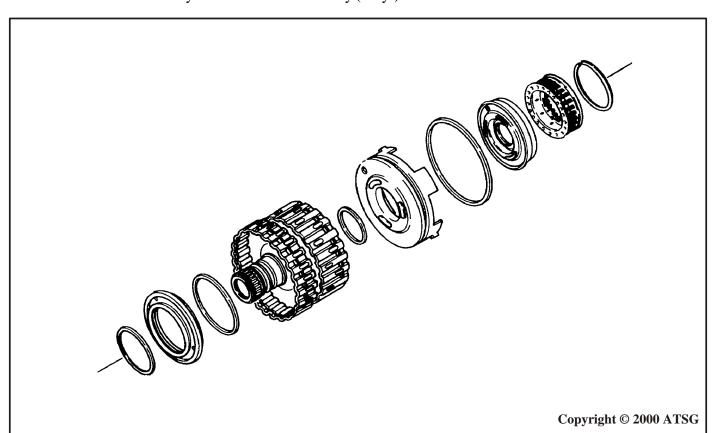
CAUSE: The cause may be due to a defective weld condition on the Forward/Coast/Direct Clutch

Cylinder, which results in fluid leakage from the forward clutch into the direct clutch. The

clutch cylinder and hub weld condition may not be identifiable visually.

CORRECTION: When extensive wear is observed on the forward clutch plates and/or the direct clutch plates,

and the transaxle serial number is 4271-0000 thru 4303-9999, built between the dates listed above, replace the Forward/Coast/Direct Clutch Cylinder Assembly with the appropriate

service part number listed below.

Clutch Cylinder and Hub Assembly (4 Cyl) F5RZ-7G120-A Clutch Cylinder and Hub Assembly (6 Cyl) F4RZ-7G120-A
