## **Technical Service Information**

## FORD AXOD HARSH COAST DOWNSHIFTS

92-16 Page 1 of 1

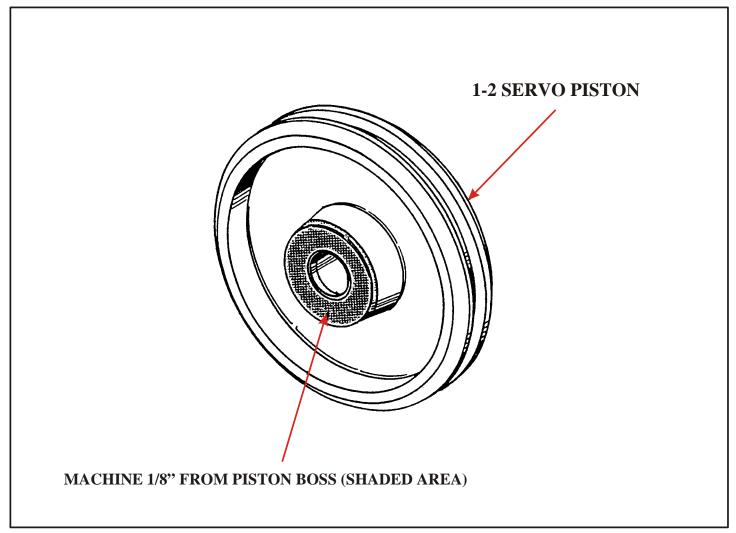
FIGURE 1

**COMPLAINT:** Harsh downshift when coasting to a stop at closed throttle.

**CAUSE:** Insufficient travel of the 1-2 piston against the cushion spring.

**CORRECTION:** Remove 1/8" from the boss on the inside of the 1-2 servo piston as shown in Figure 1. We have

shaded the area to be machined.
