# UDROŹNIENIE ŁÓDZKIEGO WĘZŁA KOLEJOWEGO (TEN-T), ETAP II, ODCINEK ŁÓDŹ FABRYCZNA - ŁÓDŹ KALISKA/ŁÓDŹ ŻABIENIEC – PROJEKT POIIS 5.1-15

## TBM 13.08 M - CONSTRUCTION FOLLOW-UP

| Type of document | Daily Report 28/08/2024 |
| Document ID | LWK-000-T-KO-SWS-210472_00.docx |

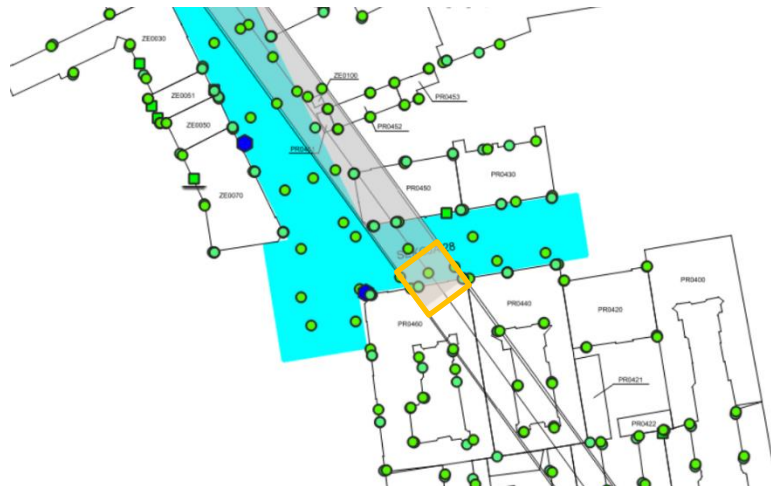
### Figure 6-1 Monitoring points

According to Geoscope, settlements of the buildings above the tunnel are kept within the limits.
