# UDROŻNIENIE ŁÓDZKIEGO WĘZŁA KOLEJOWEGO (TEN-T), ETAP II, ODCINEK ŁÓDŹ FABRYCZNA - ŁÓDŹ KALISKA/ŁÓDŹ ŻABIENIEC – PROJEKT POIIS 5.1-15

## TBM 13.08 M - CONSTRUCTION FOLLOW-UP

| Type of document | Daily Report 02/09/2024 |
| Document ID | LWK-000-T-KO-SWS-210475_00.docx |

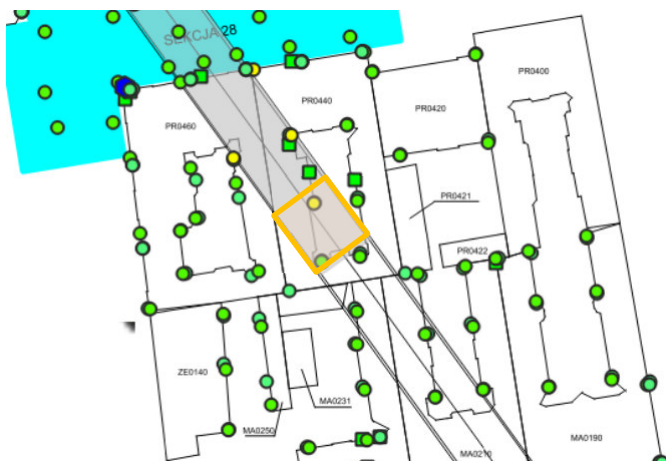
Figure 6-1 Monitoring points

According to Geoscope, settlements of the buildings above the tunnel are kept within the limits.
