# UDROŻNIENIE ŁÓDZKIEGO WĘZŁA KOLEJOWEGO (TEN-T), ETAP II, ODCINEK ŁÓDŹ FABRYCZNA - ŁÓDŹ KALISKA/ŁÓDŹ ŻABIENIEC – PROJEKT POIIS 5.1-15

## TBM 13.08 M - CONSTRUCTION FOLLOW-UP

| Type of document | Daily Report 03/09/2024 |
| Date | 04/09/2024 |

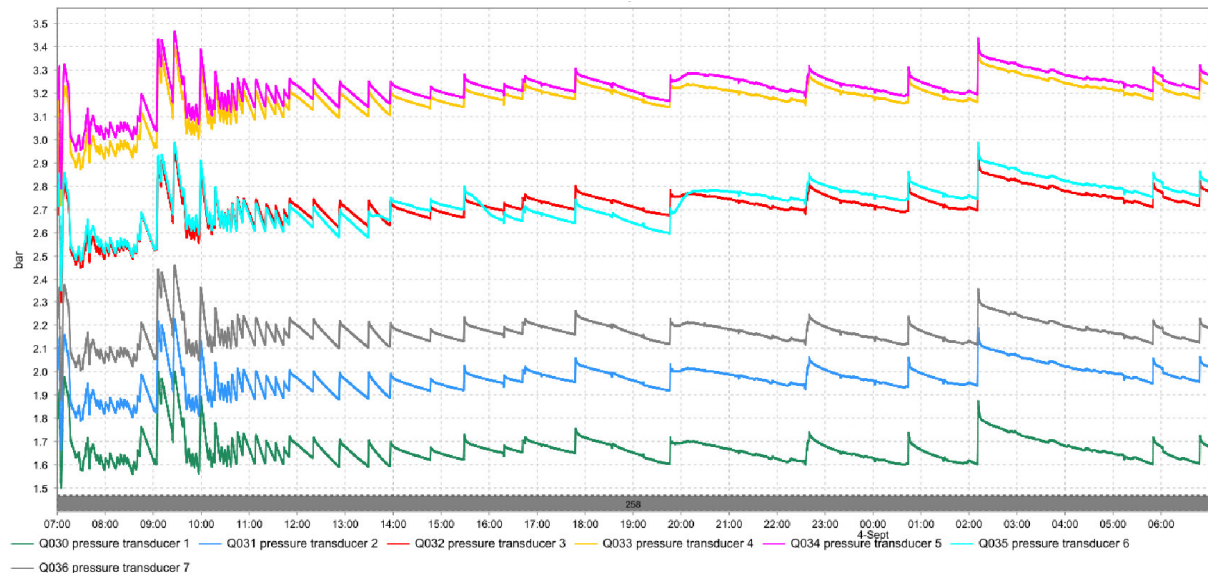
**Figure 2-1 EPB pressure sensor**

Average EPB pressure at the crown is at about 1.7 bar. The value is within the attention values. Figure 2-1 shows EPB sensors.

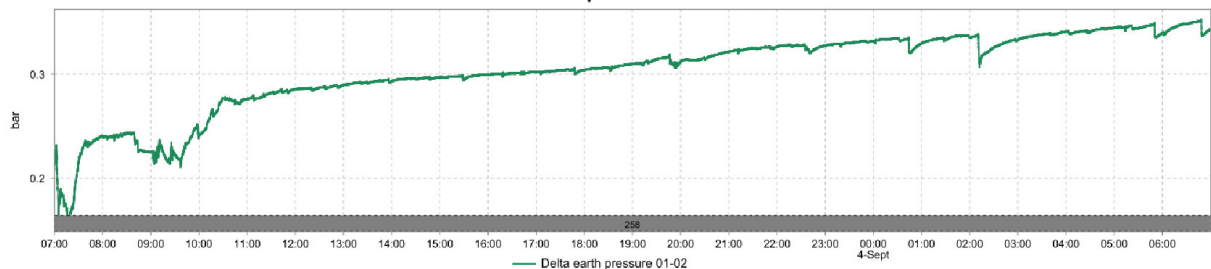
**Figure 2-2 Delta between pressure sensors 1 and 2**

The delta between pressure transducer 1 and 2 has an average value of 0.3 bar indicating that the bulk chamber is correctly filled with material.

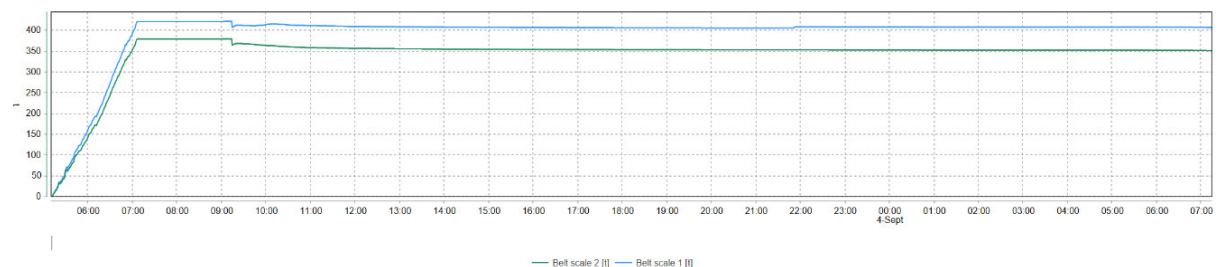
**Figure 2-3 Belt scales**

Belt scale n. 1 and belt scale n. 2 show similar values. The belt scale value is a raw indication of the excavated material quantity.

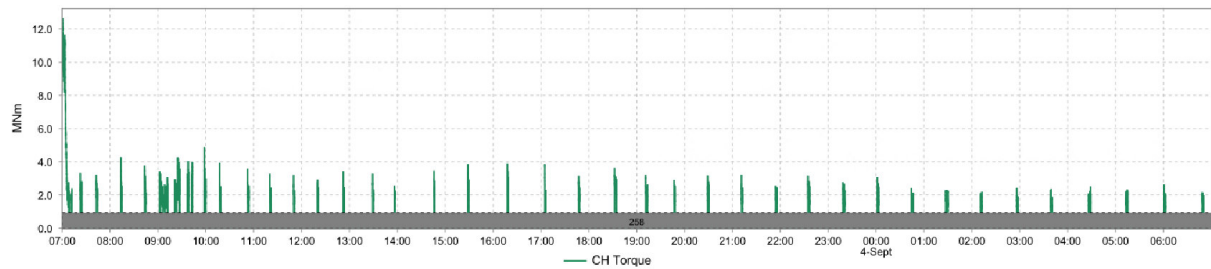
**Figure 3-1 CH Torque**

During excavation, the average torque is of 5.9 MNm.

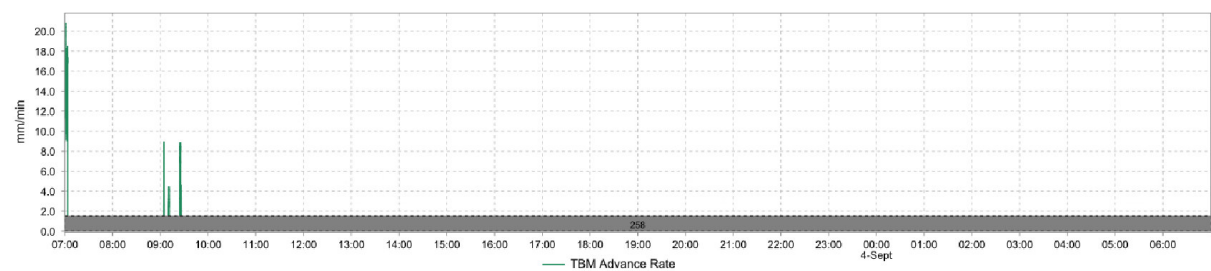
**Figure 3-2 Advance rate**

During advancement, average advance rate is of 8 mm/min.

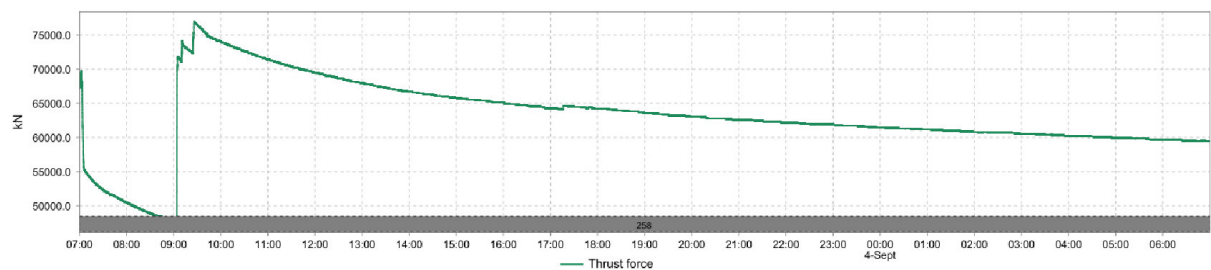
**Figure 3-3 Thrust force**

During excavation, thrust force shows an average value of 71 MN and a maximum of 76.8 MN.

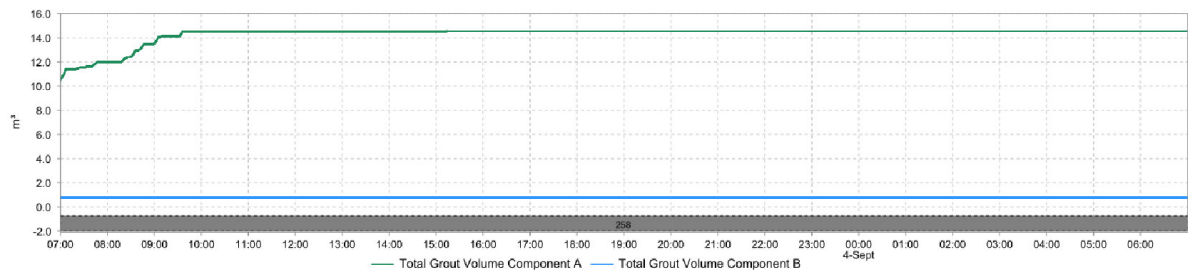
**Figure 4-1 Grout volumes**

Grout injection has a volume above the minimum theoretical annular volume  $\pm 10\%$  of  $13.54 \text{ m}^3$ . Ration B/A is at 5%.

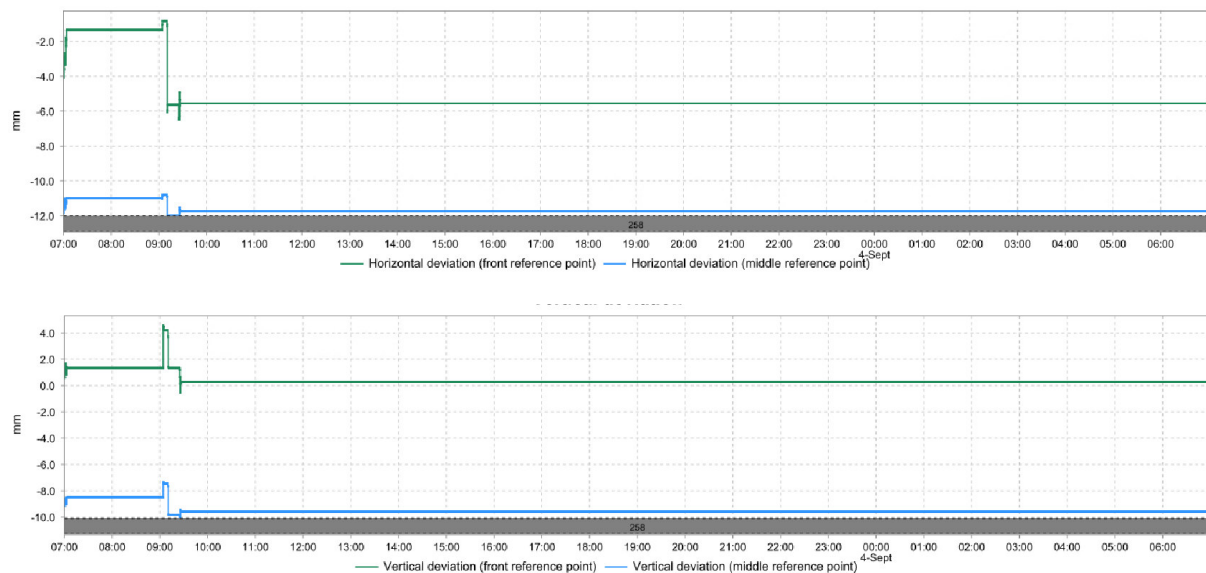
Figure 5-1 Machine deviation from the alignment

The TBM vertical deviation is of about 0.27 mm on the front edge of the shield and the horizontal deviation of about -5.56 mm (Figure 5-1). Maximum radial deviation is of 5.57 mm.

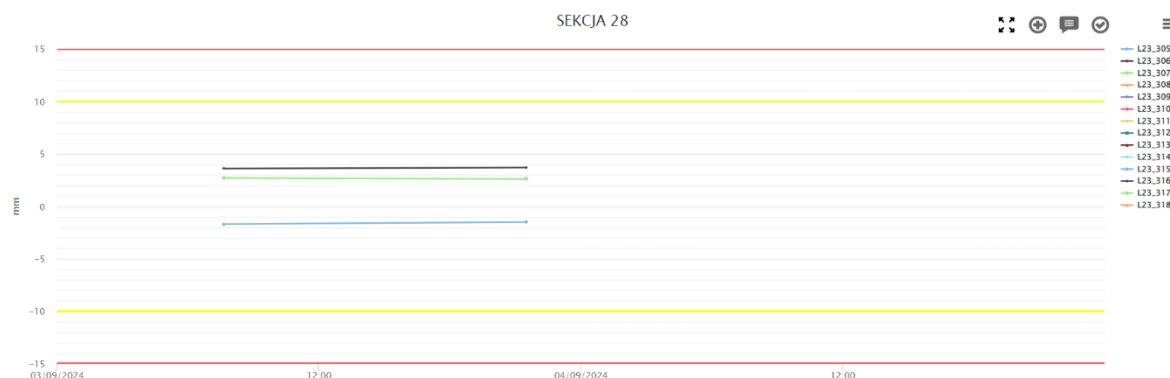
Figure 6-2 Settlement of Section on Prochnika street

The monitoring points on Prochnika street are stable.

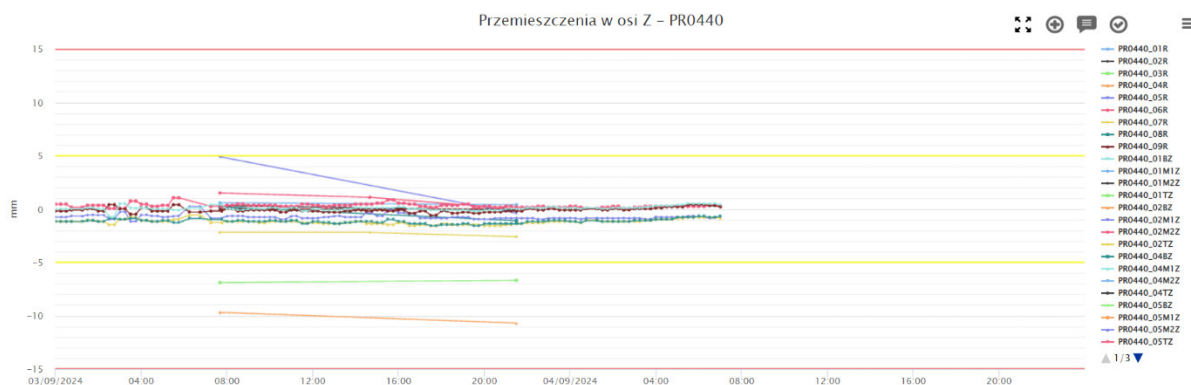
Figure 6-3 Settlement of building PR0440

On PR0440, monitoring points show a downward trend for points along tunnel axis: PR0440-05R with a maximum settlement of about 4 mm and PR0440-04R of about 1 mm.

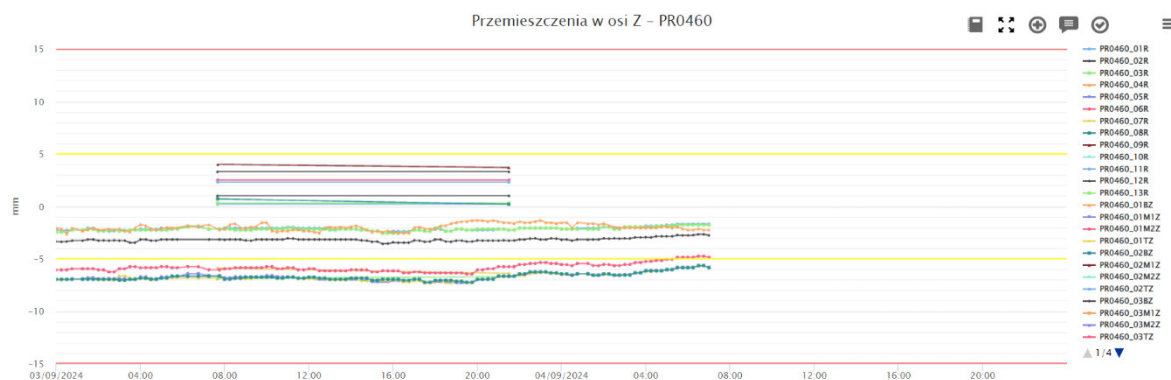
Figure 6-4 Settlement of building PR0460

On PR0460, monitoring points show a small uplift trend for point PR046\_A\_13.

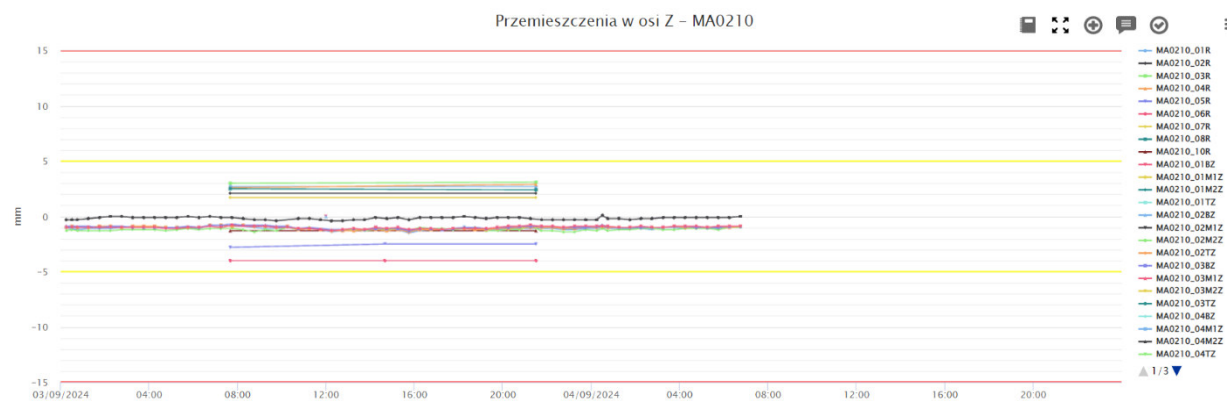
Figure 6-5 Settlement of building MA0210

On MA0210, monitoring points are stable.

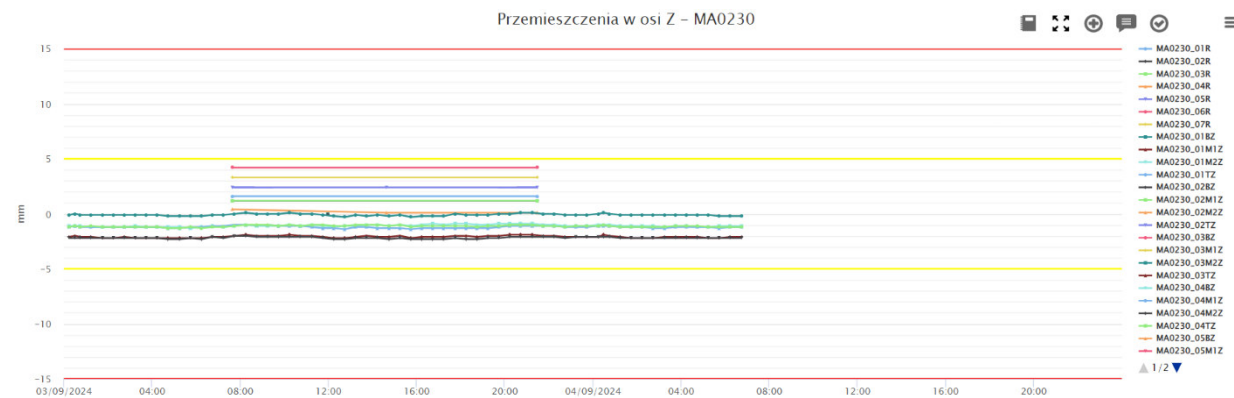
Figure 6-6 Settlement of building MA0230

On MA0230, monitoring points show a small downward trend for point MA0230\_04R.
