# UDROŻNIENIE ŁÓDZKIEGO WĘZŁA KOLEJOWEGO (TEN-T), ETAP II, ODCINEK ŁÓDŹ FABRYCZNA - ŁÓDŹ KALISKA/ŁÓDŹ ŻABIENIEC – PROJEKT POIIS 5.1-15

## TBM 13.08 M - CONSTRUCTION FOLLOW-UP

| Type of document | Daily Report 04/09/2024 |
| Document ID | LWK-000-T-KO-SWS-210477_00.docx |

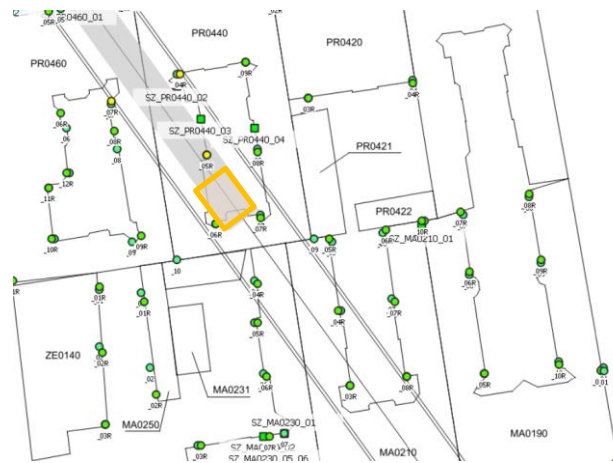
Figure 6-1 Monitoring points

According to Geoscope, settlements of the buildings above the tunnel are kept within the limits.
