# UDROŻNIENIE ŁÓDZKIEGO WĘZŁA KOLEJOWEGO (TEN-T), ETAP II, ODCINEK ŁÓDŹ FABRYCZNA - ŁÓDŹ KALISKA/ŁÓDŹ ŻABIENIEC – PROJEKT POIIS 5.1-15

## TBM 13.08 M - CONSTRUCTION FOLLOW-UP

| Type of document | Daily Report 06-08/09/2024 |
| Date | 09/09/2024 |

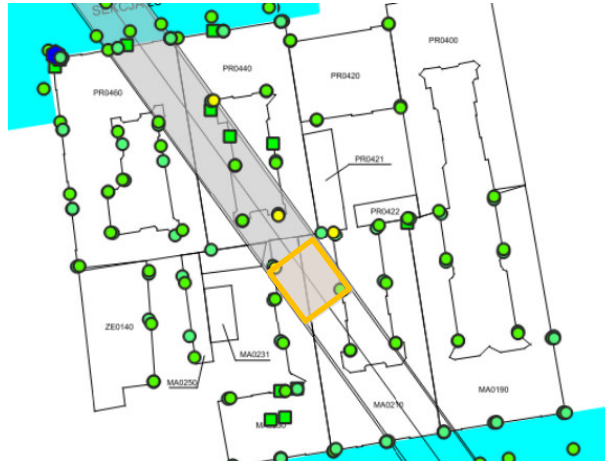
Figure 6-1 Monitoring points

According to Geoscope, settlements of the buildings above the tunnel are kept within the limits.
