# UDROŻNIENIE ŁÓDZKIEGO WĘZŁA KOLEJOWEGO (TEN-T), ETAP II, ODCINEK ŁÓDŹ FABRYCZNA - ŁÓDŹ KALISKA/ŁÓDŹ ŻABIENIEC – PROJEKT POIIS 5.1-15

## TBM 13.08 M - CONSTRUCTION FOLLOW-UP

| Type of document | Daily Report 09/09/2024 |
| Date | 10/09/2024 |

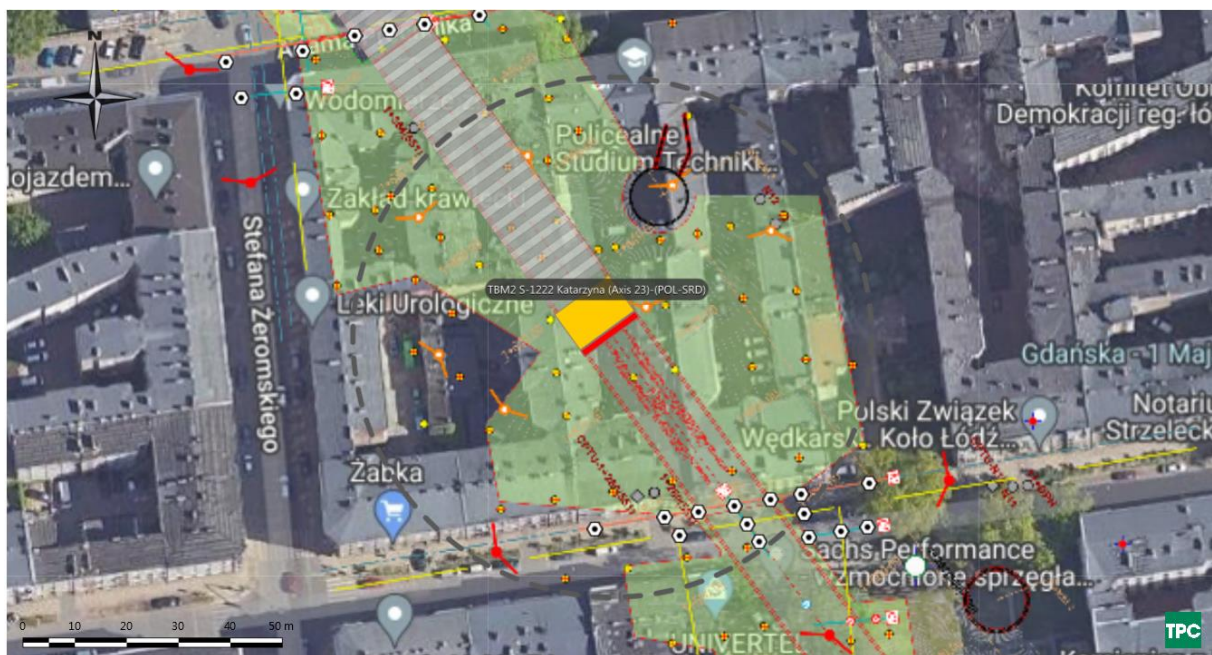
**Figure 1-2 Plan view of TBM Position on 10/09/2024**

According to VMT system, TBM is at Chainage 1+628.92 after the erection of ring n. 269; which corresponds to a total excavation length of 337.55 m from the starting chainage.

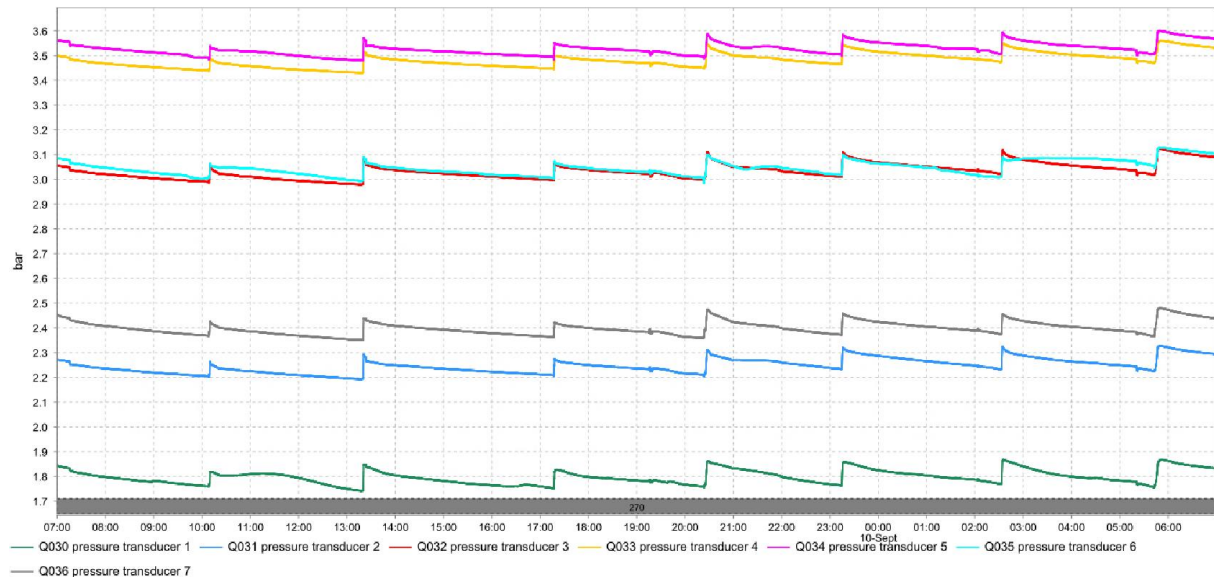
**Figure 2-1 EPB pressure sensor**

Average EPB pressure at the crown is at about 1.8 bar. The value is within the attention values. Figure 2-1 shows EPB sensors.

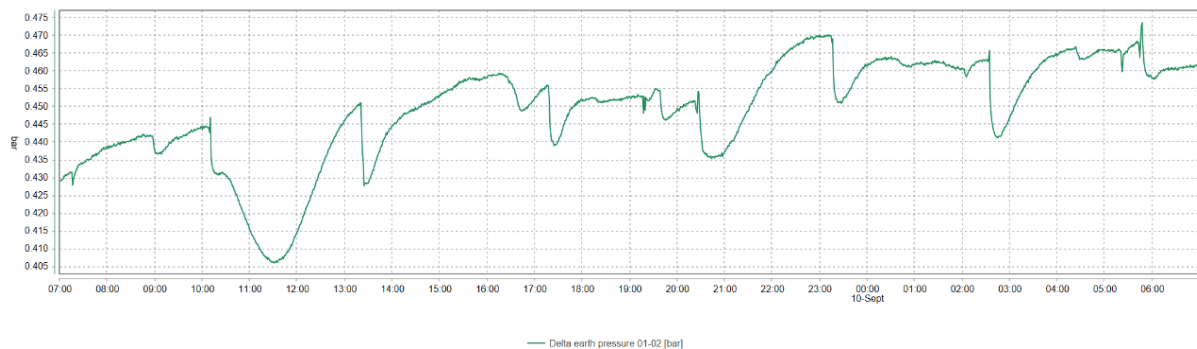
**Figure 2-2 Delta between pressure sensors 1 and 2**

The delta between pressure transducer 1 and 2 has an average value of 0.45 bar indicating that the bulk chamber is filled.

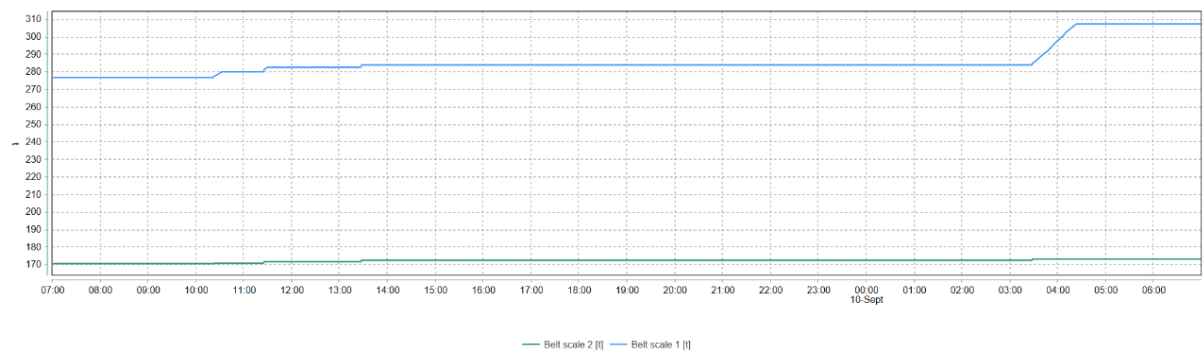
**Figure 2-3 Belt scales**

Belt scale n. 2 show values lower than n. 1. An increase in weight was observed during the stoppage, attributed to the cleaning process and the pumping of grout from the tank. The belt scale value is a raw indication of the excavated material quantity.

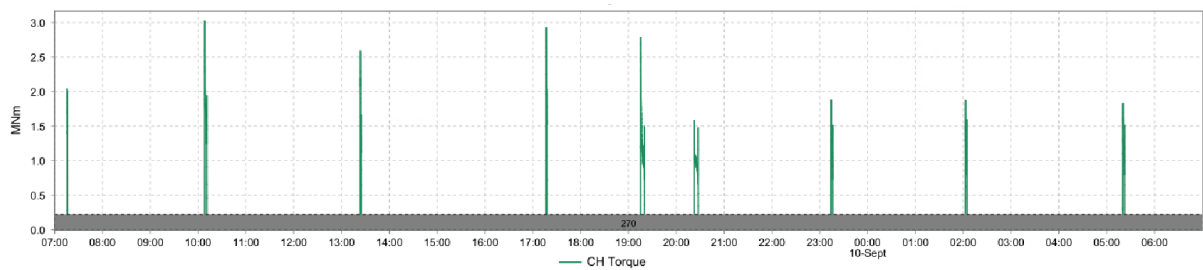
Figure 3-1 CH Torque

Graph for torque, advance rate and thrust force are below shown. The torque graph shows non-zero values due to the rotation of the cutterhead.

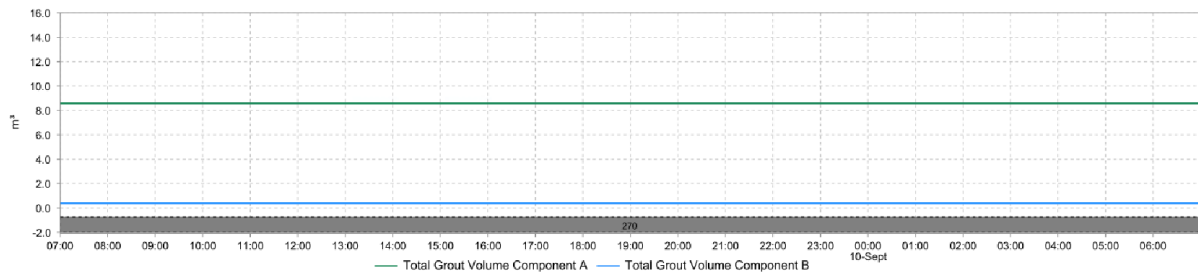
Figure 4-1 Grout volumes

Grout injection volume has to be compared to minimum theoretical annular volume  $\pm 10\%$  of  $13.54 \text{ m}^3$  at the end of ring excavation. Ratio B/A is at 5%.

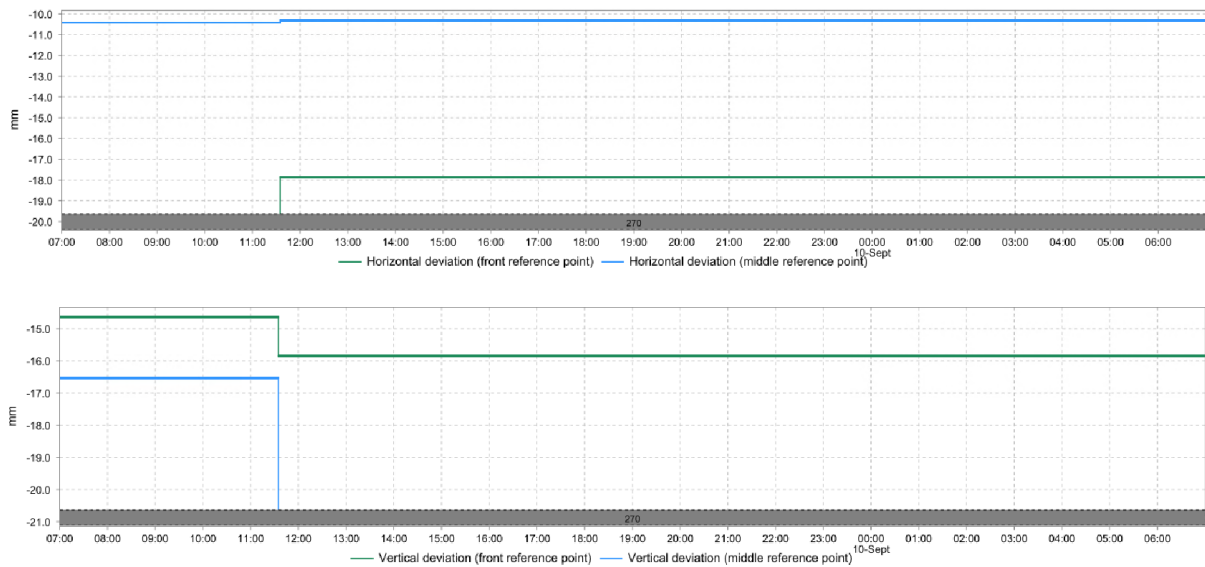
Figure 5-1 Machine deviation from the alignment

The TBM vertical deviation is of about -15.85 mm on the front edge of the shield and the horizontal deviation of about -17.86 mm (Figure 5-1). Maximum radial deviation is of 24.71 mm.

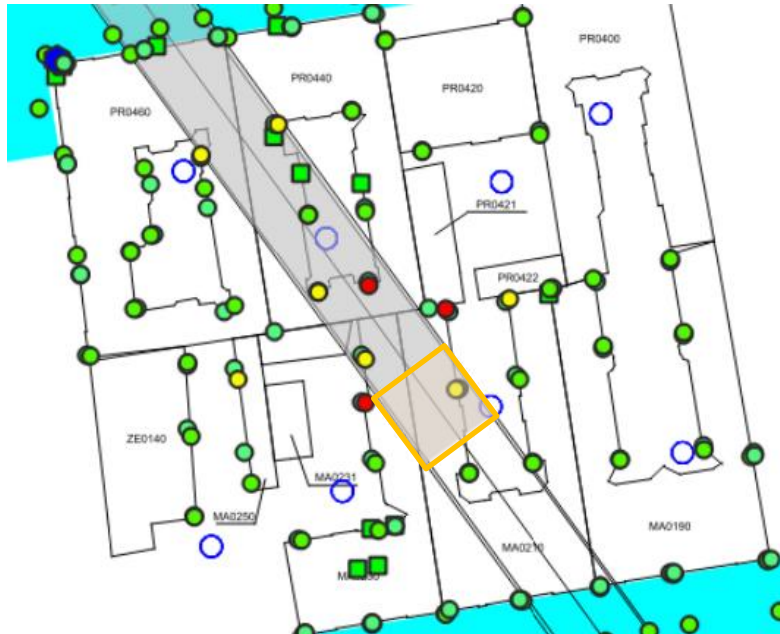
Figure 6-1 Monitoring points – Geoscope

Based on data from Geoscope and Beyond, building subsidence has been observed but is showing signs of stabilization.

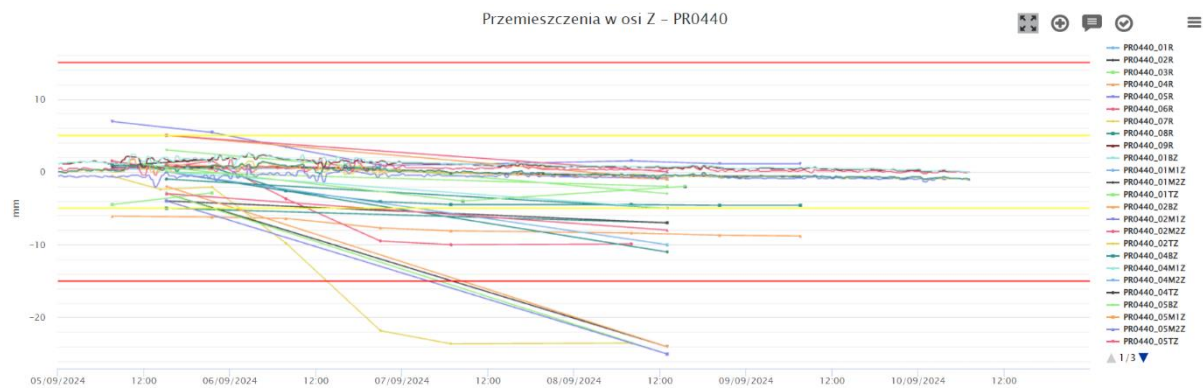
**Figure 6-3 Settlement of building PR0440 - Geoscope**

On PR0440, Geoscope monitoring points show stabilizing trends starting from 07/09/2024 at 8:00 am, following the excavation stoppage. It is not possible to appreciate a complete stabilization trend because many points have not recorded new measurements since 08/09/2024 in the morning.

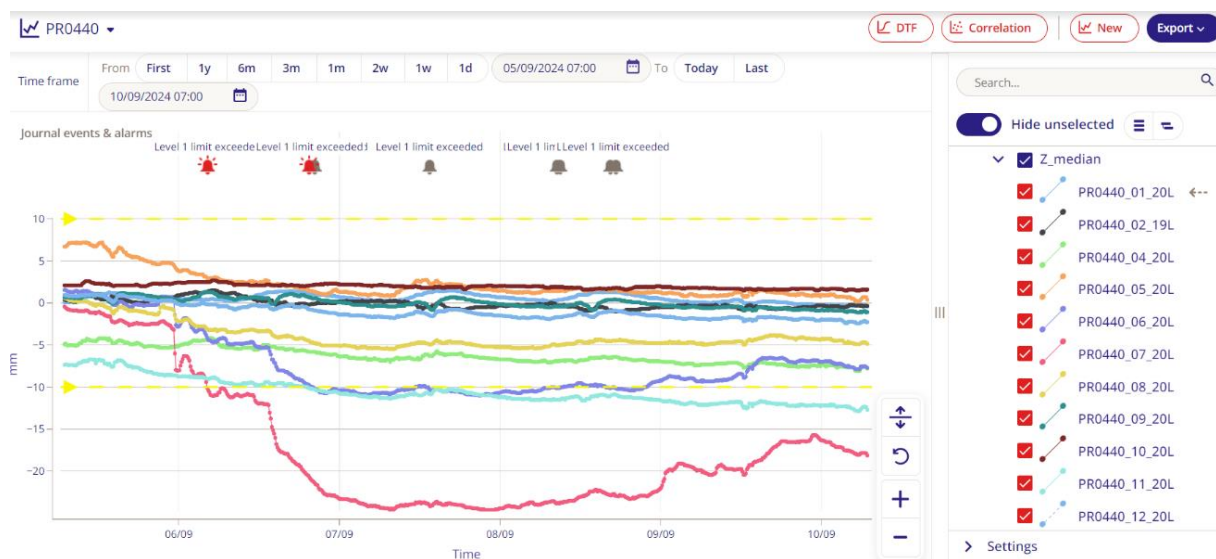
**Figure 6-4 Monitoring point PR0440 - Beyond**

In Beyond, monitoring points show stabilizing trends, except for PR0440\_06\_20L and PR0440\_07\_20L which showed an uplift followed by a new downward trend.

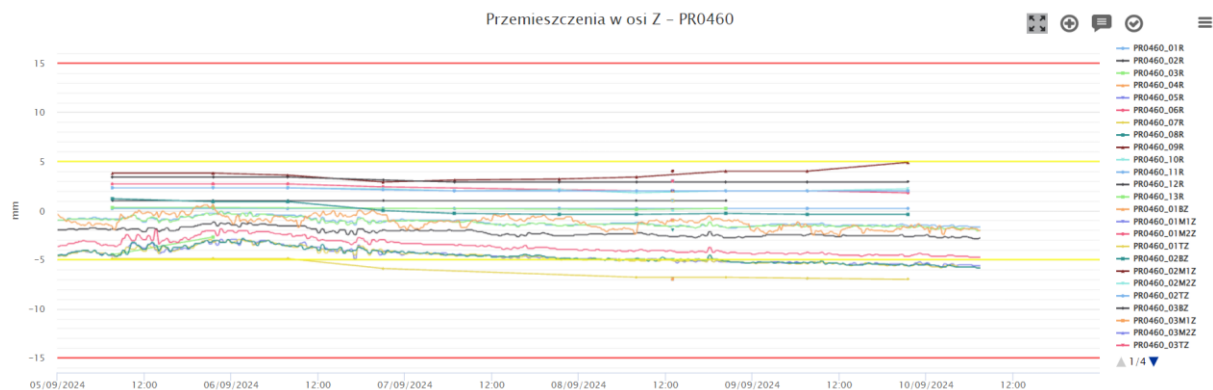
Figure 6-5 Settlement of building PR0460 - Geoscope

On PR0460, Geoscope monitoring points show a small downward trends for point PR0460\_06. Other points show stabilizing trends, included the PR0460\_07 point that has exceeded the attention threshold. Point PR0460\_09 shows a small uplift trend.

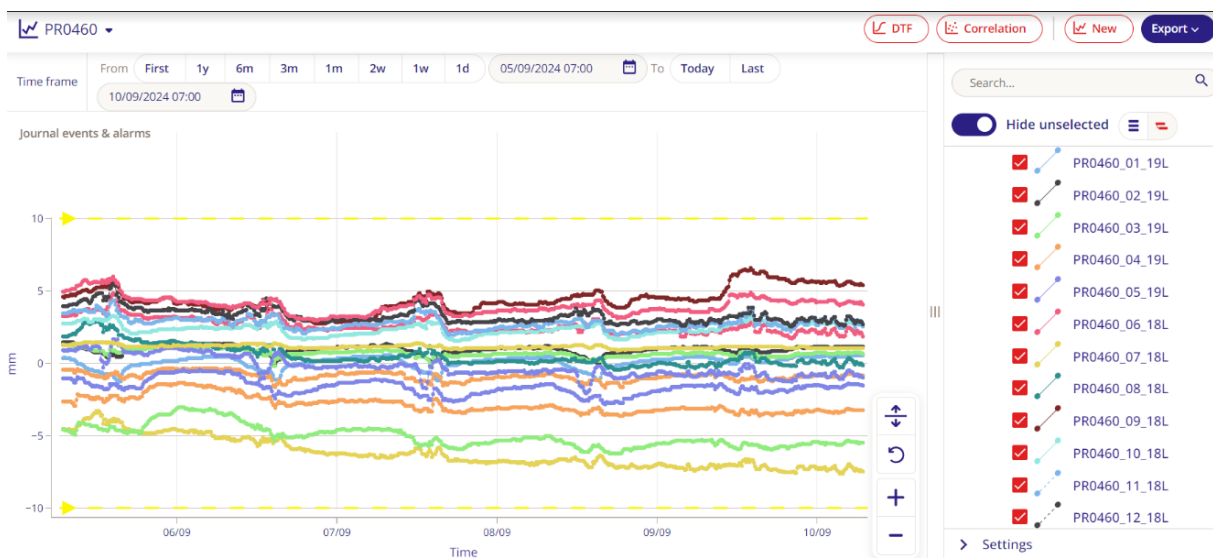
Figure 6-6 Monitoring point PR0460 - Beyond

In Beyond, monitoring points show stabilizing trends, except for PR0460\_09\_18L and PR0460\_16\_18L which showed an uplift followed by a stabilizing downward trend.

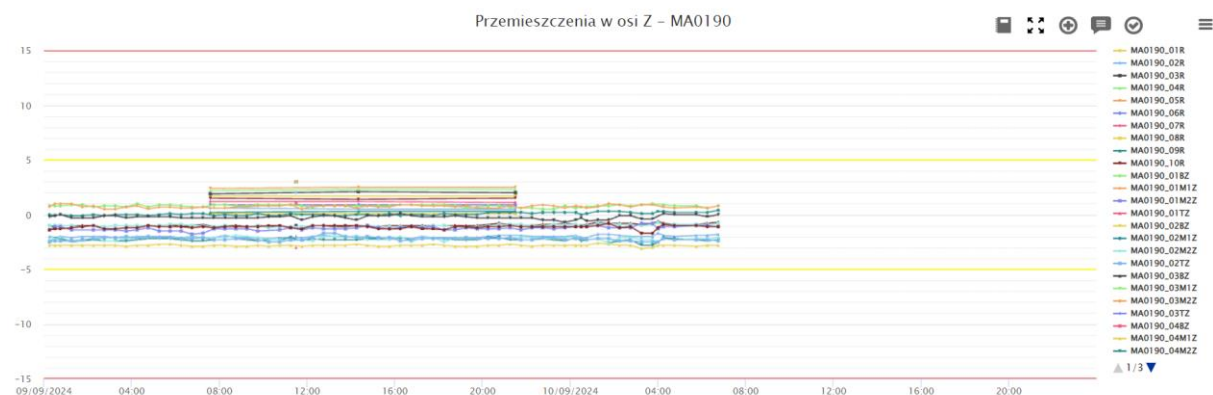
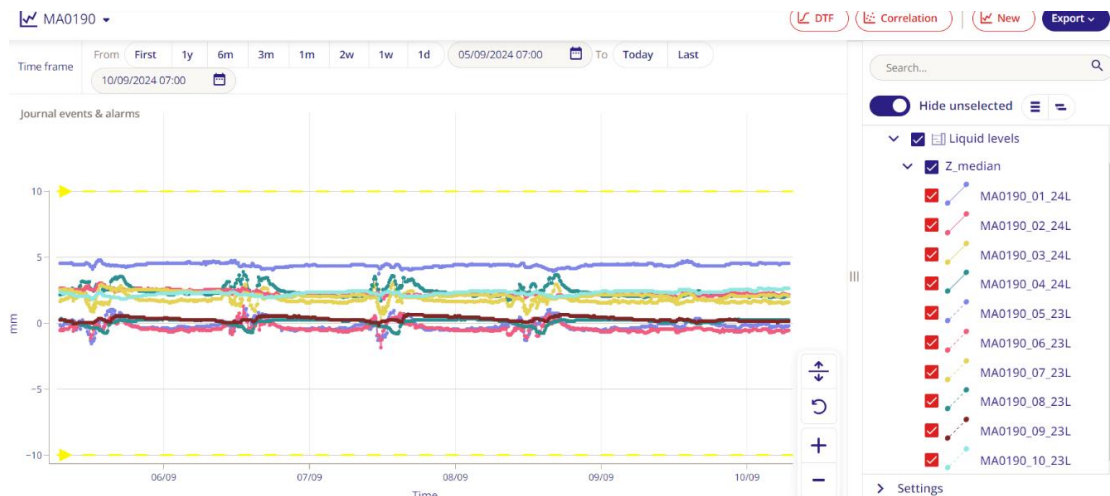
On MA0190, monitoring points are stable.

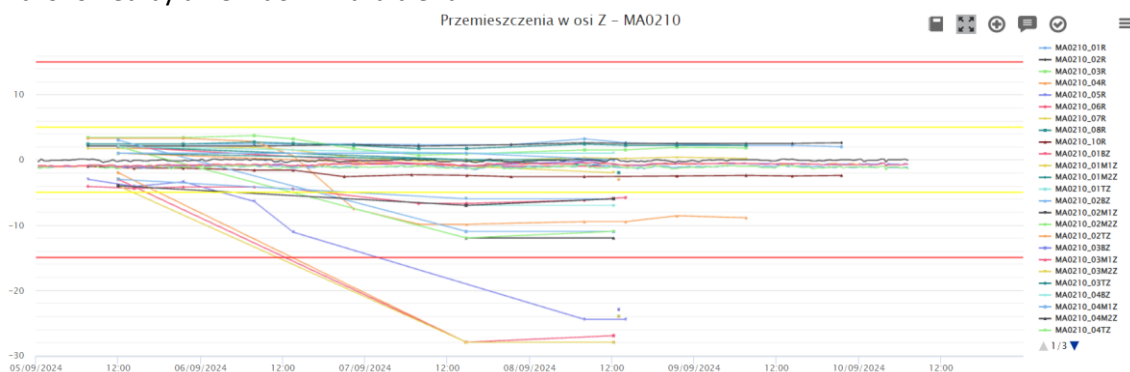
Figure 6-9 Settlement of building MA0210 - Geoscope

On MA0210, Geoscope monitoring points show stabilizing trends starting from 07/09/2024, following the excavation stoppage. It is not possible to appreciate a complete stabilization trend because many points have not recorded new measurements since 08/09/2024 in the morning.

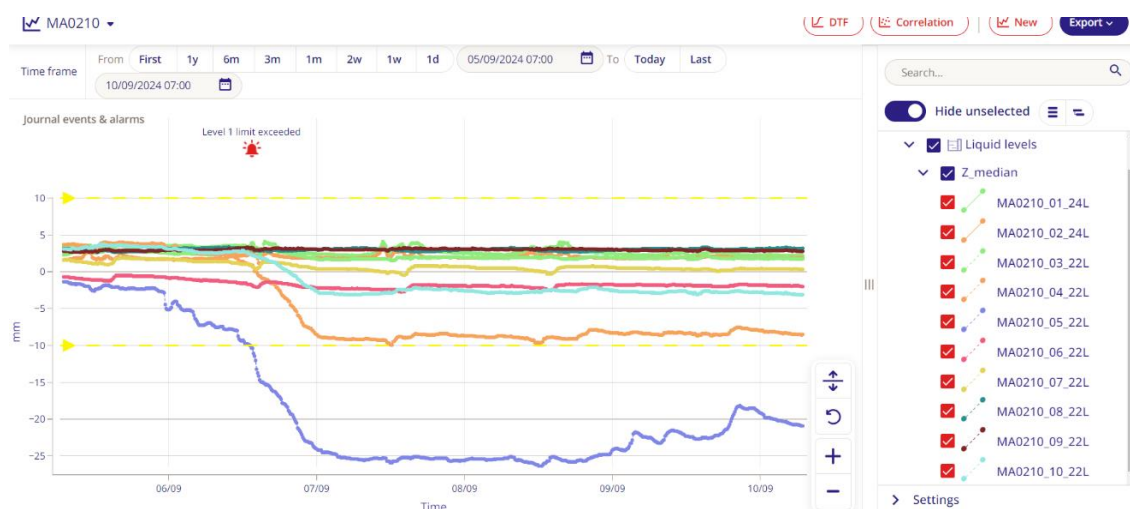
Figure 6-10 Monitoring point MA0210 - Beyond

In Beyond, monitoring points show stabilizing trends, except for MA0210\_05\_22L which showed an uplift followed by a new downward trend.

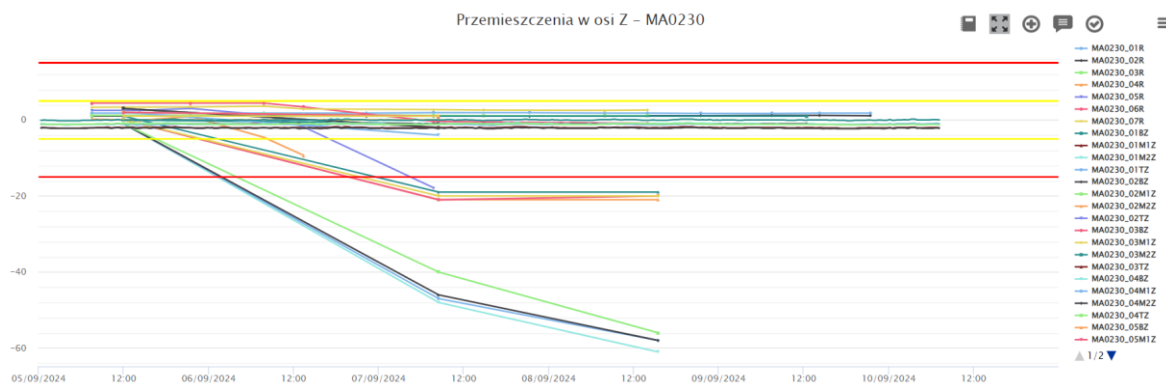
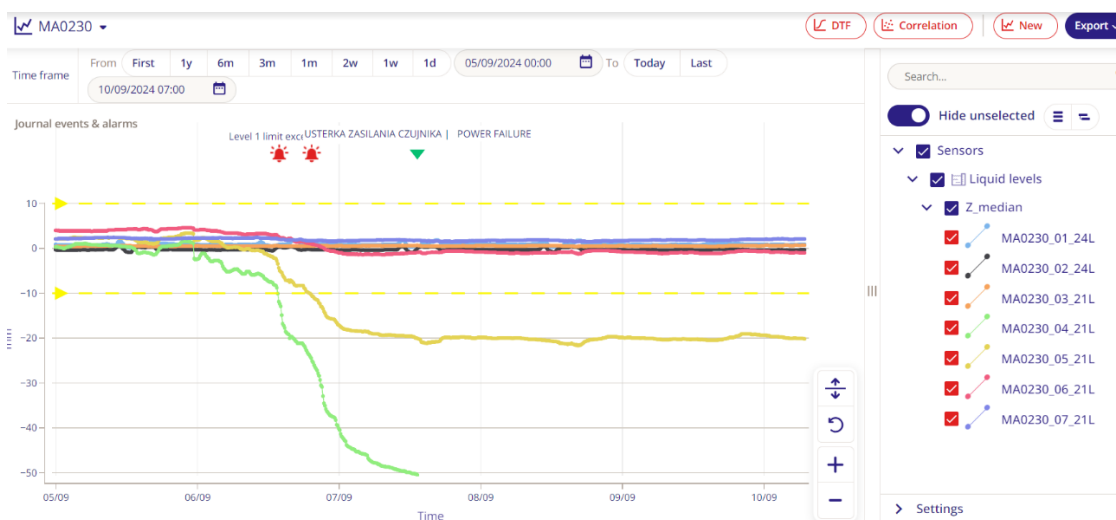
On MA0230, Geoscope monitoring points show stabilizing trends starting from 07/09/2024, following the excavation stoppage. It is not possible to appreciate a complete stabilization trend because many points have not recorded new measurements since 08/09/2024 in the morning.

In Beyond, monitoring points show stabilizing trends.

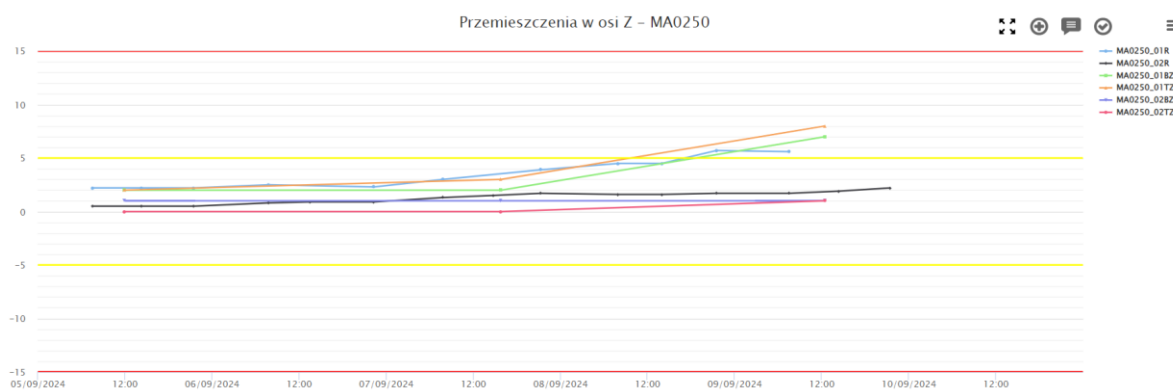
Figure 6-13 Settlement of building MA0250 - Geoscope

On MA0250, monitoring points show an uplift trend, exceeding the attention threshold.

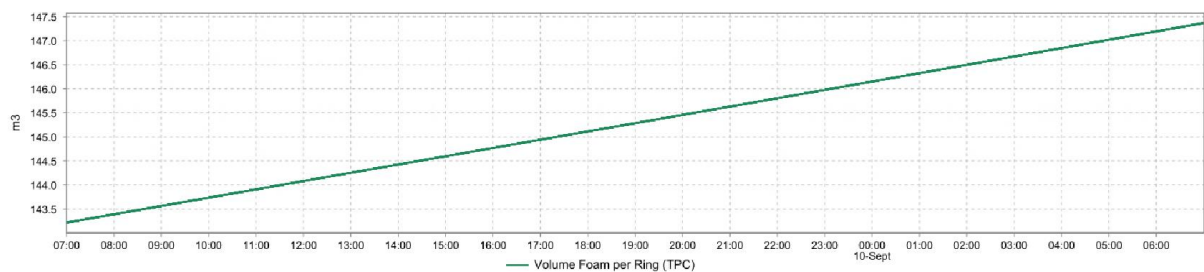
**Figure 8-1 Injected foam volume**

The volume of injected foam is plotted in the following Figure.
