# UDROŻNIENIE ŁÓDZKIEGO WĘZŁA KOLEJOWEGO (TEN-T), ETAP II, ODCINEK ŁÓDŹ FABRYCZNA - ŁÓDŹ KALISKA/ŁÓDŹ ŻABIENIEC – PROJEKT POIIS 5.1-15

## TBM 13.08 M - CONSTRUCTION FOLLOW-UP

| Type of document | Daily Report 10/09/2024 |
| Date | 11/09/2024 |

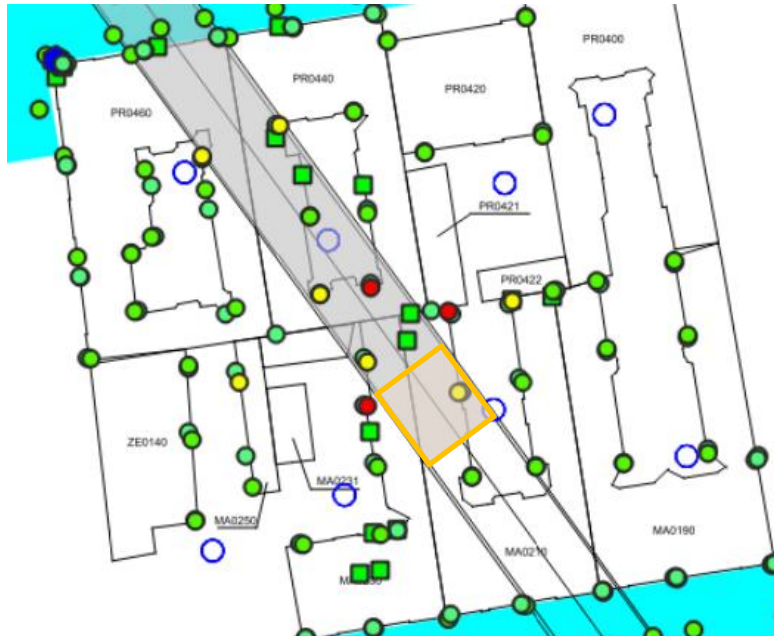
Figure 6-1 Monitoring points – Geoscope

Based on data from Geoscope and Beyond, building subsidence has been observed but is showing signs of stabilization.

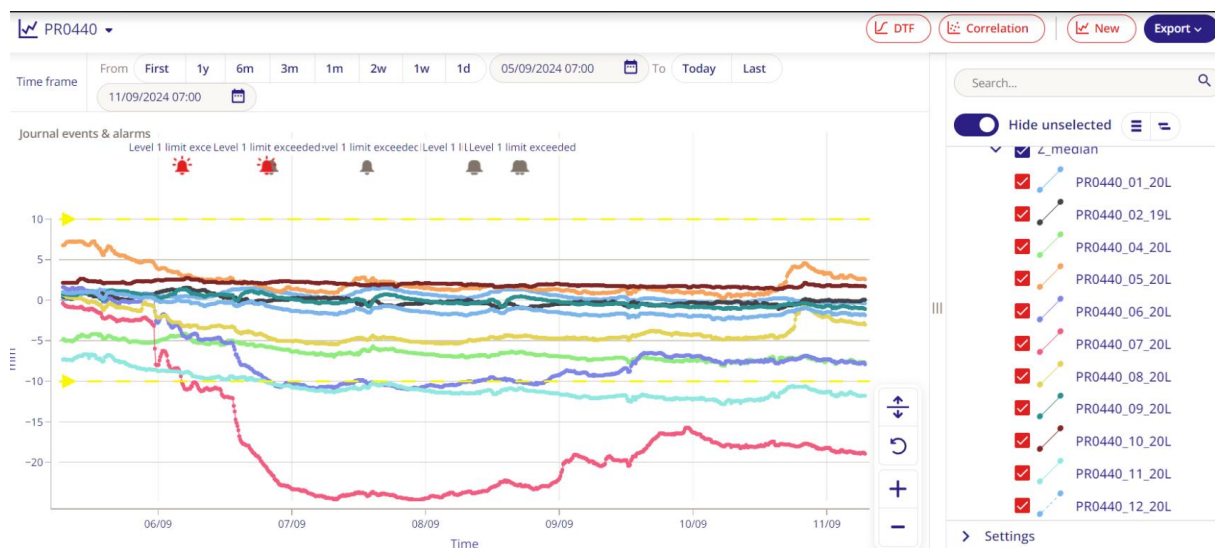
**Figure 6-4 Monitoring point PR0440 - Beyond**

In Beyond, monitoring points show a small downward trend after an uplift.

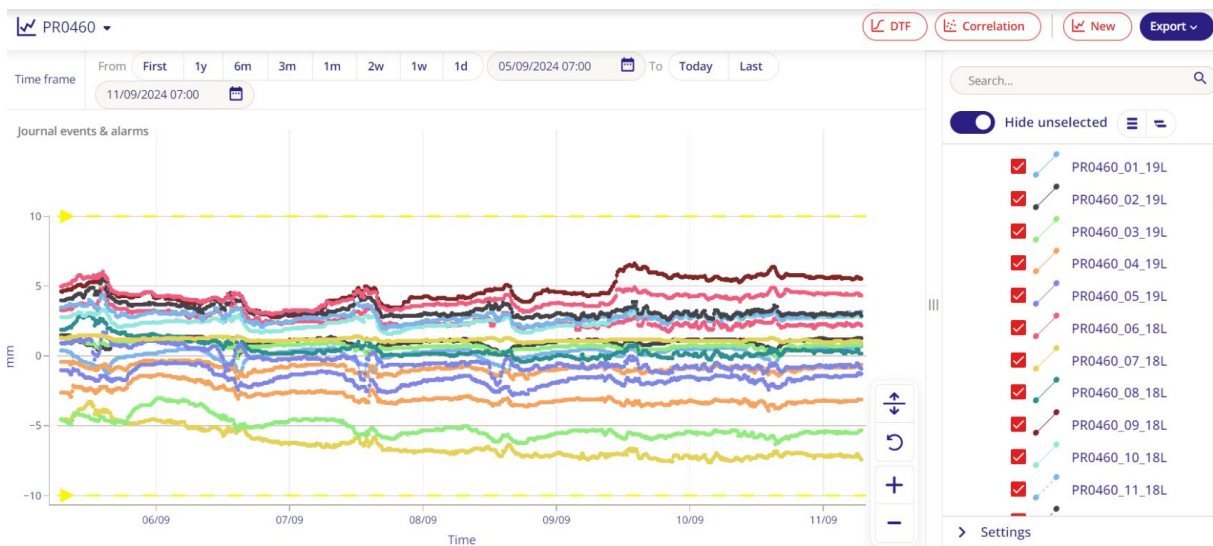
Figure 6-6 Monitoring point PR0460 - Beyond

In Beyond, monitoring points show downward trend for points PR0460\_07\_18L and PR0460\_13\_19L, that have exceeded the attention threshold. Points PR0460\_06\_18L and PR0460\_09\_18L showed a small uplift trend followed by a stabilizing trend.

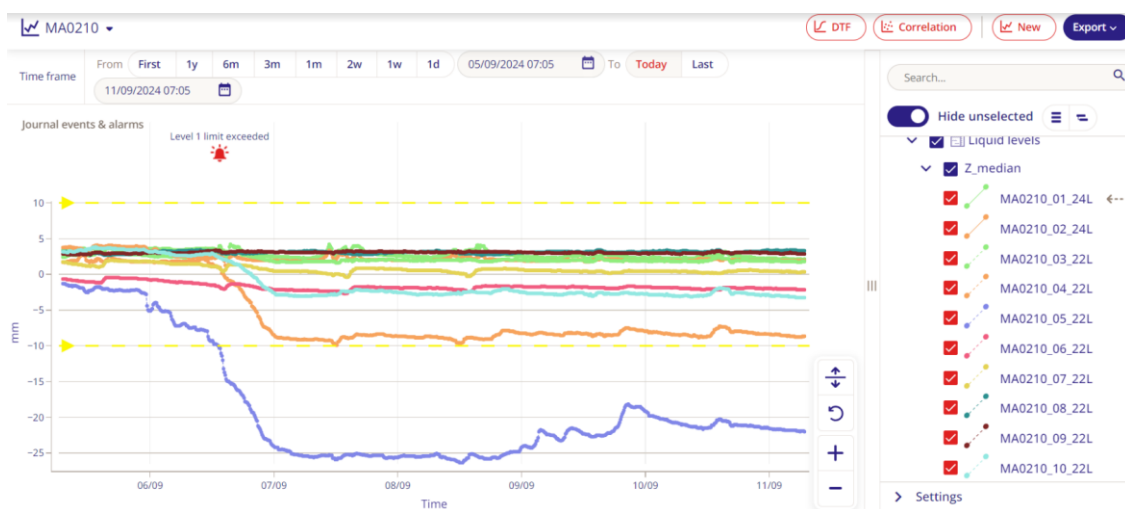
Figure 6-10 Monitoring point MA0210 - Beyond

In Beyond, monitoring points show stabilizing trends, except for MA0210\_05\_22L which showed a small uplift followed by a new downward trend.

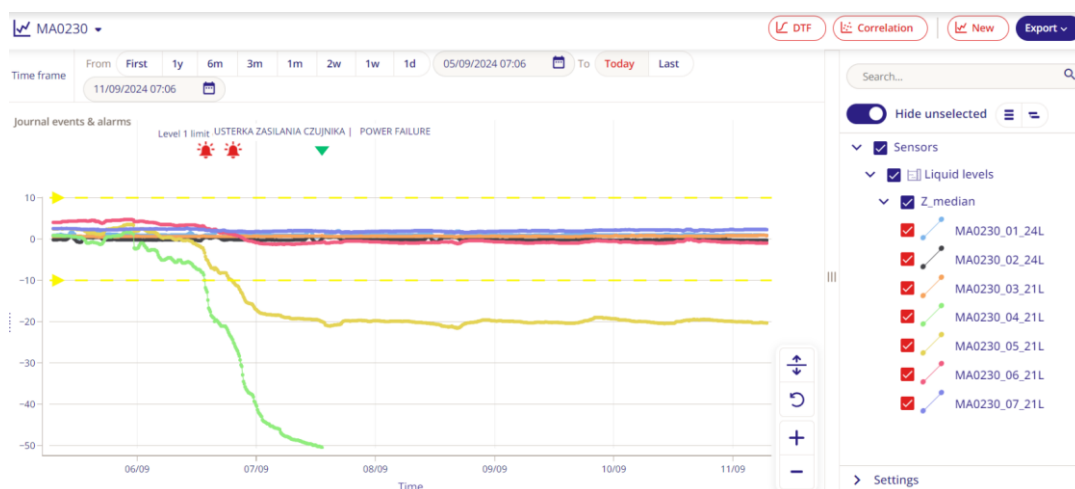
**Figure 6-12 Monitoring point MA0230 - Beyond**

In Beyond, monitoring points show stabilizing trends.
