# UDROŹNIENIE ŁÓDZKIEGO WĘZŁA KOLEJOWEGO (TEN-T), ETAP II, ODCINEK ŁÓDŹ FABRYCZNA - ŁÓDŹ KALISKA/ŁÓDŹ ŻABIENIEC – PROJEKT POIIS 5.1-15

## TBM 13.08 M - CONSTRUCTION FOLLOW-UP

| Task | TBM 13.08 m - CONSTRUCTION FOLLOW-UP |
| Type of document | Daily Report 11/09/2024 |

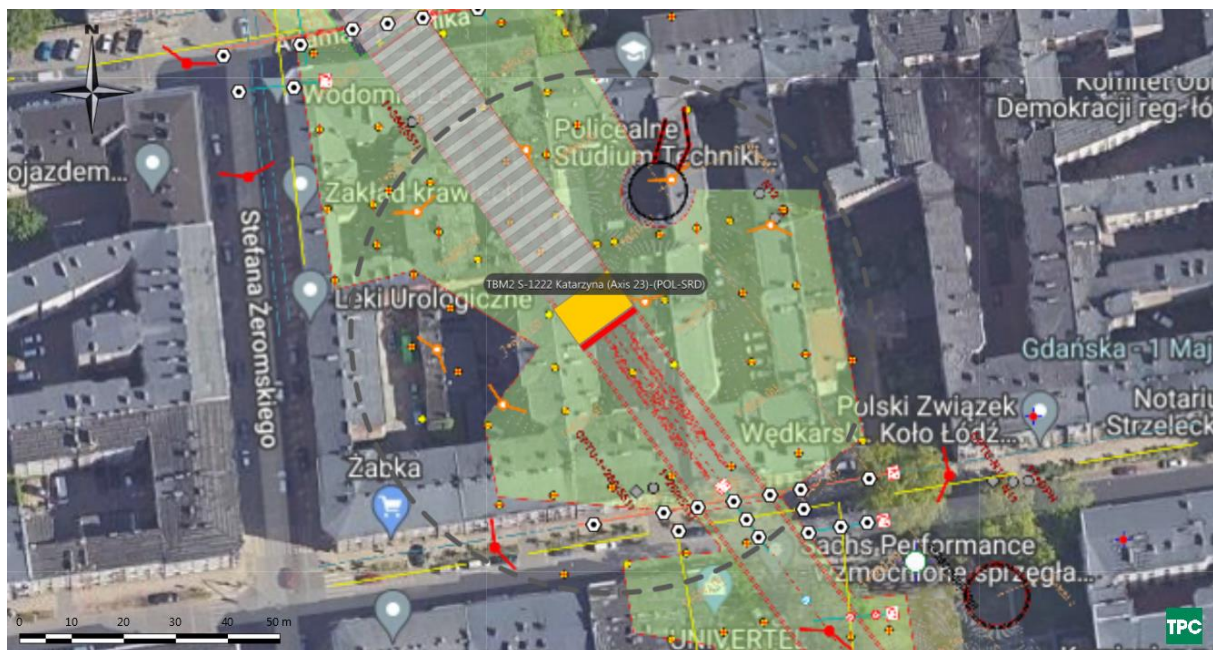
**Figure 1-2 Plan view of TBM Position on 12/09/2024**

According to VMT system, TBM is at Chainage 1+628.92 after the erection of ring n. 269; which corresponds to a total excavation length of 337.55 m from the starting chainage.

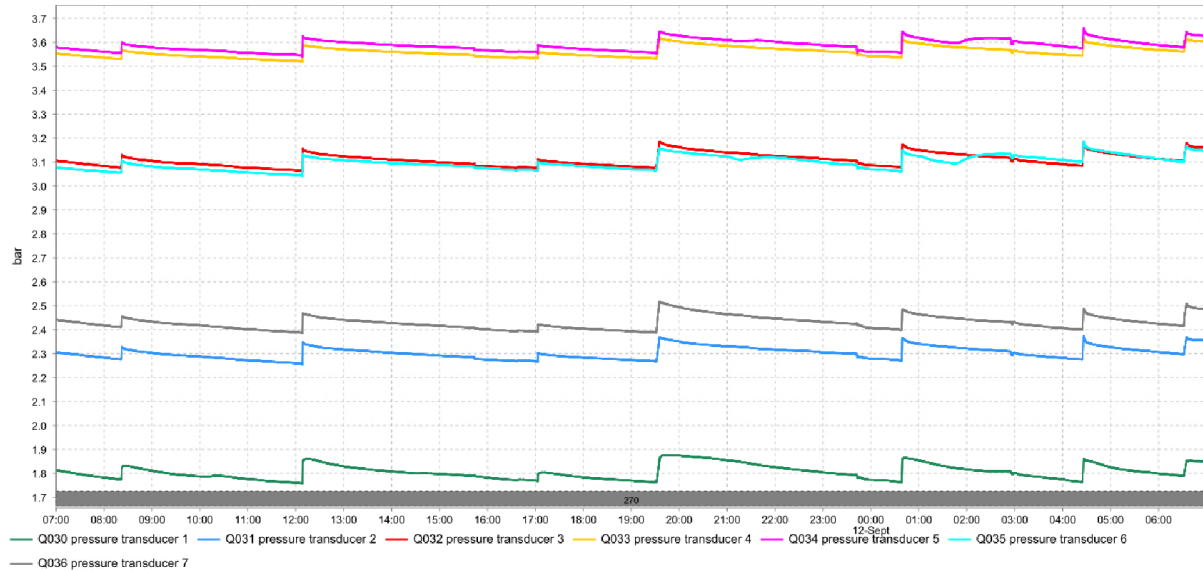
**Figure 2-1 EPB pressure sensor**

Average EPB pressure at the crown is at about 1.8 bar. The value is within the attention values.

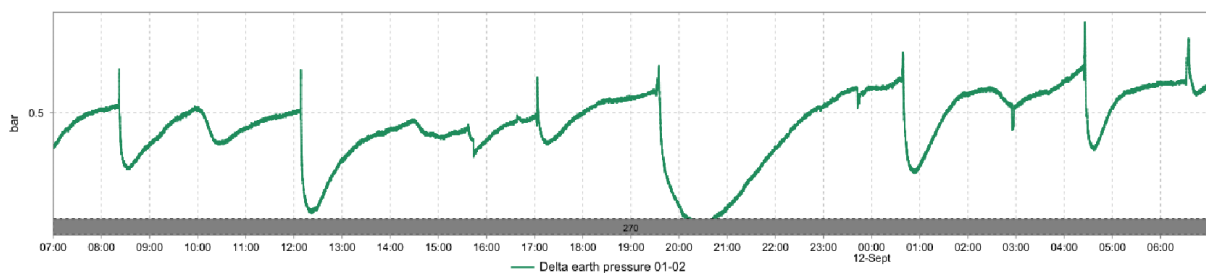
**Figure 2-2 Delta between pressure sensors 1 and 2**

The delta between pressure transducer 1 and 2 has an average value of 0.5 bar indicating that the bulk chamber is filled. The observed value in delta between pressure transducer 1 and 2 is most likely related to the injection of bentonite into the excavation chamber.

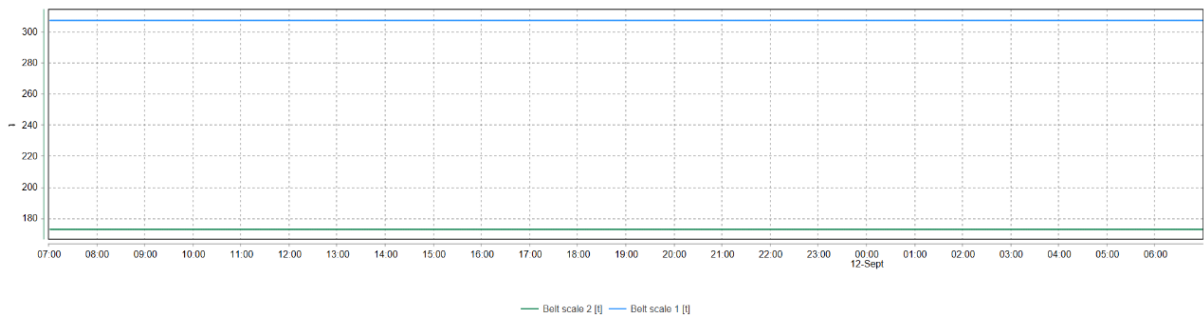
**Figure 2-3 Belt scales**

Belt scale n. 2 shows values lower than n. 1. It could be necessary the recalibration of belts before the restart of TBM excavation. The results of Belt scales have to be compared at the end of excavation of the ring. The belt scale value is a raw indication of the excavated material quantity.

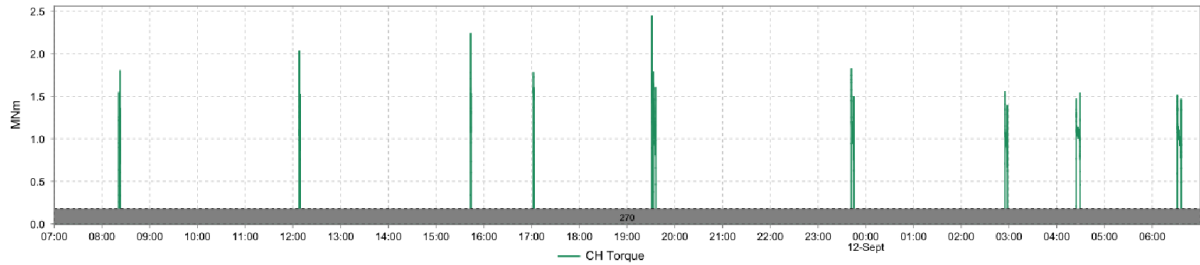
Figure 3-1 CH Torque

Graph for torque, advance rate and thrust force are below shown. The torque graph shows non-zero values due to the rotation of the cutterhead.

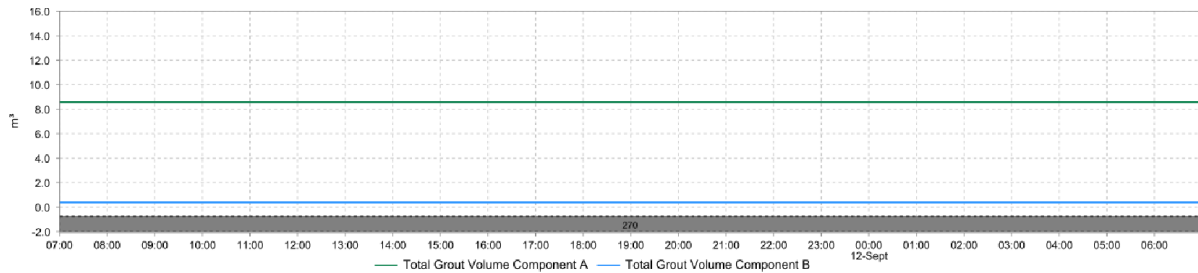
**Figure 4-1 Grout volumes**

Grout injection volume has to be compared to minimum theoretical annular volume  $\pm 10\%$  of  $13.54 \text{ m}^3$  at the end of ring excavation. Ratio B/A is at 5%. It was noted that peaks observed for average injection pressure lines are related to cleaning processes.

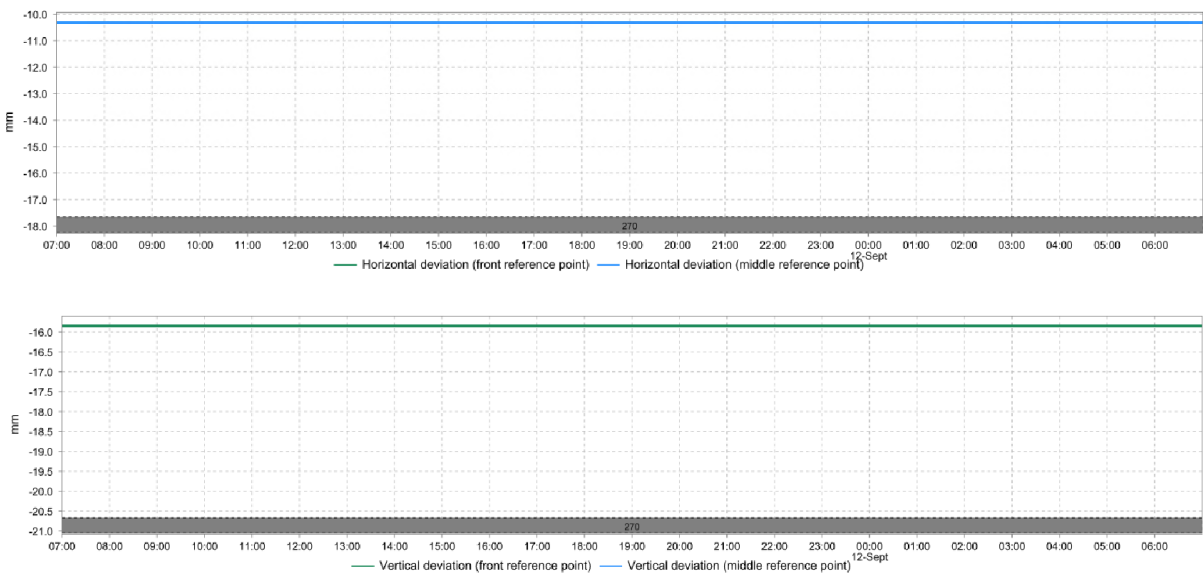
Figure 5-1 Machine deviation from the alignment

The TBM vertical deviation is of about -15.85 mm on the front edge of the shield and the horizontal deviation of about -17.86 mm (Figure 5-1). Maximum radial deviation is of 23.88 mm.

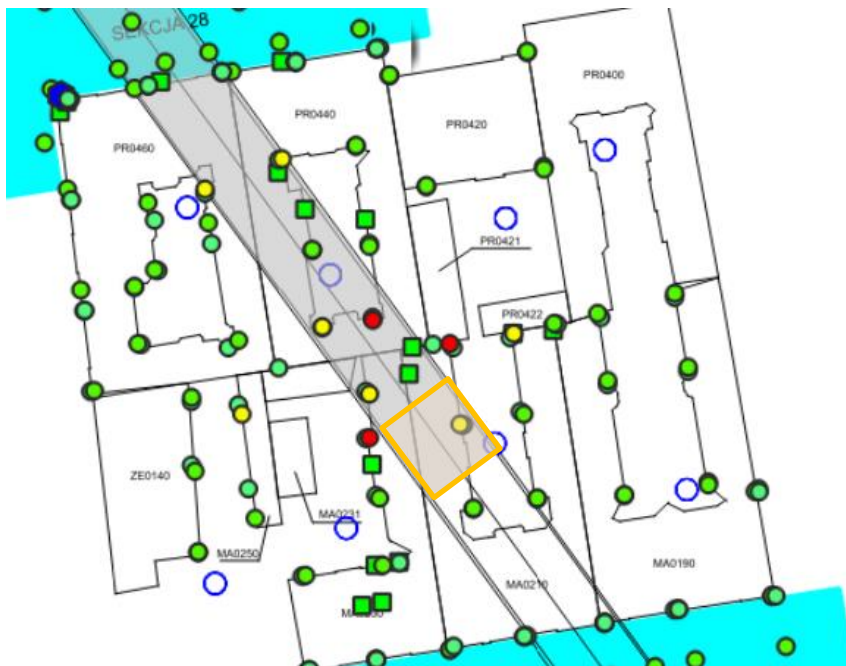
Figure 6-1 Monitoring points – Geoscope

Based on data from Geoscope (manual geodetic measurements) and Beyond (hydromonitoring measurements), building subsidence has been observed but is showing signs of stabilization.

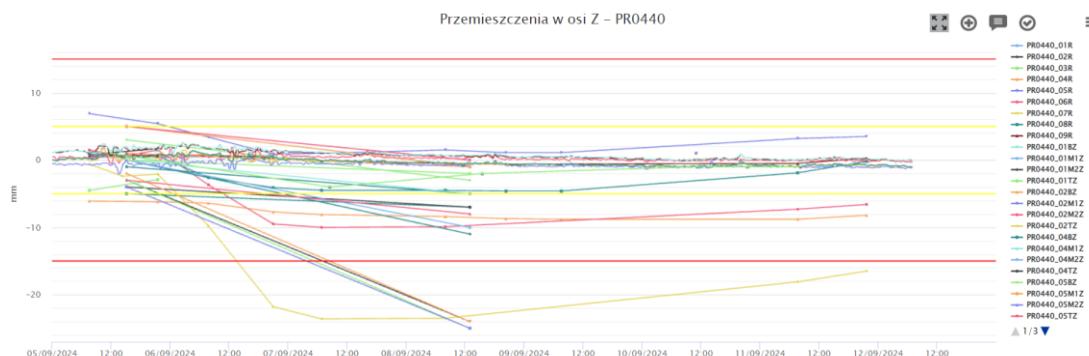
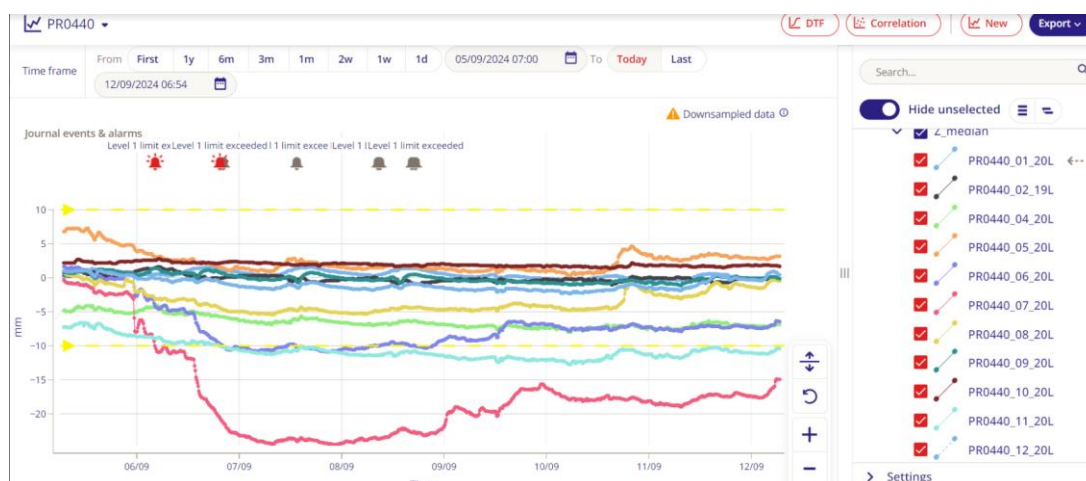
On PR0440, Geoscope monitoring points show uplift trends. However, not all trends can be fully assessed, as some points have not recorded new measurements since the morning of 08/09/2024. In Beyond, monitoring points show stabilizing trends, except for PR0440\_07\_20L and PR0440\_08\_20L which shows an uplift trend.

**Figure 6-3 Settlement of building PR0440 - Geoscope**

**Figure 6-4 Settlement of building PR0440 - Beyond**

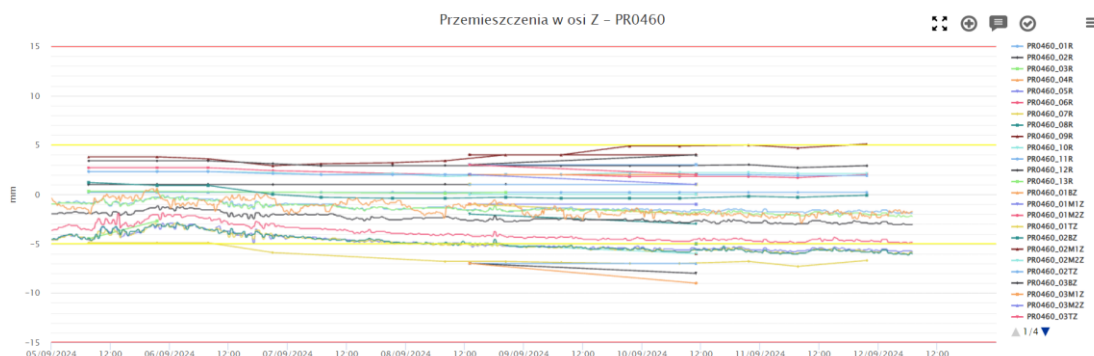
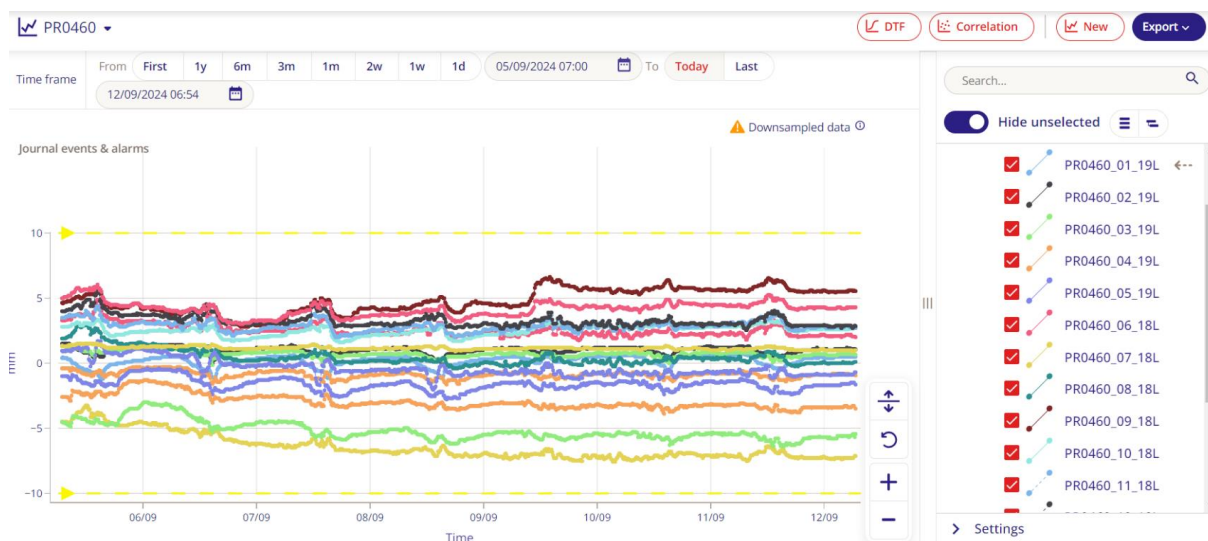
On PR0460, from Geoscope most of the monitoring points are stable. However, not all trends can be fully assessed, as some points have not recorded new measurements since the morning of 10/09/2024. In Beyond, monitoring points are stable.

**Figure 6-5 Settlement of building PR0460 - Geoscope**

Figure 6-6 Settlement of building PR0460 - Beyond

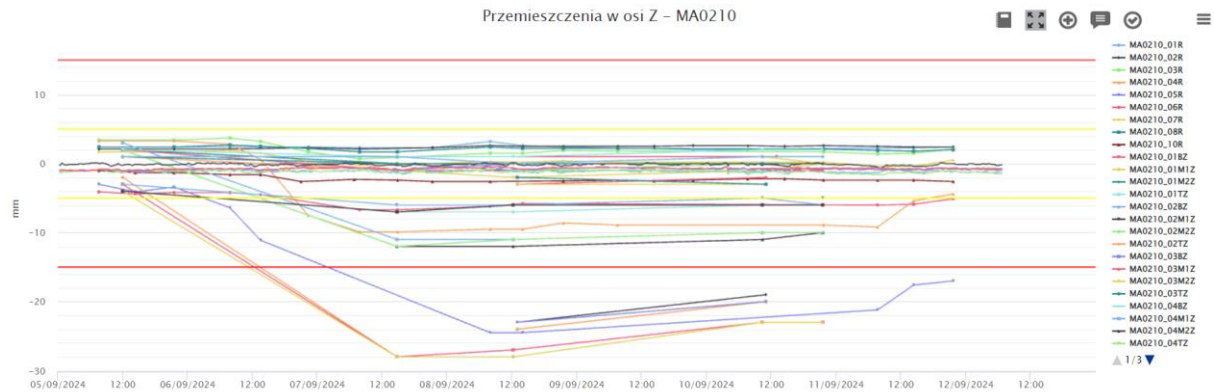
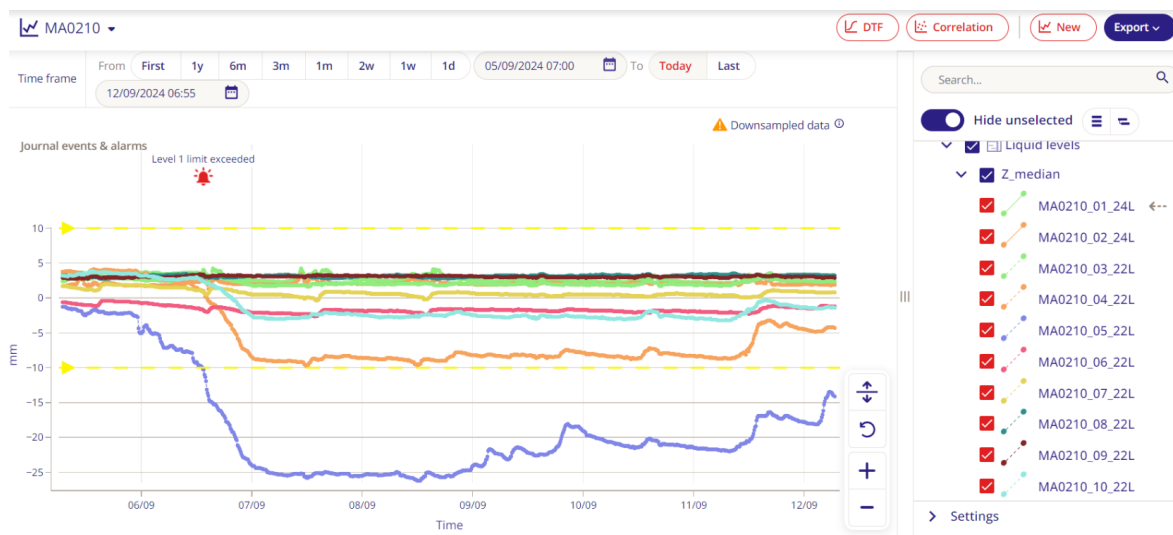
On MA0210, Geoscope monitoring points MA0210\_04R, MA0210\_05R and MA0210\_06R show uplift trends. In Beyond, monitoring points MA0210\_03\_22L, MA0210\_04\_22L, MA0210\_05\_22L show uplift trends.

**Figure 6-9 Settlement of building MA0210 - Geoscope**

**Figure 6-10 Settlement of building MA0210 - Beyond**

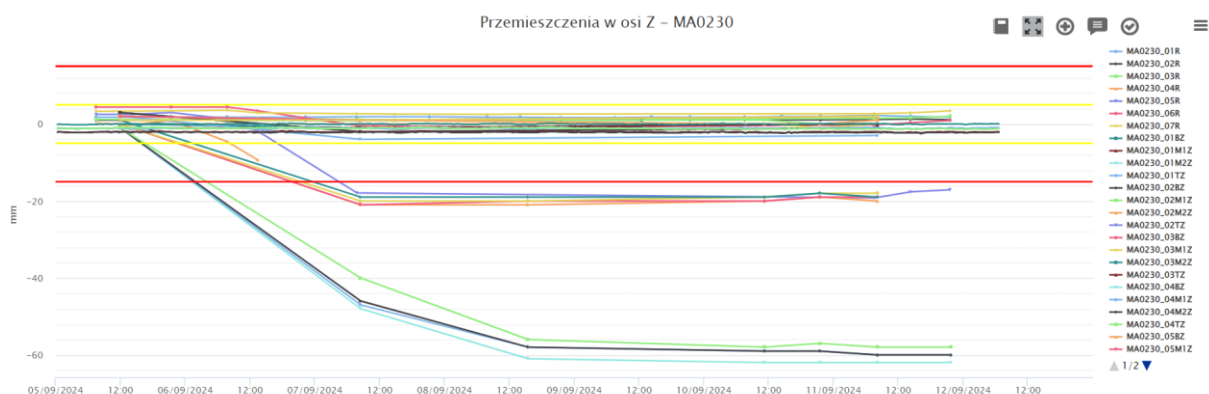
**Figure 6-11 Settlement of building MA0230 - Geoscope**

On MA0230, monitoring points are stable.

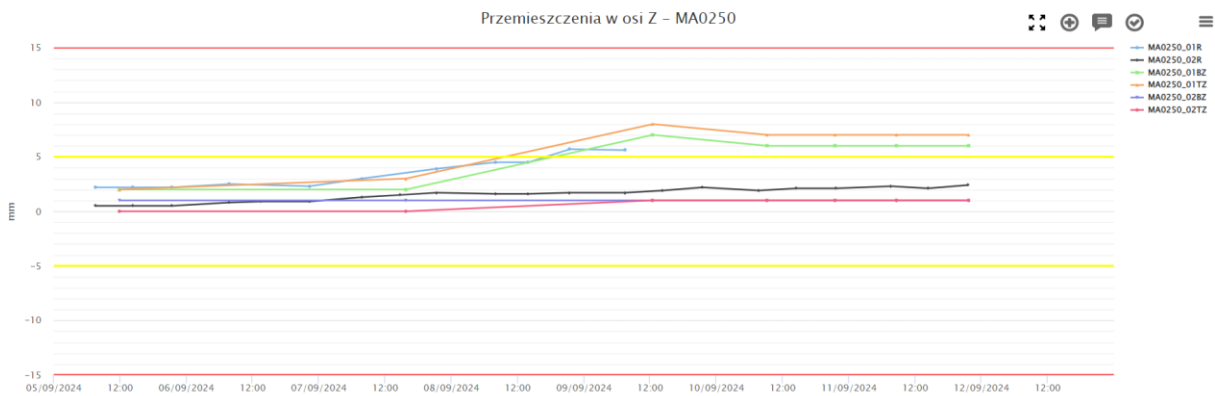
Figure 6-13 Settlement of building MA0250 – Geoscope

On MA0250, monitoring points are stable.
