# UDROŻNIENIE ŁÓDZKIEGO WĘZŁA KOLEJOWEGO (TEN-T), ETAP II, ODCINEK ŁÓDŹ FABRYCZNA - ŁÓDŹ KALISKA/ŁÓDŹ ŻABIENIEC – PROJEKT POIIS 5.1-15

## TBM 13.08 M - CONSTRUCTION FOLLOW-UP

| Type of document | Daily Report 12/09/2024 |
| Document ID | LWK-000-T-KO-SWS-210483_00.docx |

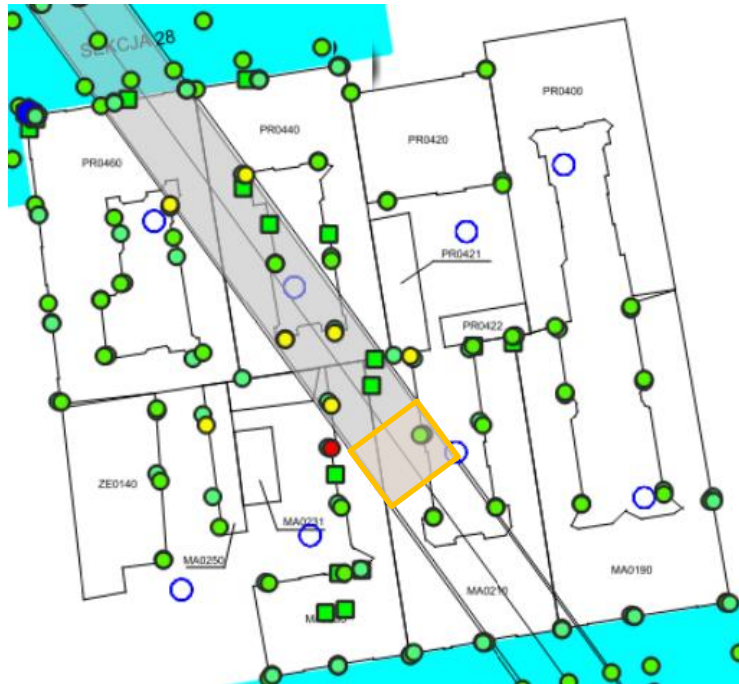
Based on data from Geoscope (manual geodetic measurements) and Beyond (hydromonitoring measurements), building subsidence has been observed but is showing signs of uplift.

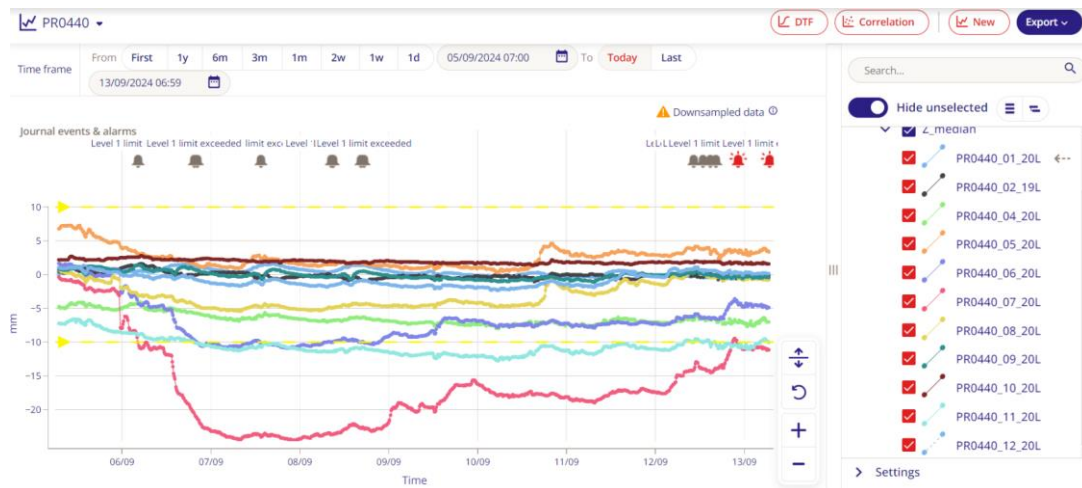
On PR0440, Geoscope monitoring points show uplift trends, especially for PR0440\_06R and PR0440\_07R. In Beyond, monitoring points have shown stabilizing trends since 9:00 pm on 12/09/2024, following the prior uplift.

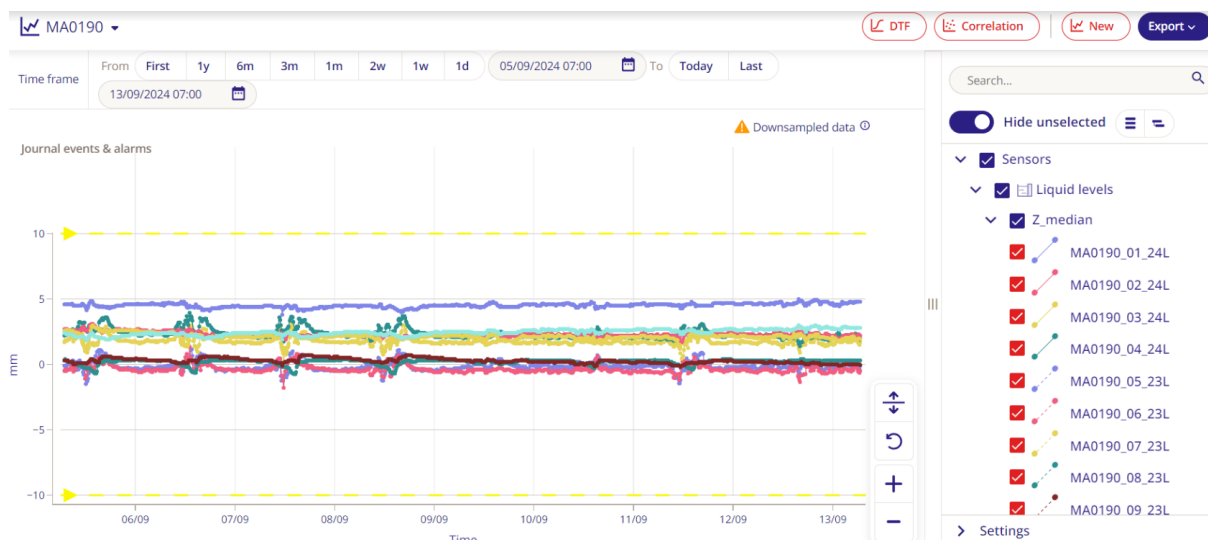
On MA0190, monitoring points are stable.

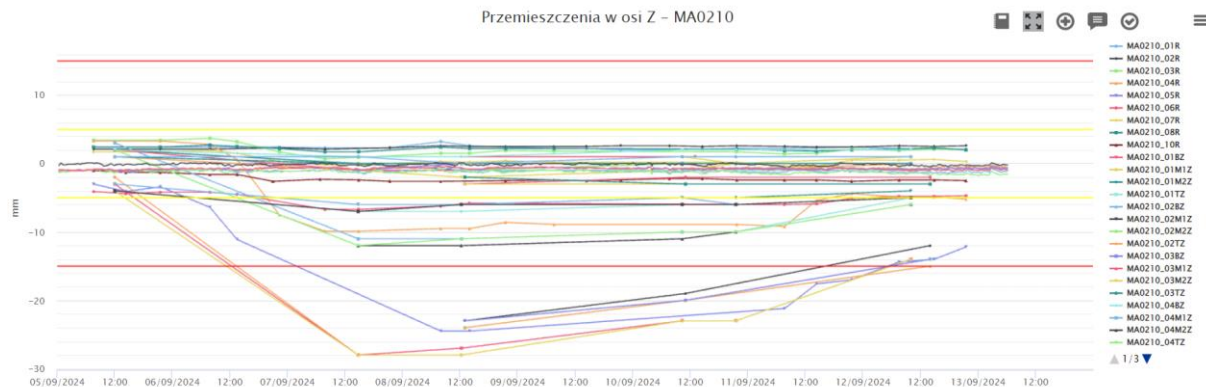
On MA0210, Geoscope monitoring points MA0210\_04R, MA0210\_05R and MA0210\_06R show uplift trends. In Beyond, monitoring points MA0210\_03\_22L, MA0210\_04\_22L, MA0210\_05\_22L show uplift trends.
