Thermal Saturation, Current Degradation and Mechanical Load Analysis in Electromagnetic Diverter Gates

Francisco González

Maintenance Mechanic, USPS Chicago P&DC

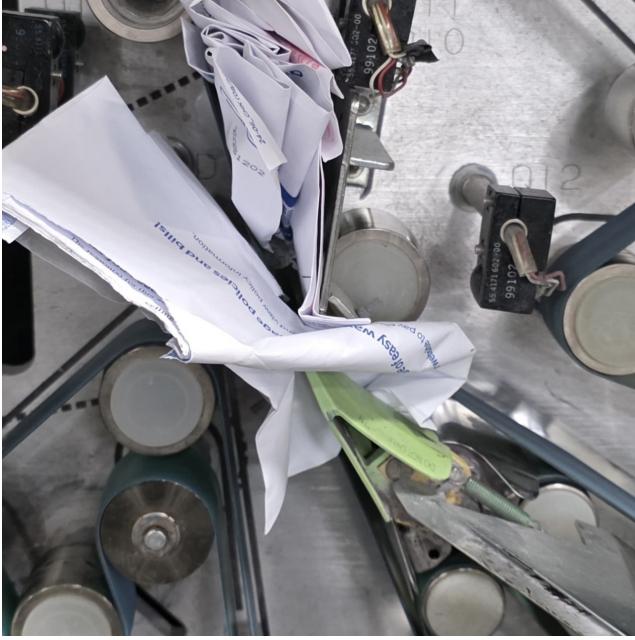
During normal operation, a large jam occurred. The diverter gate was extremely hot to the touch and exhibited delayed motion. Immediately after stopping the machine, the coil resistance initially exceeded 16Ω , consistent with severe thermal saturation. However, because the coil cools relatively quickly once de-energized, the measured value had already dropped to 15.4Ω by the time the multimeter was connected. This rapid resistance decay further confirms that the coil was operating in an overheated state compared to its baseline cold value of 13.9Ω . The jam event therefore, provides direct field evidence of the thermal overload failure mode.

Fig. 2: Large jam event associated with a thermally saturated gate.

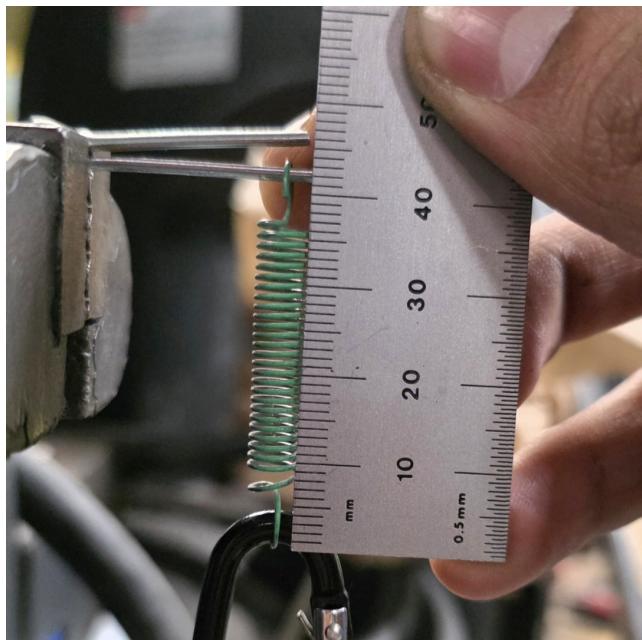
The measured free length for both springs was approximately $L_0 = 17\text{ mm}$. Under the same applied reference load, the worn spring extended to 44 mm, while the new

spring extended to 39 mm. These correspond to extensions of $x_{\text{old}} = 27\text{ mm}$ and $x_{\text{new}} = 22\text{ mm}$, respectively.

This indicates that the new spring is approximately 23% stiffer than the worn spring under the same reference load.

Fig. 4: Worn Spring.
